CENTRAL FILE COPY  
**TECHNICAL NOTE**

T/N-14

Bureau of Land Management U.S. DEPARTMENT OF THE INTERIOR

FORD TRUCKS - PARTS AND SERVICE RECOMMENDATIONS

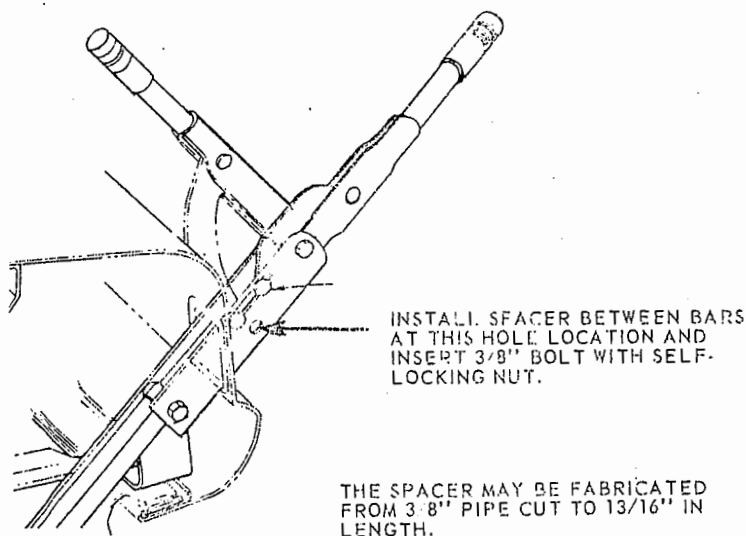
Figure 1 - Parking Brake Lever "C" Series

Effective September, 1968, the Orscheln parking brake lever on "C" Series trucks was revised by incorporating an additional spacer and rivet in the slot area between the two support bars. This change was made to reduce the possibility of the bars deforming if the parking brake lever is used as a grab handle when entering the cab.

The new lever is available for service under part number C5TZ-2780-B and can be identified by the presence of a rivet and spacer in the hole shown in Figure 1.

Parking brake levers on vehicles in service may be updated by inserting a spacer between bars and installing a 3/8" bolt and nut in place of the rivet used on production assemblies.

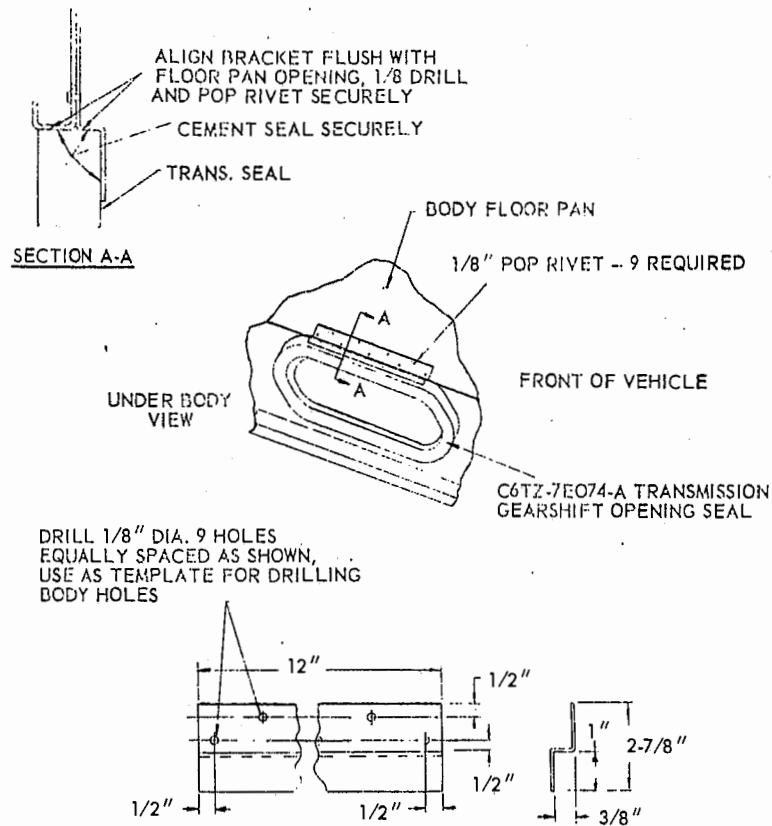
Figure 2

To correct water and dirt entry into the cab through the transmission gearshift lever opening when the seal is distorted, add a bracket to the underside of the body floor pan to provide additional support for the opening seal. Figure No. 2 includes all necessary information for fabrication and installation of the bracket.

A new opening seal, Part Number C6TZ-7E074-A, may also be required.

MATERIAL: 3-1/4" x 12" x 1/16" STEEL OR ALUMINIM

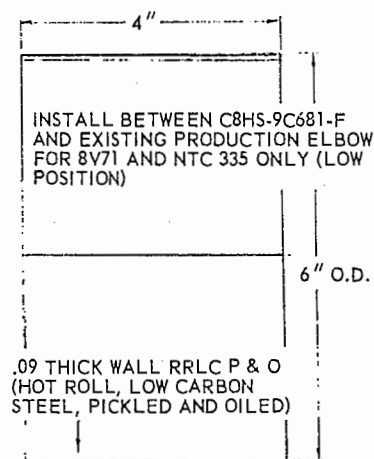
Figure 3

\* Parts are required to adopt new cleaner to the existing system. The oil bath cleaner for the 8V71 and NTC 335 engines incorporated a metal elbow. The new dry cleaner does not have the metal elbow and therefore the additional rubber elbow and sleeve are required to complete the installation as shown in Figures 3 & 4. The rubber elbow must be reworked by removing a small section of rubber as shown in Figure 7 to allow the hose to properly fit onto the cleaner outlet.

Chart 1 and Figures 3 and 4 list parts required to convert the oil bath air cleaner with minimum rework. The parts listed are DSO or RPO released.

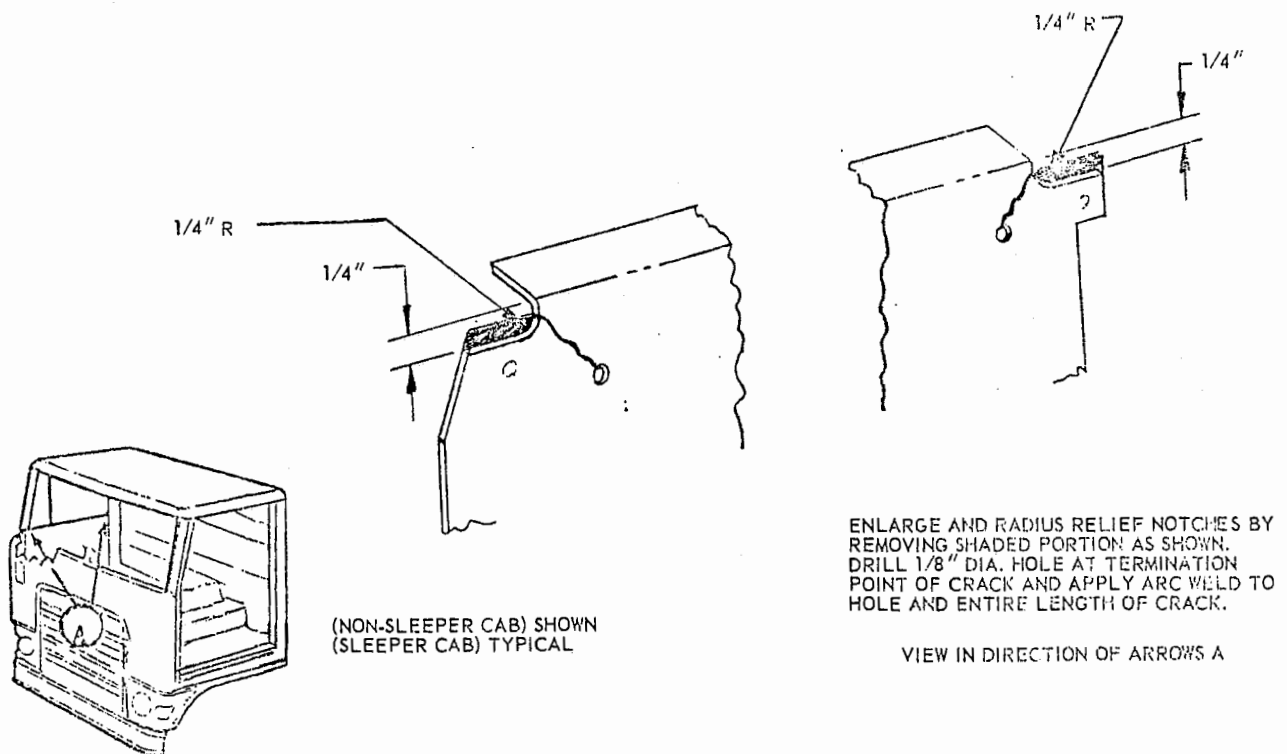
Figure 5

If sheet metal cracks occur at the front and rear belt relief notches of the door inner panels, the following procedure should be used. The production correction which enlarges the radius in the relief notches by removing metal from the vertical and horizontal trim lines was incorporated during July 1968.

1. Remove the door inner upper panel as described in the 1968 Truck Shop Manual, Volume Three, Page 17-54.
2. Drill a 1/8" diameter hole at the termination point of the sheet metal crack.
3. Enlarge and radius the front and rear belt relief notches on the door as shown in Figure 5.
4. Apply arc weld to the drilled holes and the entire length of the cracks.
5. Metal finish and repaint the repaired area as required.

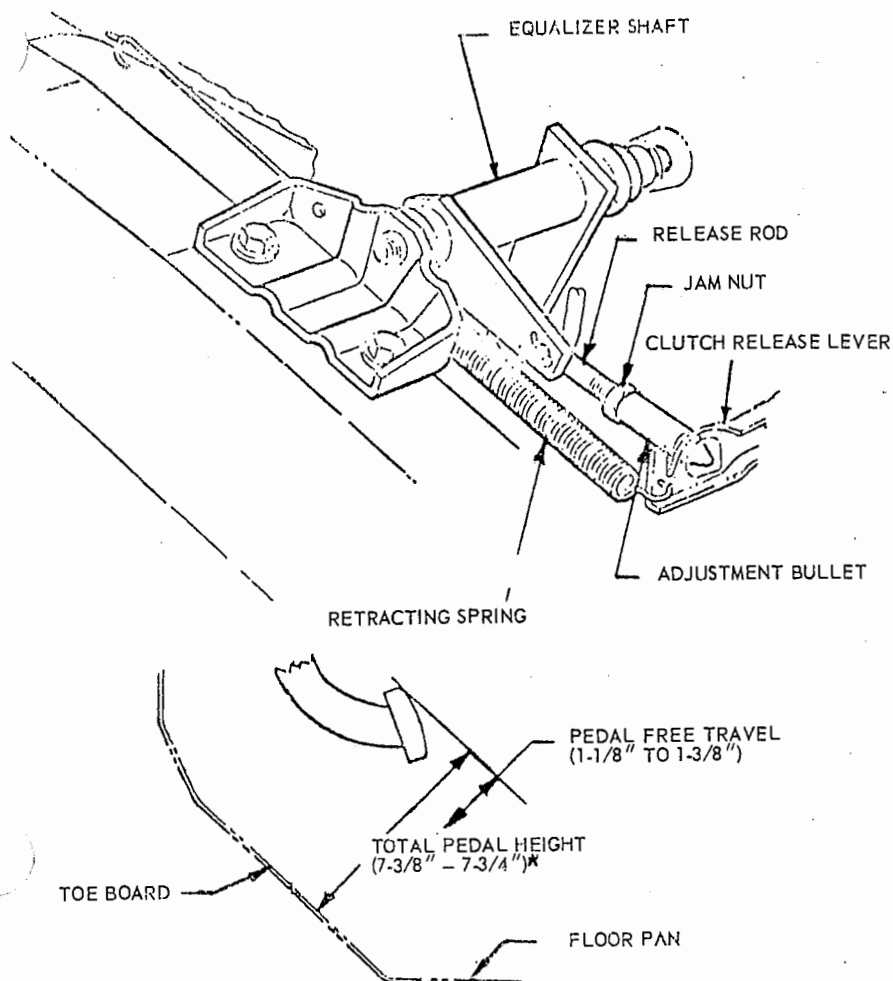
Figure 6

The clutch pedal "free travel" at the release rod "bullet" has been revised to .200 inch. To correctly adjust "free travel" follow this procedure:

NOTE: The clutch pedal height dimension remains at 7.38" - 7.75". Free travel at pedal pad is 1-1/8 to 1-3/8 inches.

1. Make sure the retracting spring is attached to the clutch release lever.
2. Loosen jam nut and back off five (5) or more turns.
3. Turn release rod "bullet" lightly against the clutch release lever facing. Use caution not to force "bullet" against the clutch release lever causing it to move against the retracting spring.
4. Place .200" gauge between the release rod "bullet" face and jam nut.
5. Return jam nut against gauge.
6. Remove gauge.
7. Hold jam nut in this position and rotate release rod "bullet" against the jam nut and tighten. (Torque specification is 12/18 ft.lbs.)

\* Mat/Carpet and/or Insulation must be folded out of way. Measure to sheet metal, perpendicular to toe board.
