## TECHNICAL NOTE

Filing Code 1525 (P-401)

Bureau of Land Management U.S. DEPARTMENT OF THE INTERIOR

FORD TRUCKS

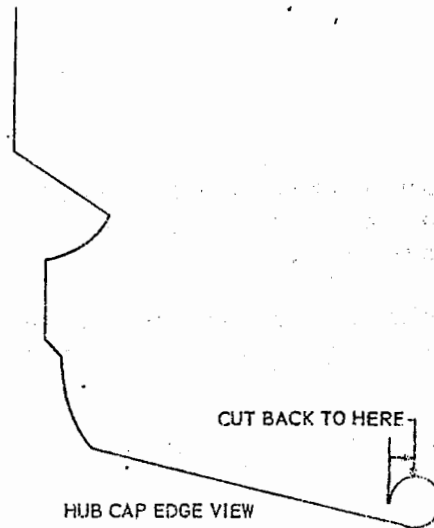
Figure 1

VI. Hub Cap Retention. (F&P250/350-1968-69)

To improve retention remove hub caps and grind the rolled inner edge of the cap at two opposite spots to match the two retaining bosses on the wheel. Remove metal from the inner rolled edge to a point approximately one-third of the total edge. Refer to Figure 1.

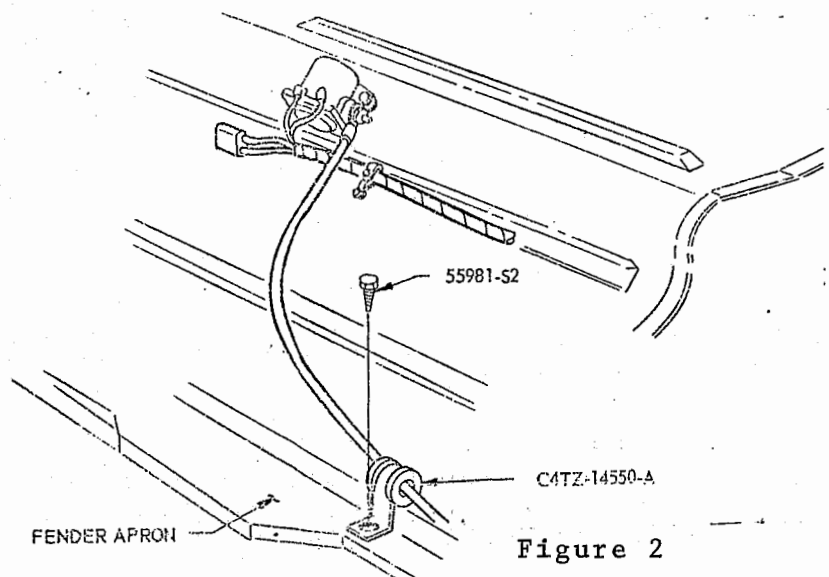
Figure 2

XIII. Grounded Starter Cable to Frame. (1968 - 69 F&B 500-750 Series Trucks)

To preclude the starter cable grounding on the frame, mount a new cable support, C4TZ-14550-A, to the right hand fender apron using a self tapping screw, Part No. 55981-S2 (1/4 inch - 14 x 1/2 inch). Refer to Figure 2.
