# TECHNICAL NOTE

Filing Code 1525 (P-401)

Date Issued December 15, 1969

Bureau of Land Management U.S. DEPARTMENT OF THE INTERIOR

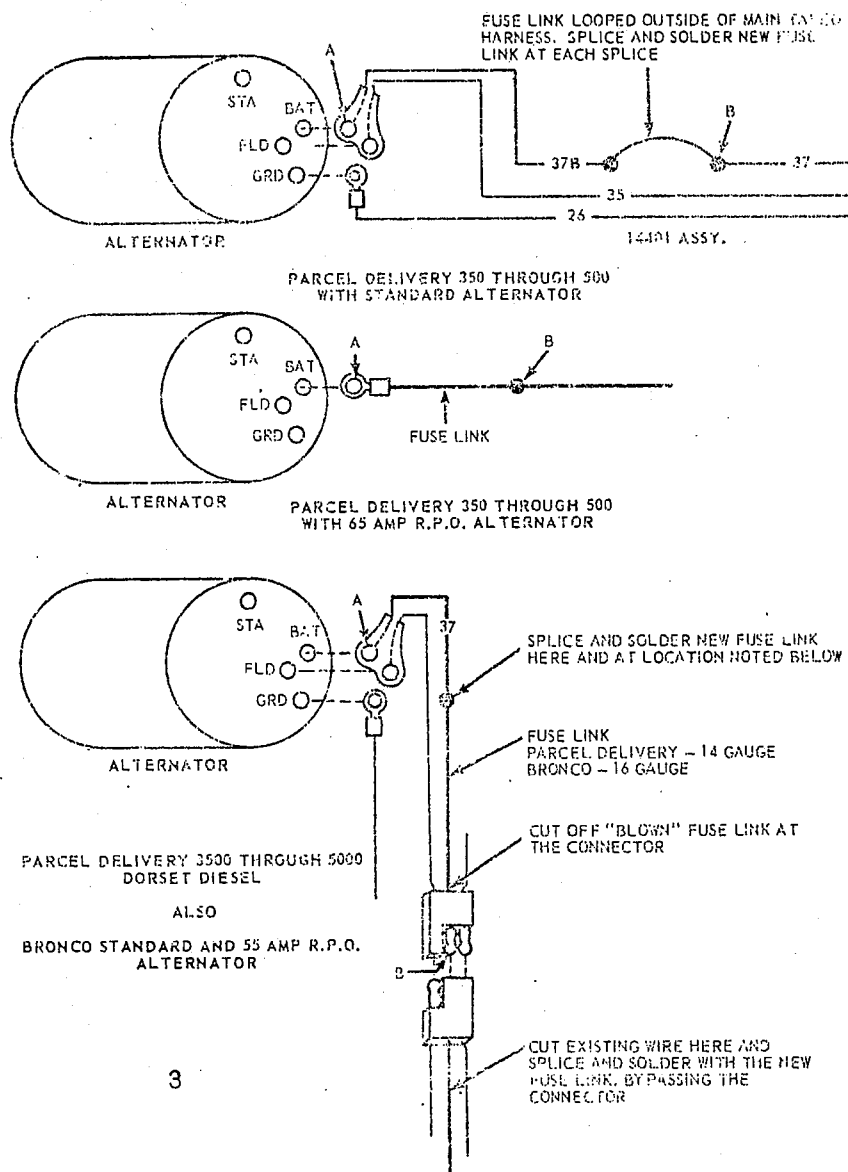
3. FUSE LINK-CHARGING CIRCUIT (All 1969 cars except Thunderbird, all light trucks, and 1970 Maverick)

A burned out link will generally have bare wire ends protruding from the insulation, or it may only have expanded or bubbled insulation with illegible identification. If it is hard to determine if the link is burned out, perform a continuity test (see main article). Do not puncture the fuse link insulation. Replace the fuse link by the procedure given if the link burns out.

- A. Disconnect the battery ground cable.
- B. Disconnect the fuse link from the battery stud of the starter relay. On the Bronco and Parcel Delivery, disconnect the wires from the BAT terminal of the alternator. Refer to Figure 1.
- C. On all vehicles except the Bronco and Parcel Delivery, use an ohmmeter or self-powered test light and check for continuity between the fuse link eyelet terminal and the BAT terminal on the alternator.

- D. On the Bronco and Parcel Delivery vehicles, include an ohmmeter or a self-powered test light and check for continuity between points A. and B. Refer to Figure 1.
- E. A good fuse link will light the test light or show zero resistance on the ohmmeter.
- F. Connect all wires and the battery cable if the fuse link is OK.

E. Cut out the original splice(s), then splice and solder the new fuse link with existing wires from the original splices. Wrap completely with vinyl electricians tape. Refer to Figure 1 for a fuse link terminating in a multiple connector on the Bronco and Parcel Delivery.

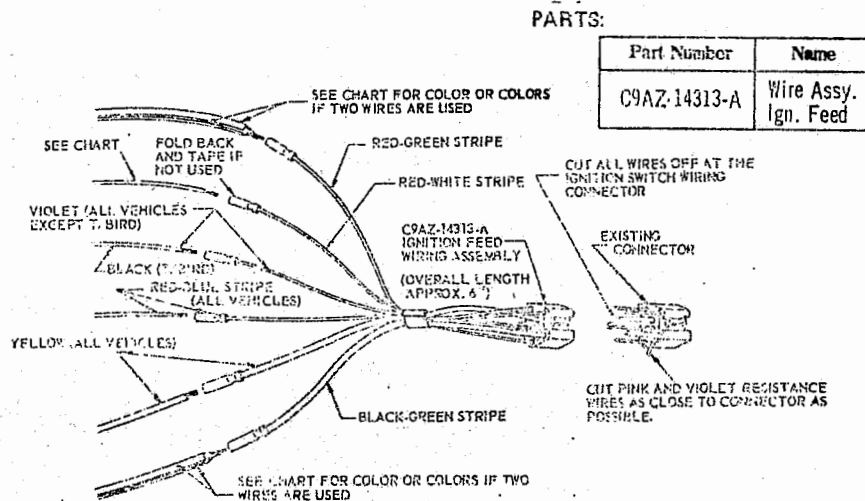
Figure 2

Inoperative electrical components can be caused by a loose electrical connection at the ignition switch. This loose connection may result in damage to the switch and wiring connector. The wiring connector should be replaced, as outlined below, on units that exhibit connector damage.

Replacement for Ignition Switch Wiring Connector  
1968-69 All Car Lines & Trucks Equipped with Pin-Type Ignition Switch

C. Cut the wires at the ignition switch and discard the connector. Refer to Figure 2.

E. Refer to Figures 2 and 3 to determine proper color match for the appropriate vehicle line and securely crimp the wire into the proper butt connector of the new ignition feed wire assembly.
