## TECHNICAL NOTE

Filing Code 1525 (P-401)

Date Issued May 1970

### CHEVROLET VEHICLES EQUIPPED WITH ROCHESTER CARBURETORS

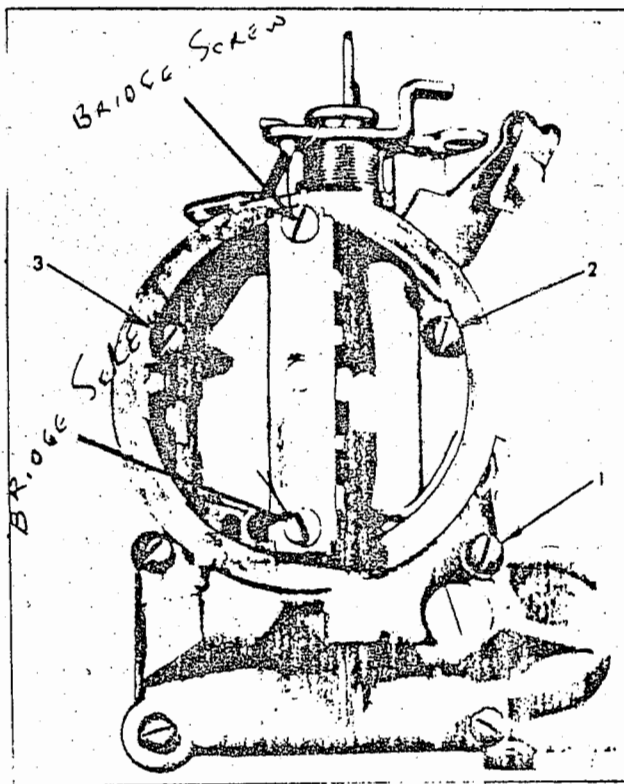
We have been advised that several 1968 and 1969 Chevrolet engines equipped with a Rochester Monojet Carburetor have been damaged, due to air cleaner stud bracket screws vibrating loose and dropping into the combustion chamber. This has caused broken cylinder heads, pistons, and cylinder wall damage.

To correct the problem, remove the bracket screws and place an internal Star Lock Washer, Size No. 10, under each screw and tighten securely.
