T/N 39  
1525

## TECHNICAL NOTE

U.S. DEPARTMENT OF THE INTERIOR - BUREAU OF LAND MANAGEMENT

### LUG BOLT TIGHTENING (1969 CHEVROLET TRUCKS) \*

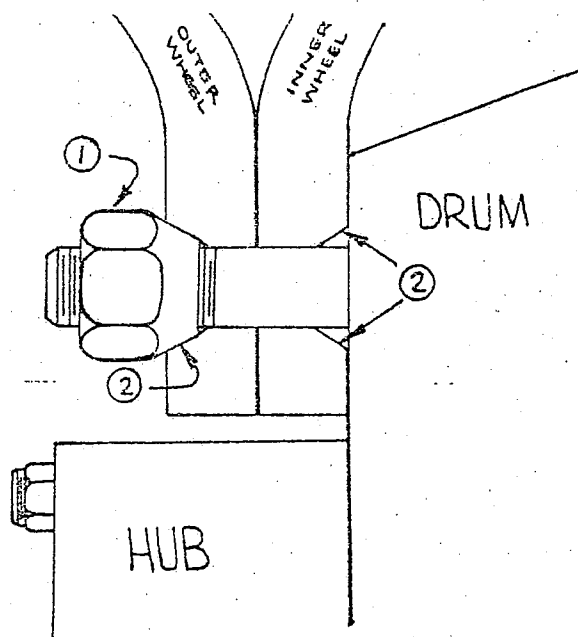
## PRE-1969 STYLE

The attached diagram indicates the conditions existing in the 1969, and pre-1969 lug bolt design.

- ① SELF-CENTERING LUG NUTS
- ② TAPERED LUG BOLT HOLES

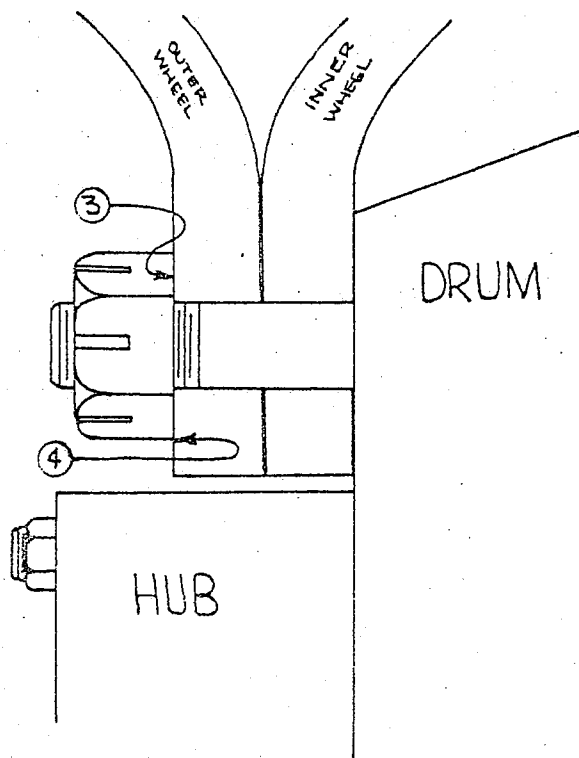
## 1969 STYLE

It has been reported that difficulty is being experienced in keeping the lug nuts tight on the 1969 Chevrolet Trucks, Model CE-30.

Upon checking with the Chevrolet Zone Service Manager, we learned that Chevrolet has received several reports on this problem. The Zone Representative indicated that the primary cause of damage was a result of failure on the part of the operator to insure that the lug nuts had been tightened to specifications and checked for tightness at the prescribed intervals listed in the Owner's and Driver's Manual. He acknowledged that Chevrolet is aware that the change in design of the wheel and lug nuts requires additional operator attention. To insure proper tightening, Chevrolet included additional instructions in the 1969 Owner's and Driver's Manual on the tightening procedure and frequency at which the lug nuts must be checked.

- ③ FLAT FACED LUG NUTS
- ④ FLUSH LUG BOLT RING FACE

On a new truck and after the wheel has been changed, the wheel nut torque must be checked at 100, 1,000, and 6,000 miles and every 6,000 miles thereafter.

Retorque wheel nuts to 75-110 ft. lbs. for 20-30 Series models.

Since this condition could have a far-reaching safety effect, we would like to recommend that all your drivers be made aware of the proper procedures for tightening and checking these lug nuts on the 1969 Chevrolet, Model CE-30 trucks. Your next safety meeting could provide an effective opportunity to instruct your drivers in the correct step-by-step method for installing and inspecting these truck wheels.
