# RIPARIAN AREA MANAGEMENT

TR 1737-12 1996 (Revised 1999)

*Using Aerial Photographs to Assess Proper  
Functioning Condition of Riparian-Wetland Areas*

U.S. Department of the Interior  
Bureau of Land Management

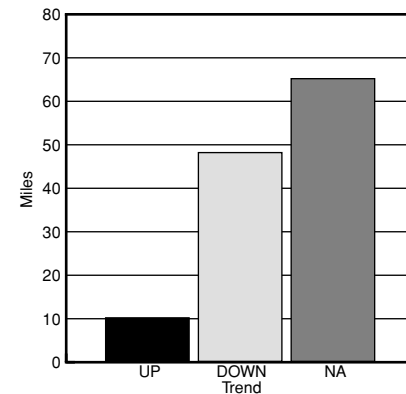
The assessment of riparian conditions resulted in 56 percent of the reaches, or 124 miles, receiving FAR ratings (Figure 2). Of the 31 reaches rated FAR:

- 5 reaches (10 miles) had a upward trend
- 11 reaches (48 miles) had a downward trend
- 15 reaches (65 miles) had no apparent trend

**Figure 2.** Trend ratings for reaches that are functional—at risk.
