BLM-Alaska Open File Report 64  
BLM/AK/ST-97/022+8111+040  
April 1997

## HISTORIC BUILDING SURVEY REPORT FLAT, ALASKA

by Rolfe G. Buzzell and Darrel L. Lewis

# **Historic Building Survey Report Flat, Alaska**

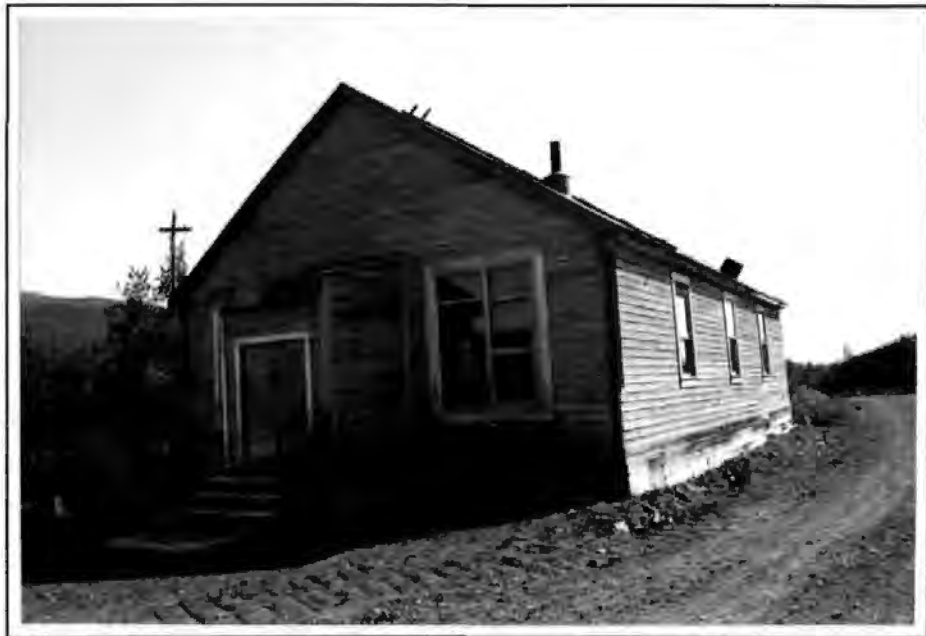
The **Community Hall (IDT-070)**, also known as the Moose Hall, is a rectangular, one-story, wood frame building (Figure 15). It measures 30'x47'7". The foundation is stacked wood blocks. The gable roof is felt (tar) paper covered with corrugated metal. Shiplap siding with corner boards covers the exterior walls. An arctic entry with double doors is centered on the west elevation and flanked on each side by a large four-light fixed sash window. The north and south elevations have three evenly spaced 1/1 double-hung windows on each side.

An addition on the east elevation measures 29'7"x23'. It has a gable roof covered with corrugated metal. Two 1/1 double-hung windows are located on the south elevation. Two shed additions are located on the north side of this addition. A five-panel door and a two-light fixed sash window face north. The interior walls of the hall curve into the ceiling.

**Figure 15. The west and south elevations of the Community Hall, 1993.**

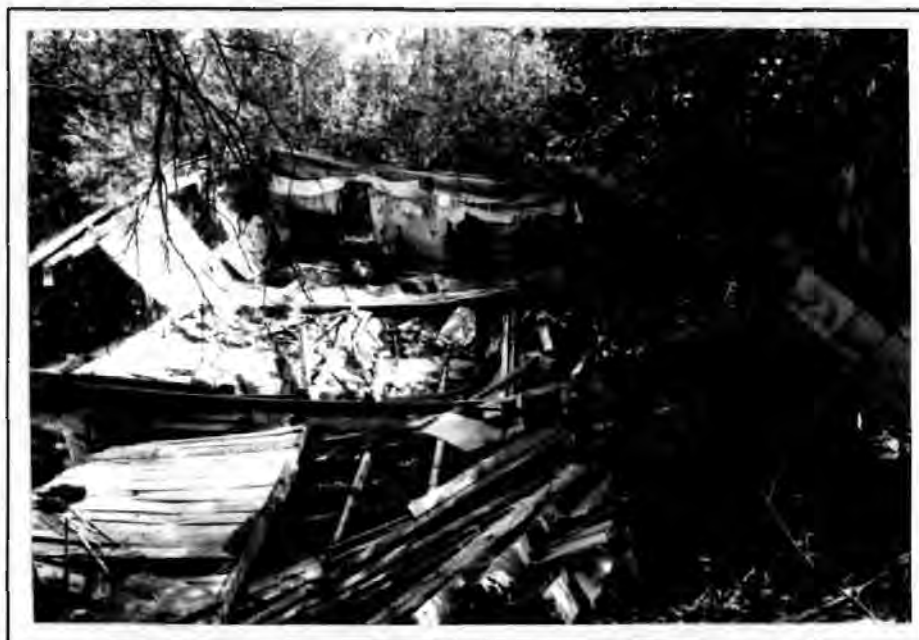
The **Andy Miscovich Bar (IDT-071)** is a partially collapsed 2.5 story, rectangular, wood frame building (Figure 16). It measures 22'x45' on the first floor and 22'x34' on the second floor. The siding consists of felt paper. The gable roof has been removed for salvage but scraps of corrugated metal roofing are visible in the debris. The gables, which have collapsed, each contain a window opening. The first floor is built into the side of a hill and the foundation is not visible. The second floor is supported by wood piers. A shed addition is located on the west end of the building and measures 11'x22'. This addition was elevated so that it was even with the second floor. Bar stools, bottles and tables are still visible in the debris. The remains of an addition, measuring 24'x45', are visible on the north side. This was added in 1926 to house a cafe (Miscovich 1995:I,7). Three collapsed wall sections and numerous whiskey barrels are located in the debris.

**Figure 16. The ruins of the Andy Miscovich Bar, 1993. The view is looking east.**

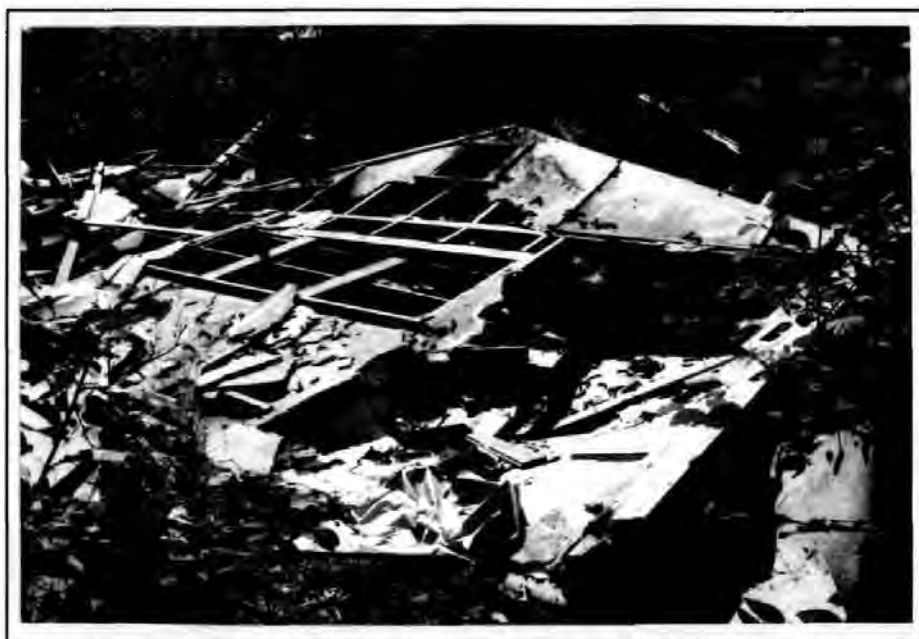
The **Durand Restaurant/Parker Bar (IDT-072)** is the ruins of a rectangular, 1.5 story, wood frame building (Figure 17). The ruins measures 40'x20'7" and has two additions in ruins on the northeast corner measuring about 17'x 35'. The foundation consisted of wooden posts. Celotex and horizontal boards cover parts of the collapsed walls. Part of the gable roof is located in the ruins. The interior walls were covered with celotex and tongue and groove boards. The main entry faced south and contained a porch. A Diebold Safe and Lock Company safe is located 39'6" southwest of the building.

**Figure 17. The ruins of the Durand Restaurant/Parker Bar, 1993. The view is looking northwest.**

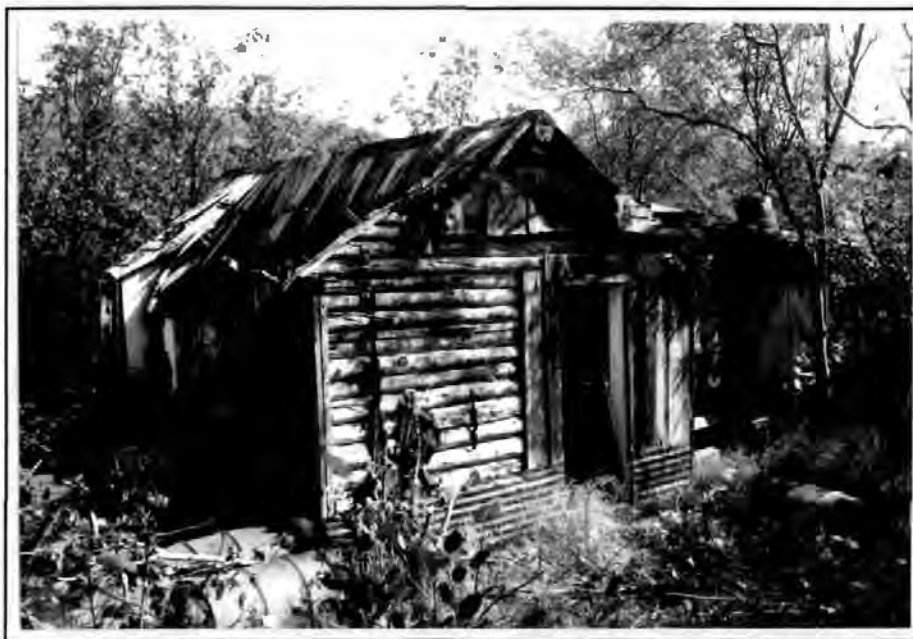
**The Adams Cabin/Parker Generator Shed (IDT-073)** is a one-story, rectangular, log building with a shed addition on the east side (Figure 18). The building measures 13'x13'6". The foundation is not visible. The partially collapsed gable roof is covered with boards and felt paper. A door opening is located on the south elevation. There is a window opening on the north and west elevations. An east addition measuring 7'10"x

**Figure 18. The Adams Cabin/Parker Generator Shed, 1993. The view is looking northeast.**

13'6" has a shed roof covered with felt paper. There is a five-panel door on the south elevation and a window opening on the north and east elevations. Corrugated metal covers the lower 2' of the exterior. Tar paper over wood planks covers the rest of the exterior. Artifacts in the building include a barber chair, a bench, shelving, a work bench, an electric heater, a cement generator stand, and chemical containers.

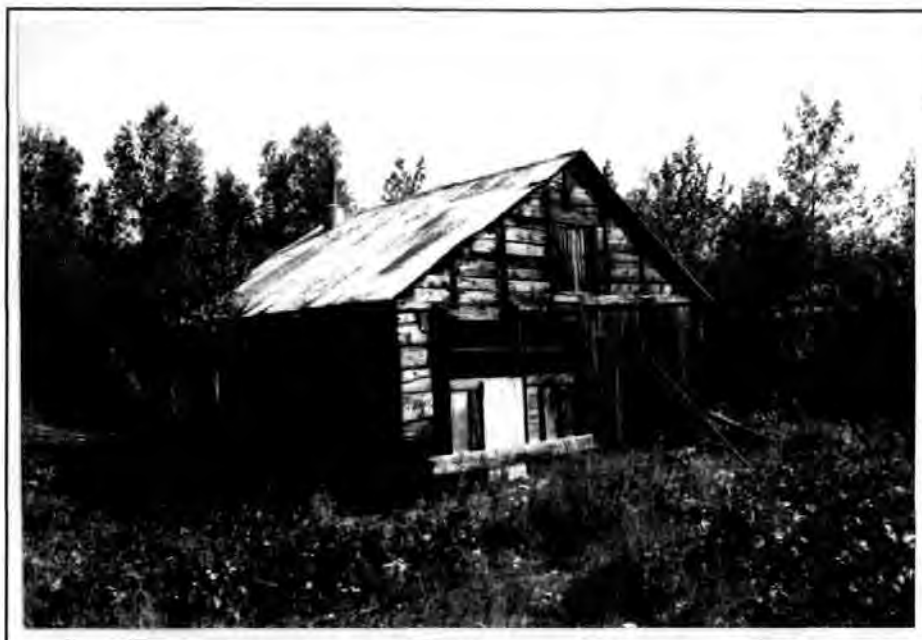
**The Savage/Fullerton Garage (IDT-074)** is a square 1.5 story, wood frame building (Figure 19). Each side measures 20'4". The building rests on a timber foundation. The main entrance faces south. The siding consists of felt paper over 1"x8" boards. The gable roof is

covered with corrugated metal. A nine light fixed sash window is located on the north and west elevations and a six-light fixed sash window is located in the north gable. Two sets of large double doors are located in the south elevation and a hay door is centered in the gable. The garage is in good condition. A horse buggy is stored inside the building.

**Figure 19. The Savage/Fullerton Garage, 1993.**  
The view is looking northeast.

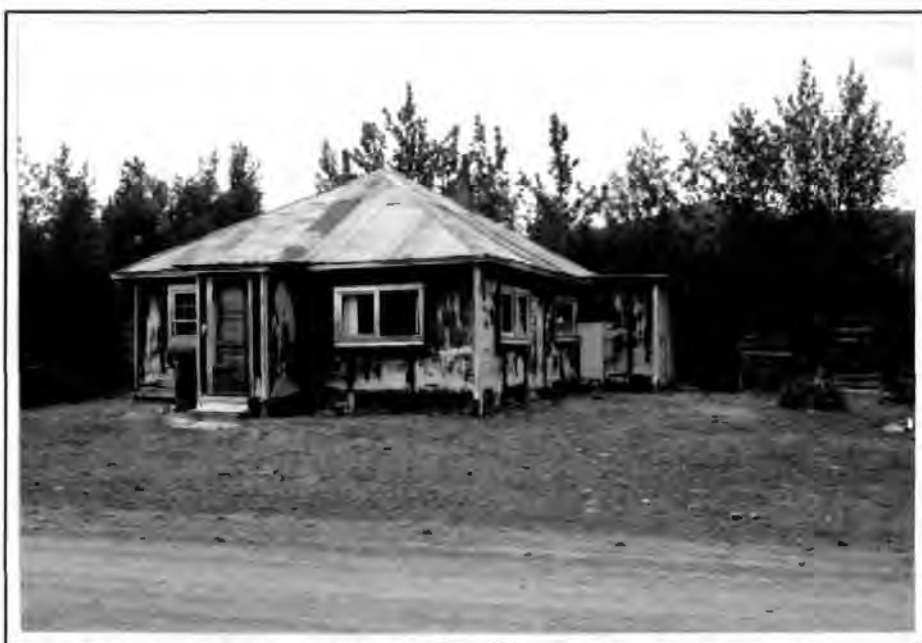
The **Gustafson/Savage/Fullerton House (IDT-075)** is a one-story, rectangular, wood frame building (Figure 20). It measures 20'1"x24'4". The hipped roof is covered with corrugated metal. The foundation consists of short vertical posts. The exterior

**Figure 20. The Gustafson/Savage/Fullerton House, 1993.** The view is looking northwest.

siding is celotex. The main entry faces south. A pair of single-light windows is on the east side and a 6/6 double-hung window is on the west side. An arctic entry with a shed roof and three panel door is centered between the windows. The west elevation has a single-light, fixed sash window and a 6/6 double-hung window. The north elevation has a 6/6 single-hung window and two single-light, fixed sash windows. The east elevation has a single-light, fixed sash window, a two-light, fixed sash window, and a 1/1 horizontal single-hung window. An arctic entry measuring 6'1"x 6'2" is located at the north end of the east elevation. The arctic entry has a shed roof covered with corrugated metal and an east facing five-panel door.

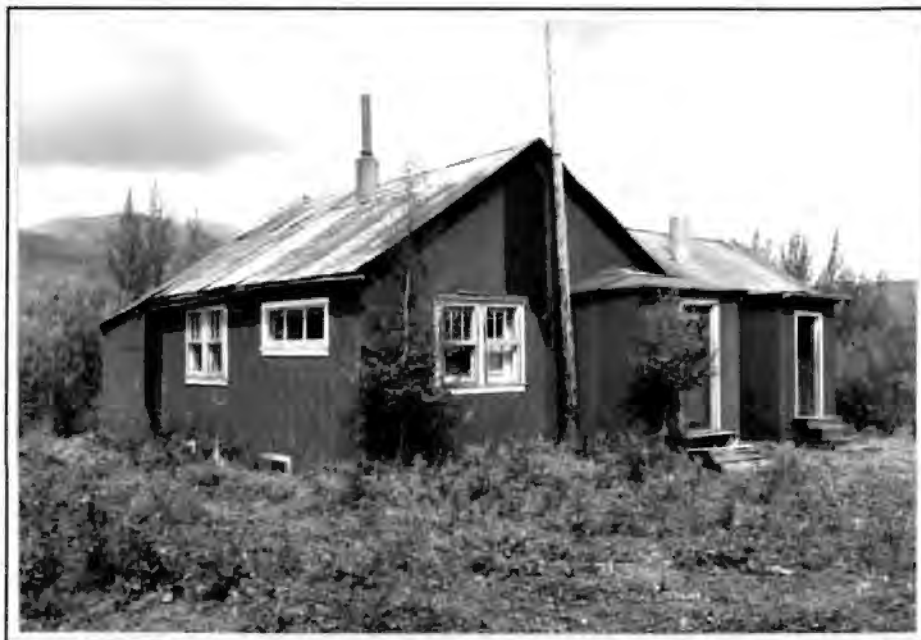
The Alderson House and Post Office (IDT-076) is a 1.5 story, L-shaped, log building (Figure 21). The building has a basement with concrete walls and floor. The exterior siding is green asphalt over felt paper. The oldest part of the house is built of logs, is oriented north-south and measures 20'x32'. It has a gable roof covered with corrugated metal. The south elevation has a pair of 3/1 double-hung windows and an arctic entry.

Figure 21. The Alderson House, 1993.  
The view is looking northwest.

The arctic entry measures 5'4"x8' and has a hipped roof. A one-panel door with one-light faces south. The west elevation has a three light, fixed sash window and a pair of 3/1 double-hung windows. The east elevation has a two-light, fixed sash window. An addition on the east side measures 12'2"x16'. It has a gable roof covered with corrugated metal. The south elevation

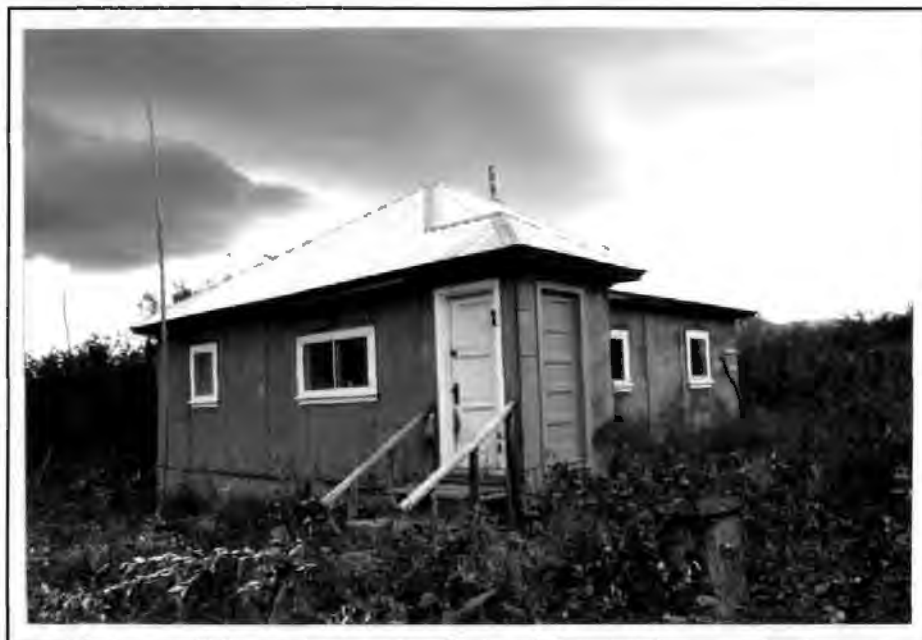
The Hill/Day/Agoff House (IDT-122) is a rectangular, one-story, wood frame building (Figure 22) measuring 24'5"x20'. Corrugated metal covers the hipped roof. The exterior is covered with celotex. The house has three arctic entries with corrugated metal roofs and celotex siding. The main entry faces north and has a single-light, fixed sash window and a two-light, fixed sash window. The west elevation has a single-light, fixed sash window and a two-light, fixed sash window. A hipped roof arctic entry measuring 4'x6' is located on the north end of the west elevation. A three panel door faces north and a five-panel door faces west. A six-light, fixed sash window faces south. The south elevation has a two-light, fixed sash window and a single-light, fixed sash window. A shed roof arctic entry is located on the east end of the south elevation. The arctic entry measures 6'x7' and has a five-panel door facing south and a four-light, fixed sash window facing west. The east elevation has three single-light, fixed sash windows and an arctic entry with a hipped roof. This 4'x4' arctic entry has a three panel door facing north and a single-light, fixed sash window.

**Figure 22. The Hill/Day/Agoff House, 1993. The view is looking southeast.**

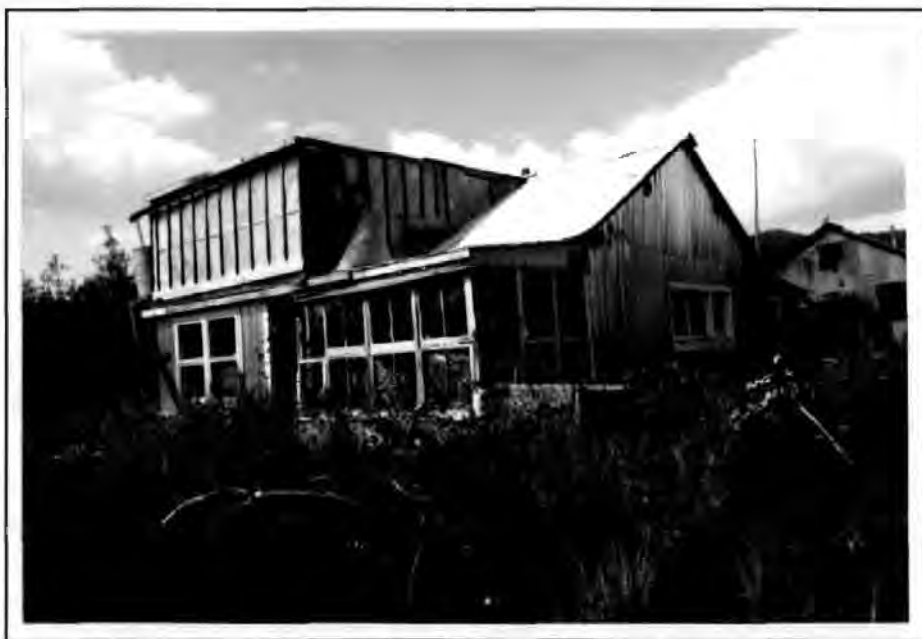
**Figure 23. The Guggenheim Office/Uotila House, 1993. The view is looking northwest.**

The Guggenheim Office/Uotila House (IDT-092) is a rectangular, 1.5 story, log building (Figure 23). The original building measures 22'2"x24'2". The gable roof and log walls are covered with aluminum siding. The east elevation has a triple, two-light, fixed sash window. The west elevation has a single-light, fixed sash window and a pair of single-light, fixed sash windows. A window covered with aluminum siding is located in the west gable. The north elevation has a pair of single-light, fixed sash windows. A 7'9"x14' wood frame addition is located on the west end of the south elevation. The south

elevation of this addition has a full length glass door and a pair of 1/1 double-hung windows. A wood frame greenhouse with a shed roof is located above this addition. The exterior of the green house is covered with clear plastic sheeting. A 7'10"x10' wood frame addition on the east side of the south elevation of the building has a shed roof covered with aluminum. The exterior walls are covered with six 2/2 fixed sash windows and a pair of single-light, fixed sash windows on the south elevation and six 6/6 fixed sash windows on the east elevation. A wood frame shed addition on the north side of the building measures 10'3"x16'2". The roof is covered with aluminum siding. A three panel door with one-light is located on the west elevation. A single-light, fixed sash window and a two-light, fixed sash window are on the north elevation. A two-light, fixed sash window is on the east elevation.

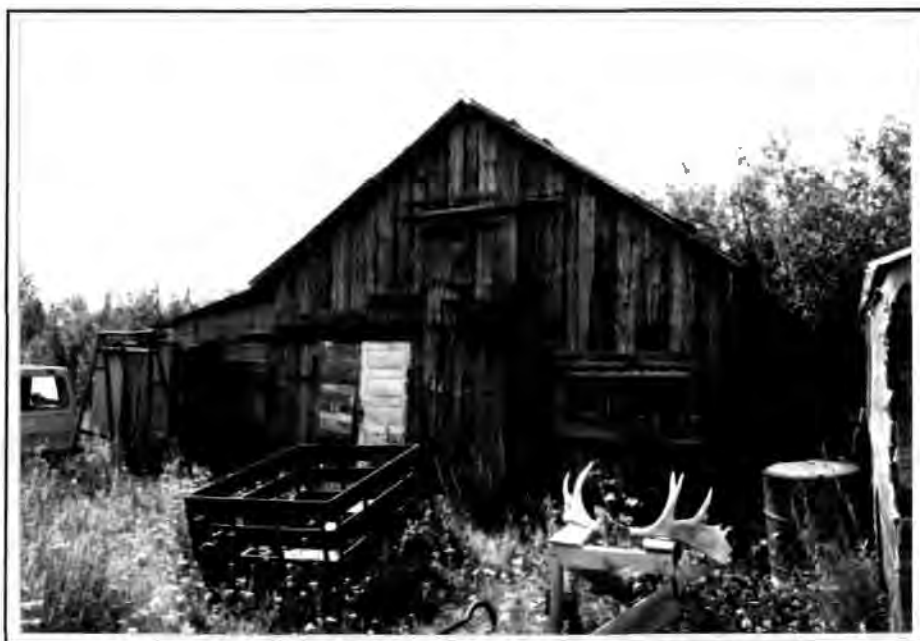
The Miscovich House/Uotila Shop (IDT-243) is a rectangular, 1.5 story building (Figure 24) located about 25' northwest of the Guggenheim Office/Uotila House. The foundation consists of logs. The building is 20' square. It has a gable roof covered with corrugated metal and is sided with vertical lumber. The east

Figure 24. The Miscovich House/Uotila Shop, 1993. The view is looking southwest.

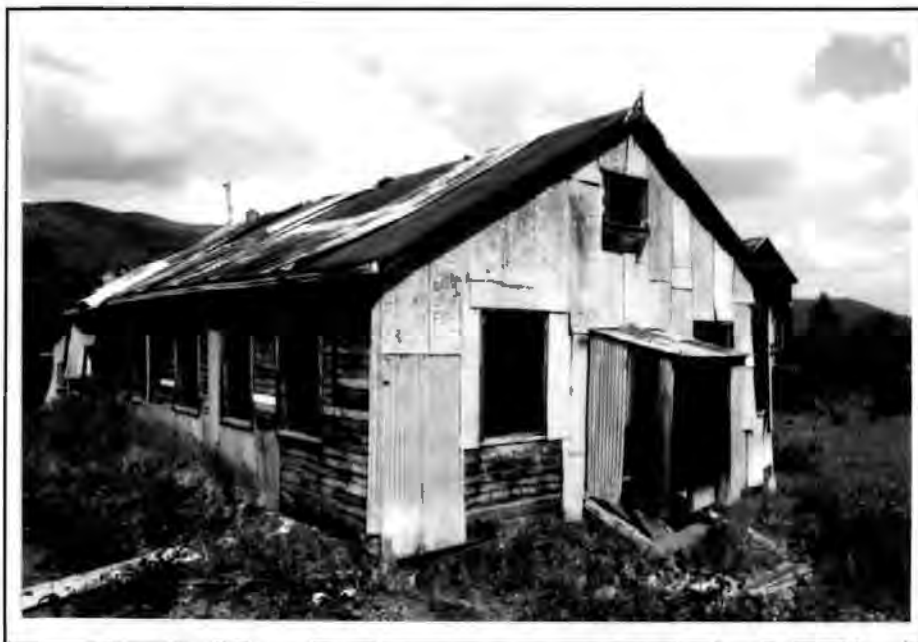
The **Guggenheim Hospital/Schoolhouse (IDT-093)** is a rectangular, 1.5 story, wood frame building (Figure 25) measuring 29'6"x52'9". The foundation consists of horizontal stacked timbers. The gable roof is covered with corrugated metal. Sections of metal have been stripped away, exposing wood decking. Corrugated metal over shiplap covers the exterior walls. The south elevation has two 1/1, single-hung windows. Between the windows is a shed roof arctic entry, which opens into the classroom. Four 6/6, fixed sash windows are located on the east elevation and five 6/6, fixed sash windows are located on the west elevation. A 6/6 fixed sash window is located on the north elevation. A shed roof addition measuring 8'4"x18'1" is attached to the north elevation. The north side of this addition has a plank door. A pair of six-

**Figure 25. The Guggenheim Hospital/Schoolhouse, 1993. The view is looking northwest.**

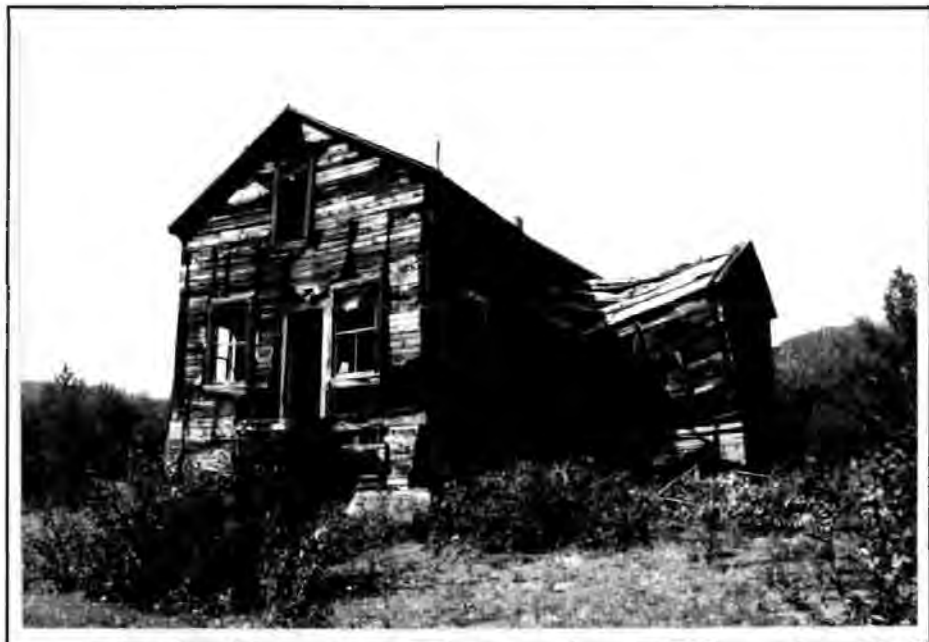
**The Mutchler/  
Miscovich House  
(IDT-094)** is a 1.5 story, rectangular, wood frame building (Figure 26). It measures 21'10"x33'. The foundation consists of 55 gallon steel drums. Weathered felt paper covers the gable roof and exterior walls. Stairs, which are no longer present, rose to an entry centered on the south elevation. A 2/2 single-hung window flanked each side of the door-way. A large window frame is centered in the south

**Figure 26. The Mutchler/Miscovich House,  
1993. The view is looking northeast.**

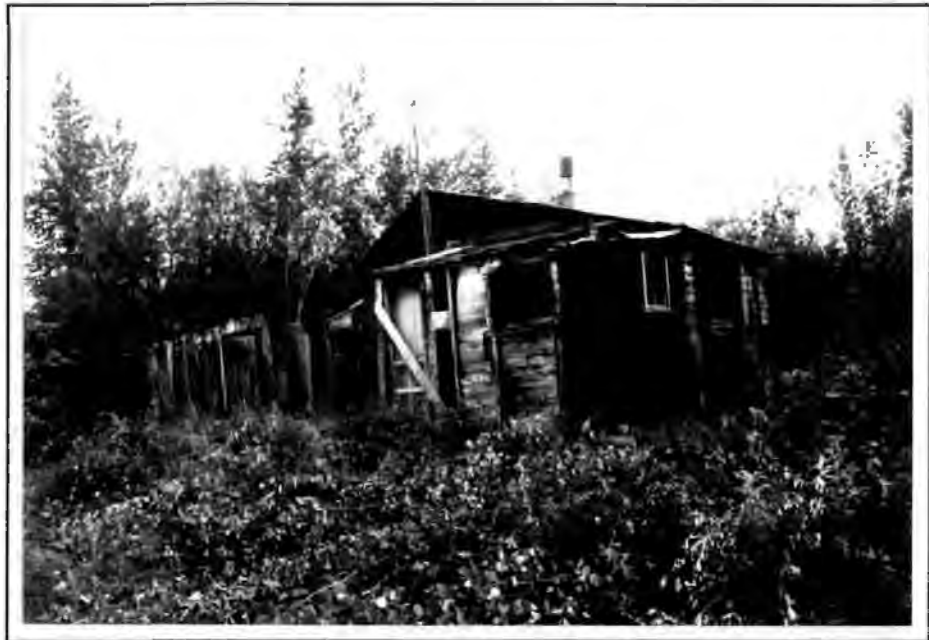
The **Michaels/Miscovich House (IDT-095)** is a modified rectangular, one-story, wood frame building (Figure 27) measuring 12'x14'2". The foundation is on grade. The gable roof is covered with corrugated metal. Roofing felt over wood siding covers the exterior walls. The main entrance faces north and has a 6/6 double-hung window. The south elevation has a four-light, fixed sash window. A shed roof addition is located on the northwest end of the building. A six-light, fixed sash window is located on the west side and a four-panel door on the east side. An addition on the west side of the house measures 7'3"x14'2". It has a shed roof covered with corrugated metal. The west elevation has a two-light, fixed window and the south elevation has a window opening covered with corrugated metal. An addition on the east side measures 6'x15'2" and has a shed roof covered with corrugated metal. The north elevation has a door opening and a single-light, fixed sash window. The east elevation has a window opening but no frame. A shed roof storage building is located 6' northeast of the house. The roof and sides of the 7'2"x11' shed are covered with corrugated metal.

**Figure 27. The Michaels/Miscovich House, 1993. The view is looking southeast.**

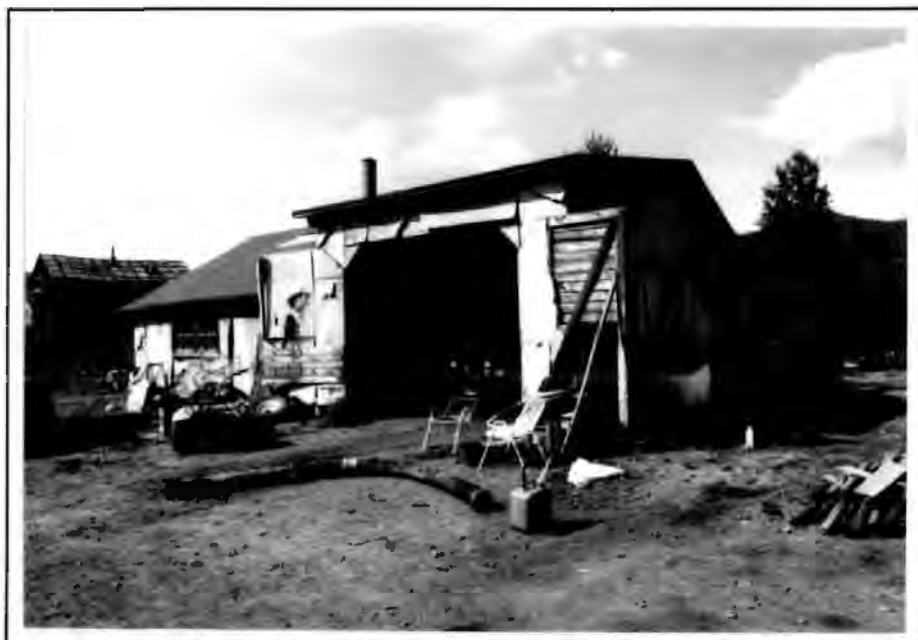
**Figure 28. The Awe/Fullerton Shop, 1993.**  
The view is looking southwest.

The **Awe/Fullerton Shop (IDT-096)** is a one-story, rectangular, wood frame building (Figure 28). It measures 24'2"x40' and rests on grade. The gable roof is covered with roofing felt. Celotex covers the exterior walls. The main entrance faces south and has a pair of six-light, fixed sash windows centered on the west half of the building. The east half of the south elevation has two large utility doors. The southeast quarter of the gable roof is raised to allow access by large vehicles through the utility doors. The west elevation has two large utility doors. The north elevation has a plank door flanked by a single-light, fixed sash window and a six-light, fixed sash window. A 4'x4' concrete foundation (Site Z) is located 27'6" northwest of the Shop Building.

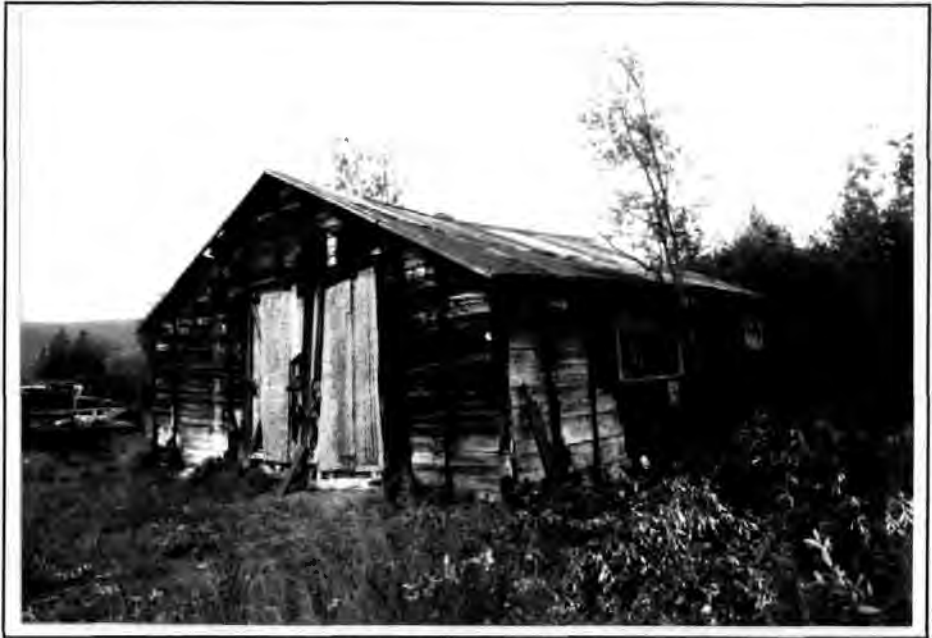
The **Mutchler/Uotila/Fullerton Barn (IDT-097)** is a rectangular, one-story, wood frame building (Figure 29) measuring 26'1"x27'5". The foundation consists of wood posts on grade. The gable roof is covered with corrugated metal. Weathered roofing felt over tongue and groove siding covers the exterior walls. The main entrance faces south and has two large utility doors just east of center. The east elevation has a pair of six-light, fixed sash windows and another six-light, fixed window. The west elevation has a pair of six-light, fixed windows. The

The Mutchler brothers built the barn near the present location of the Matheson Dredge in the 1910s. Gus Uotila bought the barn from the Mutchlers and kept horses for his freighting service in the building. Burn marks on the north-west corner are from the 1924 fire that destroyed most of downtown Flat. The building survived the fire and Uotila moved it to its current location in the late 1920s. The Awe/Durand Mining Company purchased the building in the mid-1930s. John and Richard Fullerton bought the barn from their stepfather when Durand left Flat. The building was being used to store auto parts in 1993 (Fullerton 1995:112; Miscovich 1995:I-4; II-24).

**Figure 29. The Mutchler/Uotila/Fullerton Barn, 1993. The view is looking northwest.**

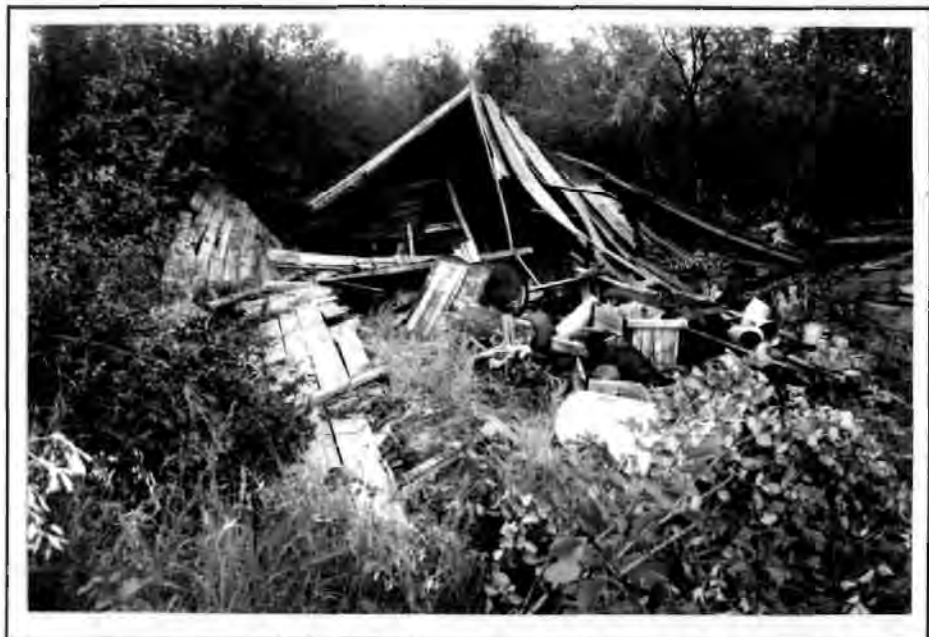
**Figure 30. The Mutchler/Hard/Uotila/Awe Blacksmith Shop, 1993. The view is looking north.**

the ruins of a rectangular, one-story, wood frame building (Figure 30) measuring 17'7"x36'4". The foundation is on grade. The collapsed shed roof was covered with roofing felt over wood decking. The north wall and gable and part of the east wall are standing. Sections of the west wall and the south gable are intact but laying on the ground. The north elevation has a window frame and a plank door. A window frame is located on the north end of the west elevation. A six-light, fixed sash window is located in the south end of the east elevation. The ruins of the south elevation contain a two-panel door with one light. A wood stove is located south of the center of the west side of the building. The ruins contain saddles, crates, auto parts, gas cans and lengths of stove pipe.

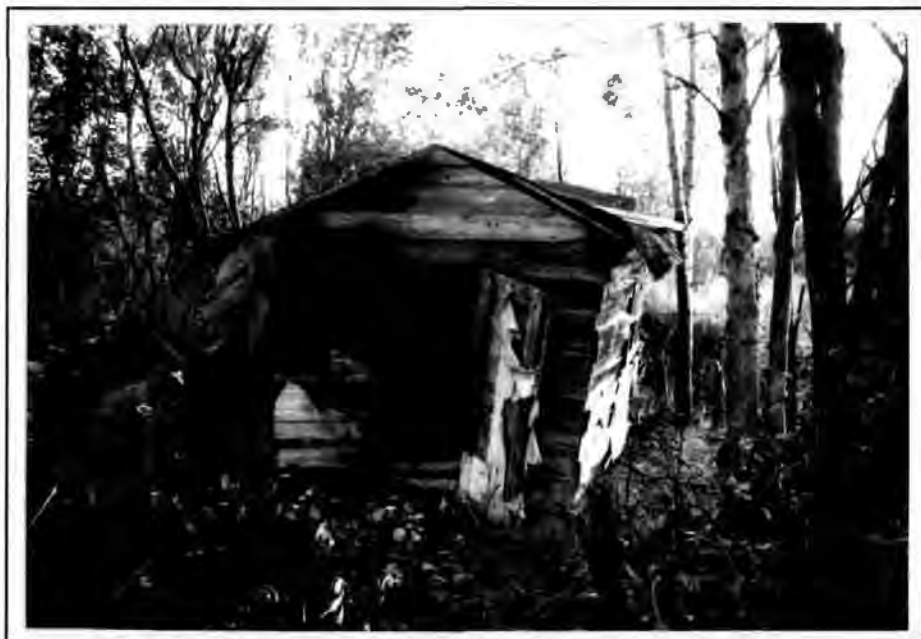
**Figure 31. The DeHouse/Kobler Storage Building, 1993. The view is looking southeast.**

The **DeHouse/Kobler Storage Building (IDT-099)** is a rectangular, one-story, wood frame building (Figure 31) measuring 7'x9'7". The foundation consists of logs and the gable roof is covered with corrugated metal. Weathered roofing felt over wood siding covers the exterior walls. The main entrance faces north and contains a plank door. A four-light, fixed sash window is centered on the west elevation. The roof was sagging in 1993 and the building was in poor condition.

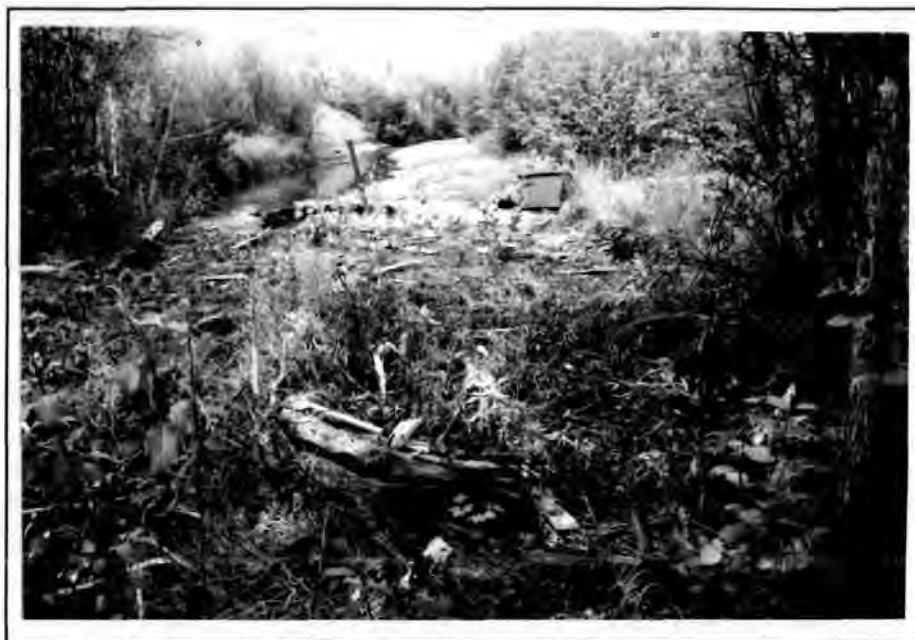
**Figure 32. Ruins of the Uotila/Marcell House, 1993. The view is looking north.**

The **Uotila/Marcell House Ruins (IDT-100)** consists of the remains of a rectangular, two-story wood frame building (Figure 32). The house had a log foundation and measured 15'7"x 22'10". The walls and roof are missing. The floor of an arctic entry is located in the southeast corner and measures 6'7"x7'. A large metal box, possibly a boiler, is located in the northeast corner of the site. A broken porcelain mug is located near the boiler. The northwest corner of the foundation is undercut by Otter Creek. Some shiplap and wood siding are in the debris.

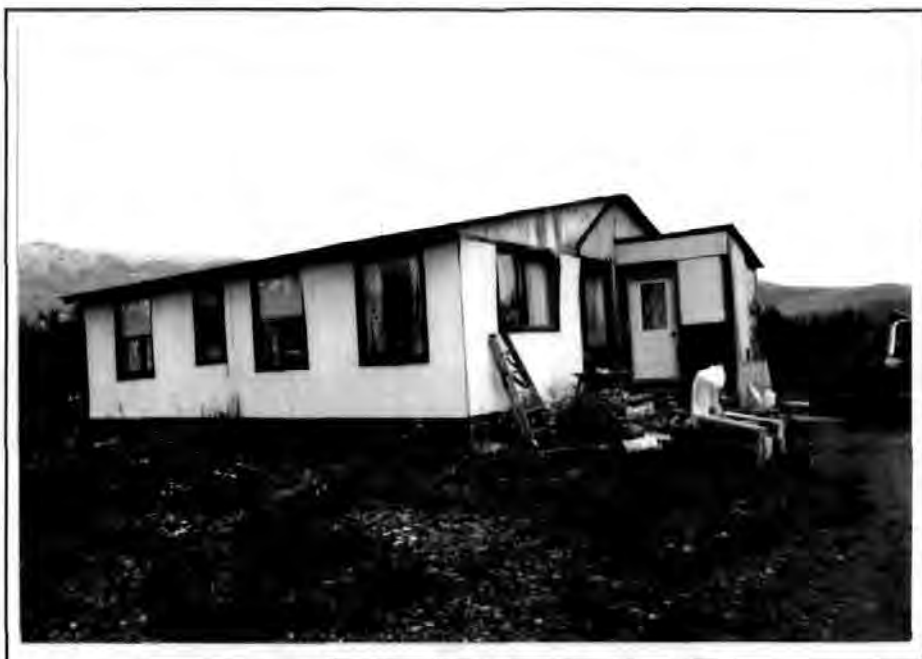
**Figure 33. The Williams House, 1993.**  
The view is looking northeast.

The **Williams House (IDT-101)** is a rectangular, one-story, wood frame building (Figure 33). The east portion measures 15'x46'4" and the west portion measures 18'x32'2". An arctic entry measuring 7'6"x7' is located on the south end of the east section and has a metal door. A gable roof with asphalt shingles covers the entire structure and runs north-south. Plywood and T1-11 cover the exterior walls. All windows are recent metal casement windows. A shed roof addition, measuring 12'x18', is located on the north end of the house. The roof is covered with aluminum siding and the exterior is covered with plywood.

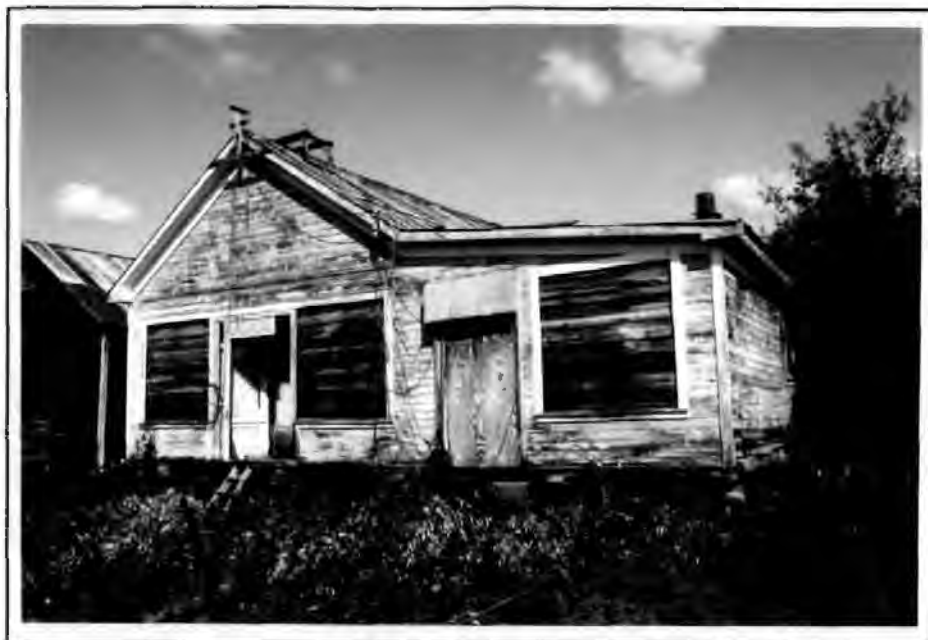
**Figure 35. The Donnelley and Sheppard Store, 1993. The view is looking northeast.**

The Donnelley and Sheppard Store (IDT-077) is a rectangular, one-story, wood frame commercial building (Figure 35). The main portion of the building measures 34'x76'4". The foundation consists of wood blocks. The building has a gable roof covered with corrugated metal. The siding consists of shiplap with corner boards. The main entrance is the west side

of the building. A recessed storefront entry is centered on the east and west elevations. Each entry is flanked by a four-light window that is boarded over. Each recessed entry has a two-light, fixed sash window on each side of the door. The door has a single-light window and a transom window. The outer part of the west entry has a single-light, fixed sash window on the north side and a transom window. The outer door and the

south side window are missing. The outer part of the east recessed entry has a single-light, side window on either side of a single-light door and a transom window. The east outer entry way is boarded over. The north elevation has a boarded over window. There are no windows or doors on the south elevation. Decorative elements on the building include awning fixtures and enclosed cornices with returns.

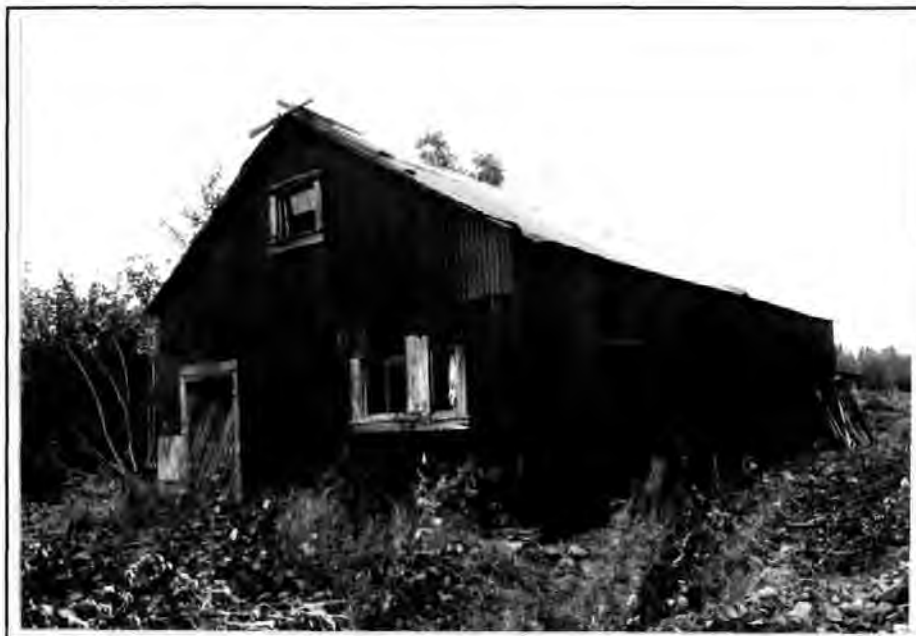
**Figure 36. The Donnelley and Sheppard Cold Storage Building, 1993. The view is looking southwest.**

The **Donnelley and Sheppard Cold Storage Building (IDT-078)** is a rectangular, 1.5 story, wood frame building (Figure 36). The foundation is logs and wood beams. The gable roof and exterior walls are covered with corrugated metal. The building measures 20'3"x52'4". A six-light, awning window is centered in the east and west gables. The east elevation has a large diagonal plank door and a pair of two-light, fixed sash windows. The north elevation has a door opening at the east end. The west elevation has a two-panel door with one-light and a three-light, fixed sash window. A two-light, fixed sash window is located on the west end of the south elevation. Inside the building is a large walk-in refrigerator. The condensers that operate the refrigerator are located in the west end of the building. A hand operated gasoline pump is laying next to the outside wall at the east end of the south elevation.

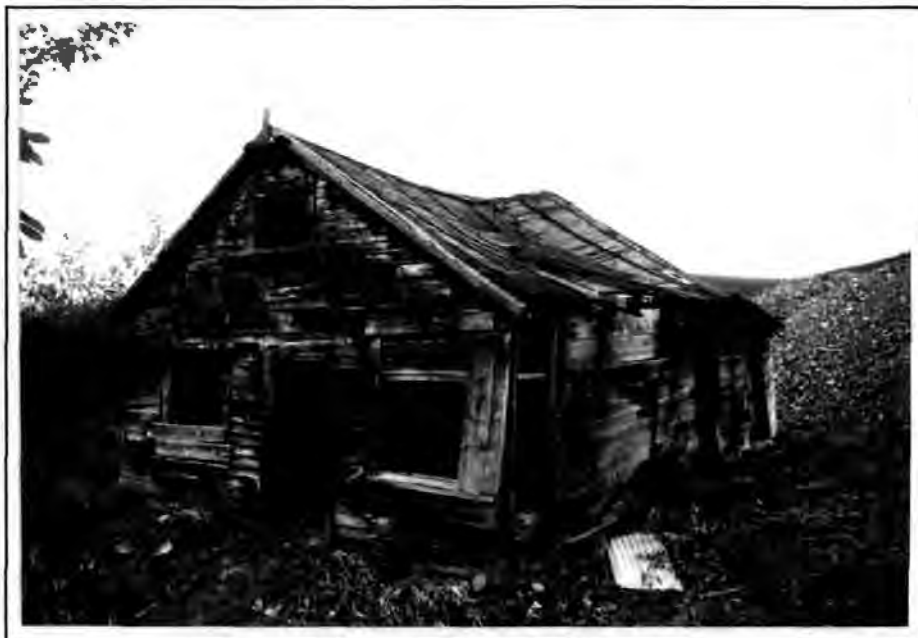
Figure 37. The Assay Office, 1993.  
The view is looking northwest.

The **Assay Office (IDT-079)** is a rectangular, 1.5 story, wood frame building (Figure 37). The building is 20' square and the foundation is on grade. The gable roof is covered with roofing felt over wood decking. The exterior is covered with roofing felt over shiplap. The main entrance faces south and has a five-panel door flanked on each side by a large window opening. A six-light, fixed sash window is centered in the north and south gables. A two-light, fixed sash window is located in the south end of the east elevation. The west elevation has two boarded up windows. A shed addition measuring 12'x20' is located on the north side of the building. The roof and exterior siding of the addition are the same as the rest of the building.

The north elevation has a three panel door with one-light and a four-light, fixed sash window. The east elevation has a boarded up doorway. The west elevation has a window opening with no frame or lights. The interior of the building contains building debris, furniture and a number of containers with chemicals associated with assaying. The building is in poor condition. An outhouse measuring 4'2"x 4'7" is located 15'6" southwest of the Assay Office. The outhouse has a shed roof and walls covered with corrugated metal over wood siding.

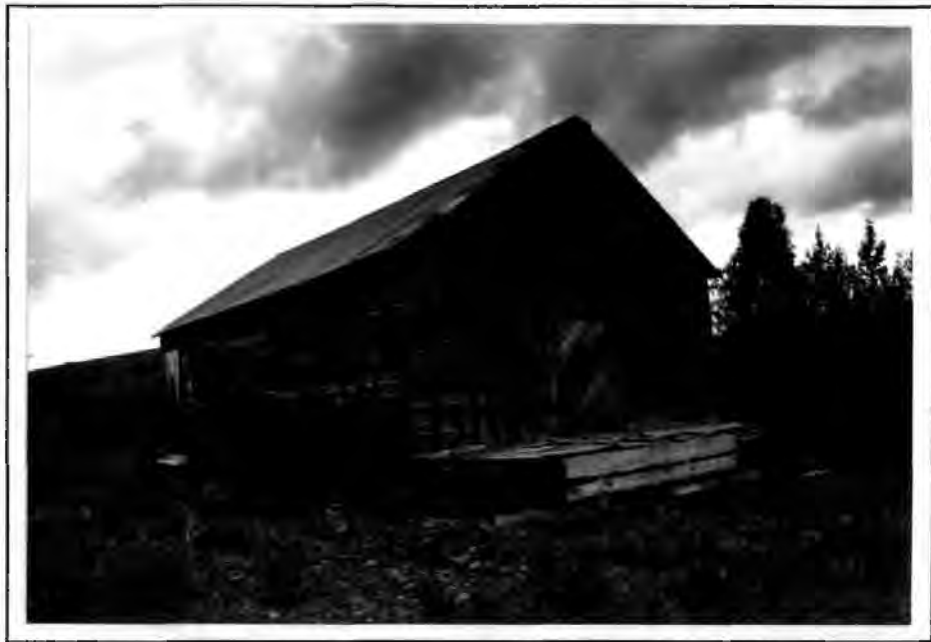
**Figure 38. The Turner/Donnelley Hardware Building, 1993, The view is looking northwest.**

The Turner/Donnelley Hardware Building (IDT-080) is a rectangular, one-story, wood frame building (Figure 38). It measures 24'x40' and the foundation consists of wood blocks. The gable roof is covered with corrugated metal. Shiplap covers the exterior walls. The main entrance faces east and a large plank door in the center opens onto a 5'6"x 18'10" loading dock. A screen window is above the door. The west elevation has a boarded up doorway and a six-light, fixed sash window.

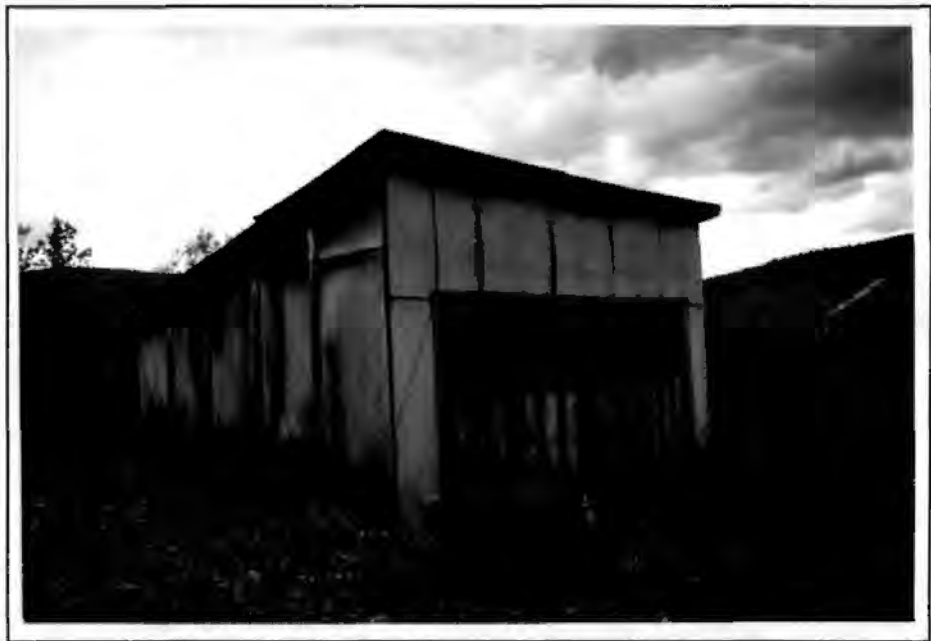
**Figure 39. The Donnelley Garage, 1993. The view is looking northwest.**

The **Donnelley Garage (IDT-081)** is a square, one-story, wood frame building (Figure 39) measuring 20' on each side. The foundation consists of beams. The shed roof is covered with corrugated metal. Celotex siding covers the exterior walls. The main entrance faces east and has two pairs of large utility doors. Each door contains three panels and a six-light, fixed sash window.

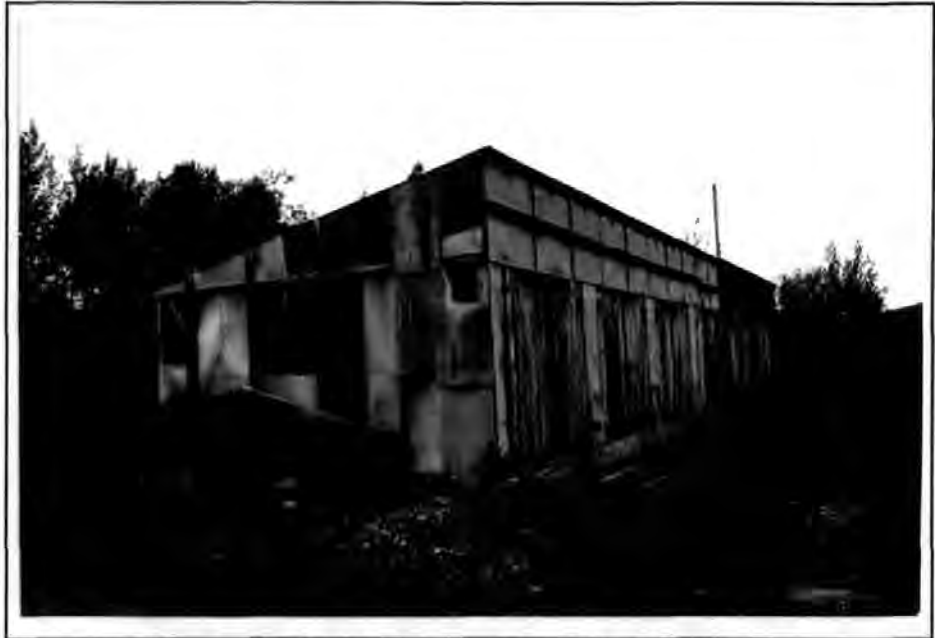
**Figure 40. The Donnelley Lumber Warehouse, 1993. The view is looking southwest.**

The **Donnelley Lumber Warehouse (IDT-082)** is a rectangular, one-story, wood frame building (Figure 40). The foundation consists of logs and wood beams.

The shed roof is covered with corrugated metal. The building measures 19'x40'. Celotex covers the exterior walls although portions of the south and west wall covering is missing. Corrugated metal covers some of those missing wall sections. The main entrance faces north

and contains four pairs of large plank doors. A shed roof addition on the west side measures 24'3"x29'8". The roof and walls are covered with the same materials as the rest of the warehouse. The addition has two pairs of large plank doors. A pair of window openings without glass are located above one of the sets of doors. The building has a dirt floor.

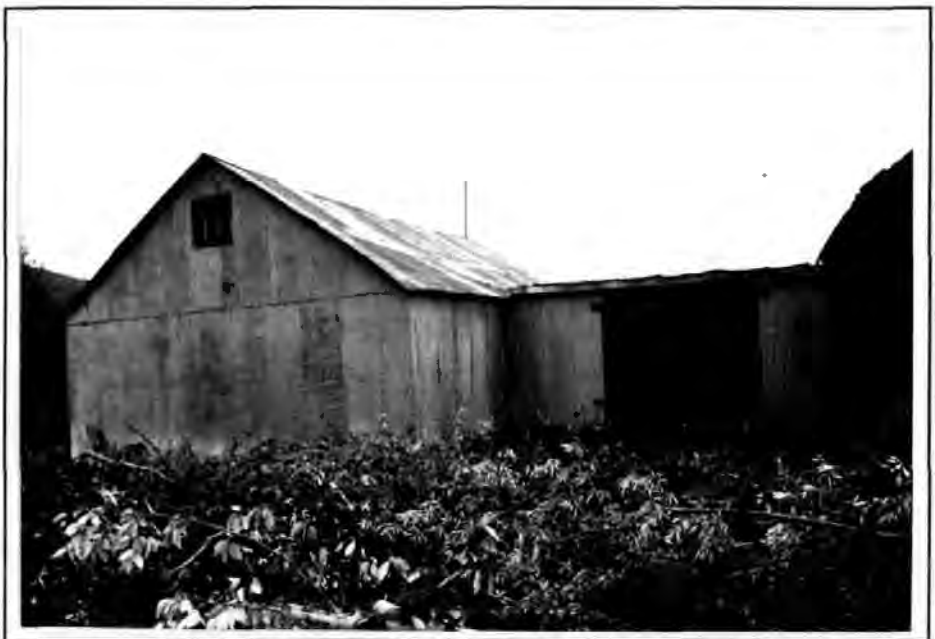
**Figure 41. The Donnelley Pipe Warehouse, 1993. The view is looking northeast.**

The Donnelley Pipe Warehouse (IDT-083) is a 1.5 story, rectangular building (Figure 41). The gable roof and exterior walls are covered with corrugated metal. The foundation is logs and wood beams. The building measures 22'3"x35'. A six-light, fixed sash window is centered in the west gable. A pipe rack with a shed roof is located on the east side of the building.

The pipe rack measures 11'2"x17'6". The shed roof is covered with corrugated metal. Access to the building is through an 8'x19'5" addition on the south side of the Pipe Warehouse. The addition connects the warehouse with the Donnelley/Standard Oil Warehouse (IDT-084). The north-south gable roof and exterior walls of the addition are covered with corrugated metal. The west elevation has a set of plank doors. The east elevation has a plank door and a four-light, fixed sash window.
