BLM-Alaska Open File Report 64  
BLM/AK/ST-97/022+8111+040  
April 1997

## HISTORIC BUILDING SURVEY REPORT FLAT, ALASKA

by Rolfe G. Buzzell and Darrel L. Lewis

# **Historic Building Survey Report Flat, Alaska**

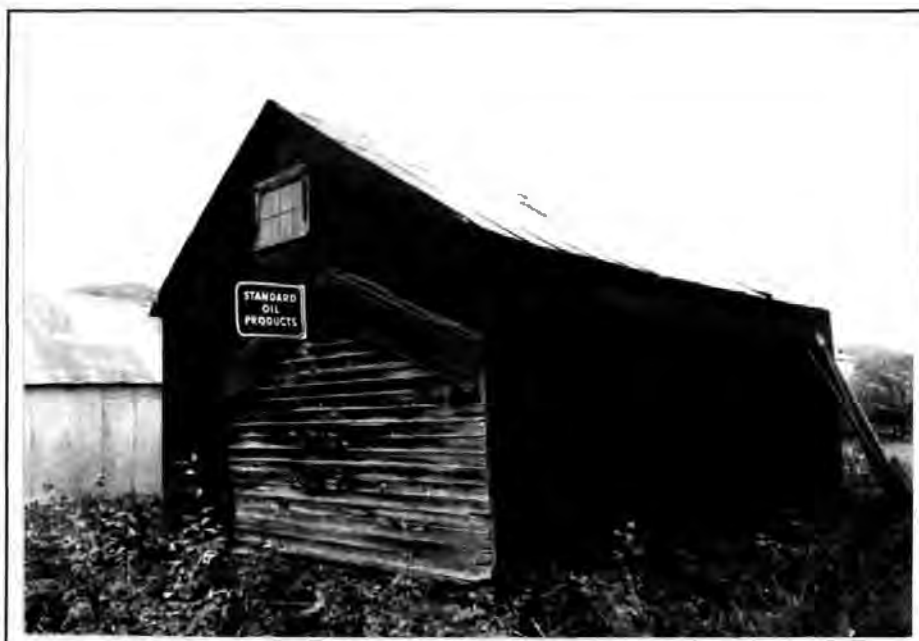
**Figure 42. The Donnelley/Standard Oil Warehouse, 1993. The view is looking northeast.**

The **Donnelley/Standard Oil Warehouse (IDT-084)** is a rectangular, 1.5 story, wood frame building (Figure 42) measuring 20'x30'. The foundation consists of logs on grade. The gable roof and exterior walls are covered with corrugated metal. The west elevation has a six-light, fixed sash window centered in the gable and a "Standard Oil" sign on the upper part of the building. A six-light, fixed sash window located in the east gable and a door covered by corrugated metal is located at the south end of the of the east elevation.

unknown. Prior to 1930, the building had a gable roof addition. The outline of that addition, which faced south prior to 1930, is still visible on the west side of the building. In 1993, a power plant that generated electricity for the Donnelley House was located in the Donnelley/Standard Oil Warehouse (Miscovich 1995:III-41).

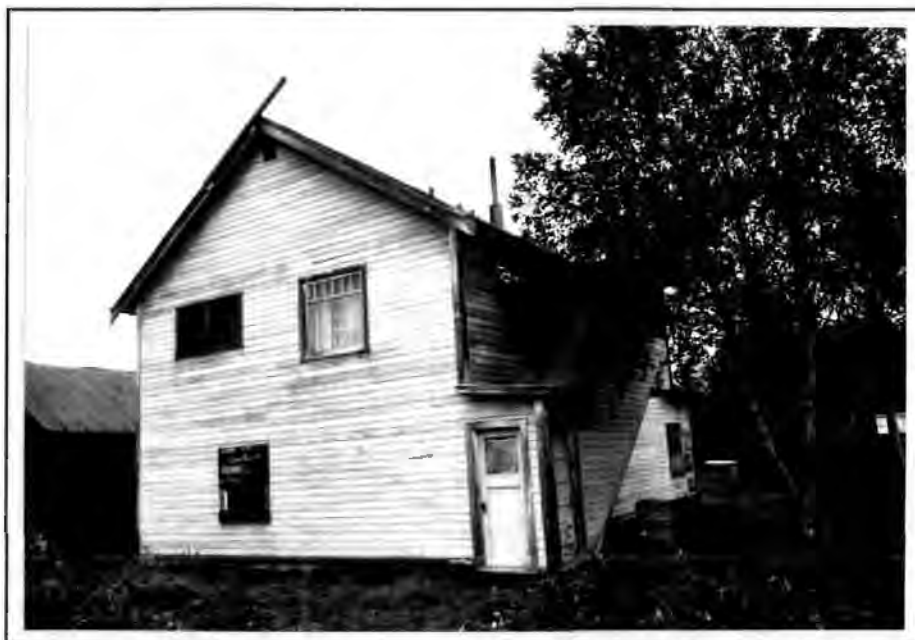
**Figure 43. The Donnelley House, 1993.**  
The view is looking northeast.

The **Donnelley House (IDT-085)** is a rectangular, two-story, wood frame building (Figure 43) measuring 26'5"x31'5". The foundation consists of wood blocks. The gable roof is covered with corrugated metal. Shiplap siding with corner boards covers the exterior walls. The main entrance faces west and has a boarded up window centered on the first floor. The second floor has a 1/1 horizontal single-hung window and a seven-light, fixed sash window. The second floor of the south elevation has two single-light, fixed sash windows. An enclosed exterior stairwell with a shed roof extends from the west end of the first floor to the center of the second floor. At the lower end of the stairway is a single-panel door with one light facing west and a five-panel door facing south. The upper end of the enclosed stairway has a single-light, fixed sash window facing south and east. The ground floor of the north elevation contains a one-panel door with one-light and two single-light, fixed sash windows. The second floor has a 1/1 horizontal single-hung window and a single-light, fixed sash window.

The north end of the east elevation of the house has a two-story gable roof addition measuring 10'2"x12'2". A one-light, fixed sash window is located on the ground floor of the north elevation and a 1/1 double-hung window is located on the second floor of the south elevation. A one-story shed roof addition is located on the south end of the east elevation of the house. The addition measures 10'2"x14'2". The addition has a boarded up window on the south elevation and a one-story, shed roof arctic entry on the east elevation. A five-panel door is centered on the south elevation of the arctic entry. Both additions and the arctic entry have corrugated metal roofs and shiplap siding with corner boards.

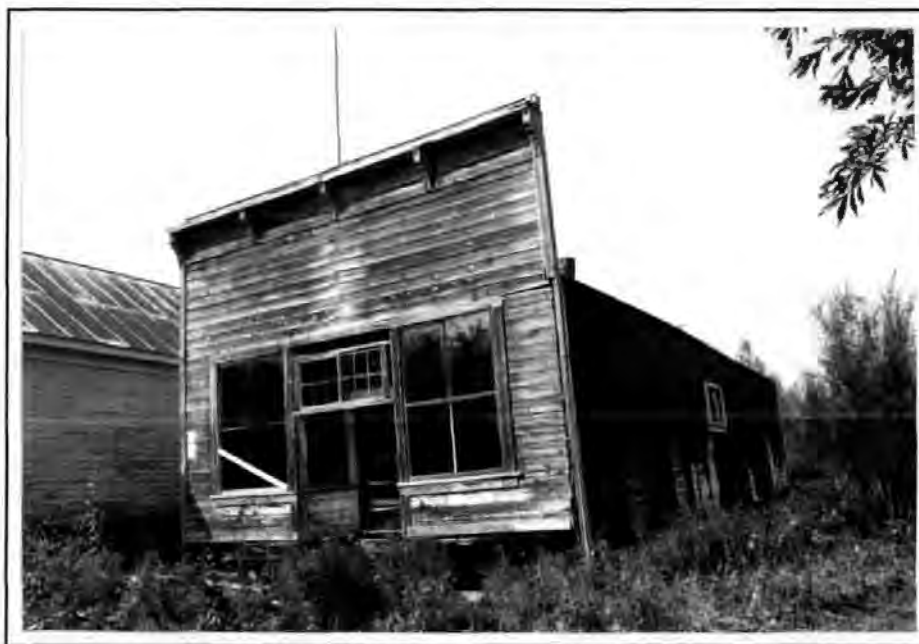
The **Turner and Wood Store (IDT-086)** is a rectangular, 1.5 story, wood frame commercial building (Figure 45). The foundation consists of timbers. The gable roof is covered with corrugated metal and the building measures 24'9"x60'3". Shiplap covers the east elevation. Roofing felt covers the other elevations. The main entrance faces east and has a false front with a recessed entry. The false front has a cornice with five brackets. A large four-light, store front window is located on each side of the recessed entry and a pair of six-light windows is located above the door. The recessed entry has a three light window on each side, a three panel door with one light, and a hopper transom window. The north elevation has a six-light, fixed sash window. The south elevation has a plank door covered with vertical shiplap. The west elevation has a five-panel door with a transom window, a fourteen light, fixed sash window on each side of the door, and a six-light, fixed sash window in the gable.

**Figure 45. The Turner and Wood Store, 1993. The view is looking southwest.**

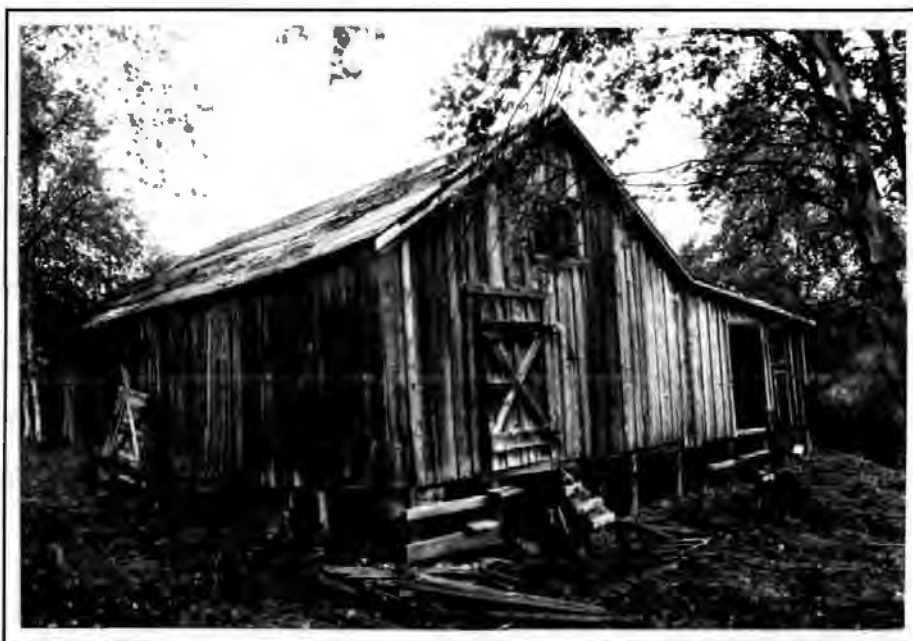
**Figure 46. The Turner and Wood Warehouse #1, 1993. The view is looking northwest.**

The **Turner and Wood Warehouse #1 (IDT-087)** is a rectangular, 1.5 story, wood frame building (Figure 46) measuring 18'10"x42'6". The foundation consists of horizontal timbers and wood posts. The gable roof is covered with roofing felt over wood decking. The exterior siding is board and batten partially covered with roofing felt. The main entrance faces east and has a large plank door and a six-light, fixed sash window in the gable. Two pairs of utility doors are located on the west end of the south elevation. The west elevation has a boarded up window at ground level and a boarded up window in the gable. Two pairs of utility doors are located on the west end of the south elevation.

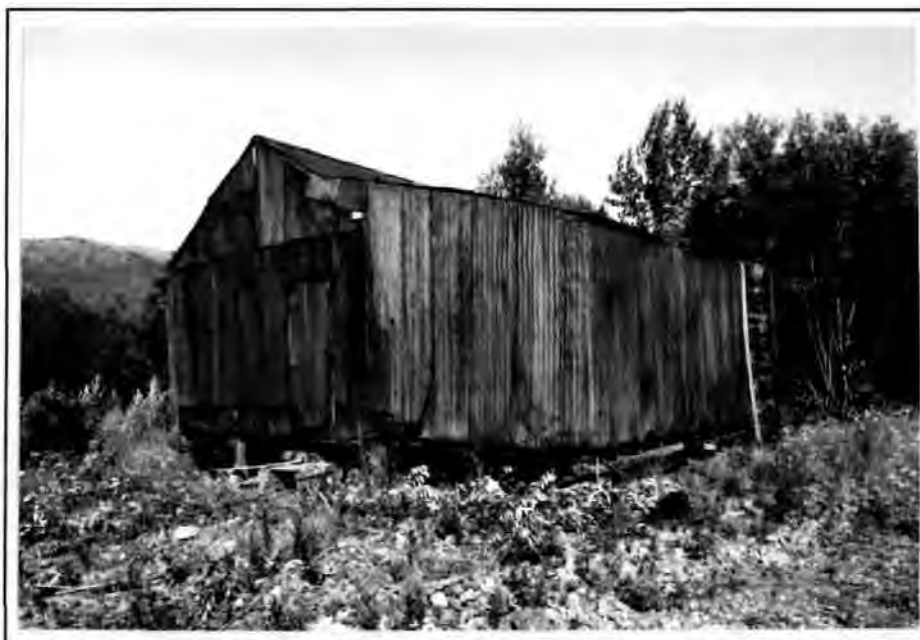
The **Turner and Wood Warehouse #2 (IDT-088)** is a one-story, rectangular, wood frame building (Figure 47). The foundation consists of stacked wood blocks and logs. The gable roof on the main building, a shed roof addition on the south side, and the exterior walls are covered with corrugated metal. The building measures 16'x24'. The main entrance faces east and features a large utility door which opens onto a 6'x6'6" loading dock. A large plank door covered with corrugated metal is located on the west elevation. The south addition measures 10'x24'. A window opening is located on the east elevation of the addition. The building is in fair condition. Blazo cans, cases of paper bags, aviation fuel, wire, and chains were located in the warehouse in 1993.

**Figure 47. The Turner and Wood Warehouse #2, 1993. The view is looking northeast.**

George Turner and Ira Wood built warehouse #2 in the late 1920s about the same time they built their store building. Turner and Wood used the building to store inventory, including dog fish and other commodities, for the general store. The building was originally located on the north side of Otter Creek, but it was moved to the south side when Turner moved his store in the late 1930s. Harry Donnelley purchased the building from Turner and Wood after World War II. He used the building as a warehouse and kept furniture in it (Miscovich 1995:I-14-15).

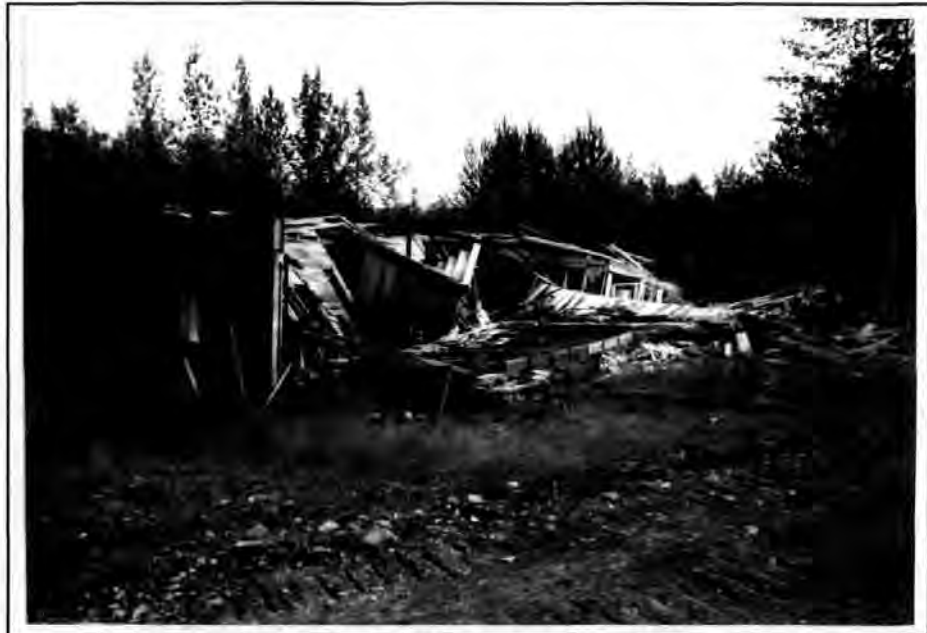
The **Adams/Lawrence Hotel and Bar (IDT-089)** was a two-story, wood frame, false front building that is in ruins (Figure 48). The foundation was beams on grade. The gable roof was covered with galvanized metal over rolled roofing and wood decking. The exterior siding was covered with shiplap. The main building ruins measures 24'x66'. The main entry faced south, but the south wall has collapsed and is buried in structural debris. The first floor walls on the north elevation and part of the west elevation are still standing. Door and window openings are visible, but the doors and windows are missing. The second floor and roof has collapsed onto the first floor. A collapsed stairway to the second floor is visible in the ruins. The covering on the first floor is linoleum over tongue and groove decking.

The collapsed and scattered ruins of a one-story addition are located on the east side of the hotel. These were the living quarters for the Lawrence family who operated the hotel. A collapsed wood frame addition measuring 11'x20' is attached to 6' of the east end of the south elevation of the hotel. The addition was a wood shed and storage area (Miscovich 1995:II-170). It appears to have been one-story with a shed roof.

**Figure 48. The Adams/Lawrence Hotel, 1993. The view is looking northeast.**

The Adams/Lawrence Hotel and Bar was the third in a succession of hotels. The first hotel, known as the Grand Hotel, was located where the Turner and Wood Warehouse #1 is now. It was destroyed in the 1924 fire. The second hotel was constructed on the site of the original hotel. George Adams bought the second hotel. This was the only hotel in Flat in the years after the 1924 fire. In the late 1920s, the building was cut in half and moved to make way for the Matheson Dredge. The top half of the second hotel became the Adams Dog Barn (IDT-090). George Adams built the third hotel (IDT-089) about 1930, shortly after the second one was cut in half and moved. Adams also operated a still and sold liquor to old timers during Prohibition. Adams left Flat in 1933 or 1934, about the same time that Harry Lawrence came to Flat. George Turner bought the hotel and took Lawrence on as a partner. Lawrence built the bar on the north side of the hotel in the mid-1930s. The bar was a one-story, wood frame addition that ran the length of the hotel and extended 20' to the north. Lawrence also built living quarters on the east side of the hotel for his wife and daughter. Lawrence continued operating the hotel and bar until the summer of 1943 when he suffered a stroke and left Flat. Turner died shortly thereafter and the building was abandoned. In 1966, Alvin and Sergie Agoff bought the partially collapsed building from Turner's sons. The Agoffs and other residents of Flat tore down the bar addition and have salvaged lumber from the hotel ruins. (Miscovich 1995:I-14-15; II-16-17; Agoff 1995:222-223).

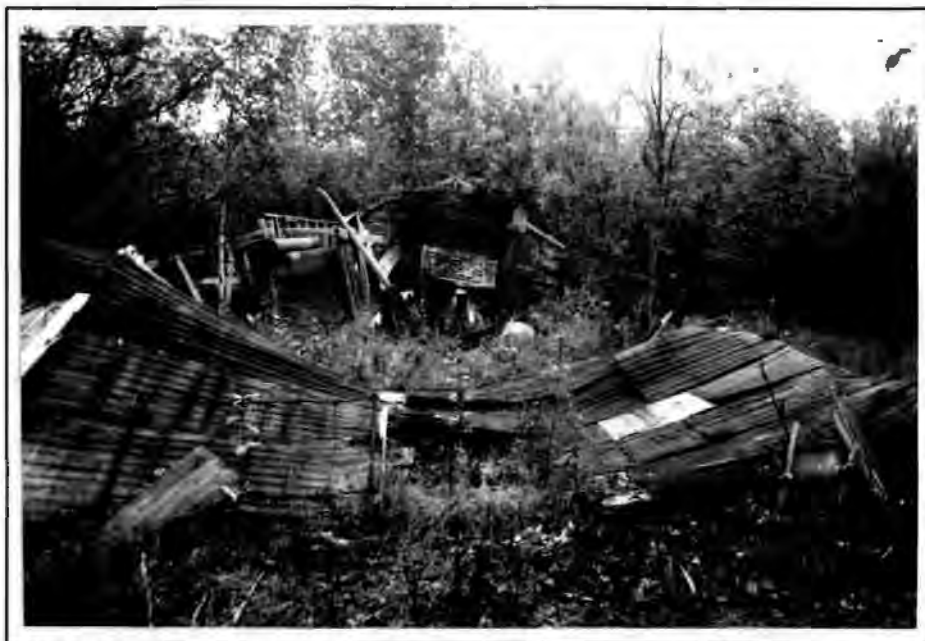
The Adams Dog Barn (IDT-090) is the ruins of a collapsed rectangular, one-story, wood frame building (Figure 49). The foundation was on grade. The gable roof and shed roof additions were covered with corrugated metal. The building measures 14'x41' and is oriented north-south. Corrugated metal covered the exterior walls. Only the north elevation and part of

the west elevation are standing. The north elevation has a door opening. Dog stalls measuring 1'9"x 3'8" are located in the interior of the west elevation. The south elevation, which has collapsed into the building, had a door opening. The south gable measured 11'6". A shed addition on the west side of the building measures 8'x41'. The north wall, which is still standing, has an awning window. The west elevation of the addition is partially

**Figure 49. The ruins of the Adams Dog Barn.  
1993. The view is looking north.**

standing and has dog stalls lining the north end of the interior wall. These stalls measure 2'6"x4'. The south elevation has a plank door. A shed addition on the east side of the building measures 12'x41'. All of the walls of this addition have collapsed. The east elevation has a window opening and there was a plank door on the south elevation.

The main portion of the Adams Dog Barn was the bottom half of the Grand Hotel (Kepler 1995:130). George Adams moved the lower half of the old hotel in the late 1920s and converted it to a dog barn to shelter sled dogs for mail carriers who stopped in Flat. Airplanes began delivering mail to Flat in 1925 and airmail cut into the work of dog mushers who carried the mail. By 1927 or 1928, airmail replaced the winter delivery of mail by dog sled and Adams abandoned the building in the 1930s. The building was still standing in the 1950s. After the roof collapsed, local residents salvaged lumber and corrugated metal from the building (Miscovich 1995:II-18).

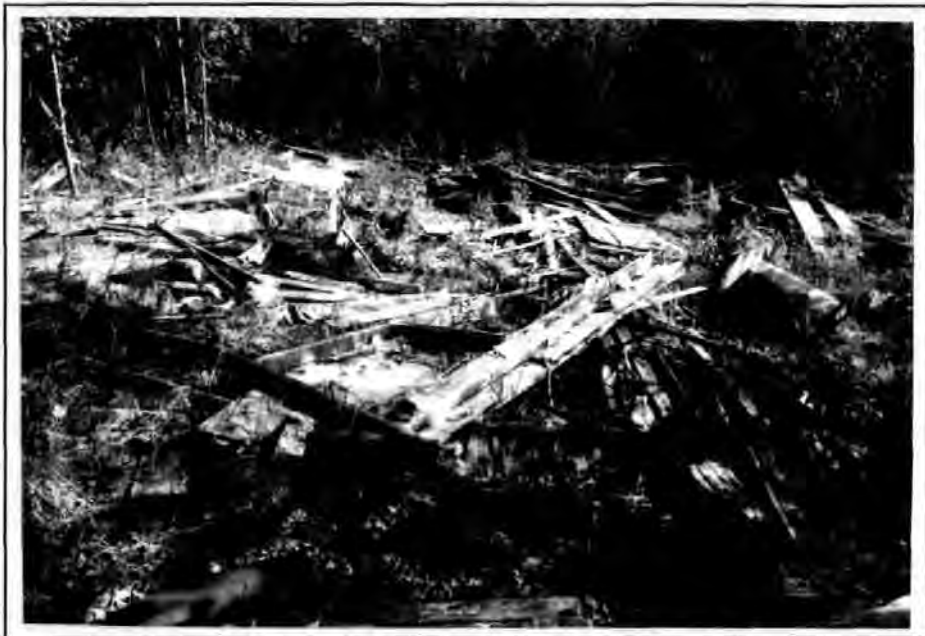
**ACS Wireless Station Site (IDT-091)** consists of the foundation and ruins of a rectangular, one-story, wood frame building (Figure 50). Most of the roof and walls have been salvaged. The foundation consists of wood blocks. A section of the collapsed roof in the northeast corner of the ruins consists of rolled roofing over wood decking. The ruins of the building measure 24'x40'. Collapsed wall sections are located on the north and west sides of the site. The exterior was covered with rolled roofing over horizontal wood siding. A door frame, flanked by two window openings, is located in the remains of the north elevation. A window frame is located in a section of the west wall that is laying outside the building. Interior artifacts include a metal sink, metal bedposts, stove pipe, a section of interior wall with a door frame, and a concrete generator stand.

**Figure 50. Ruins of the ACS Wireless Station near Otter Creek, 1993. The view is looking north.**

The building was abandoned in the 1940s and 1950s. The roof had collapsed by 1966 when Minnie Brink tore the building down and salvaged the lumber (Agoff 1995:223).

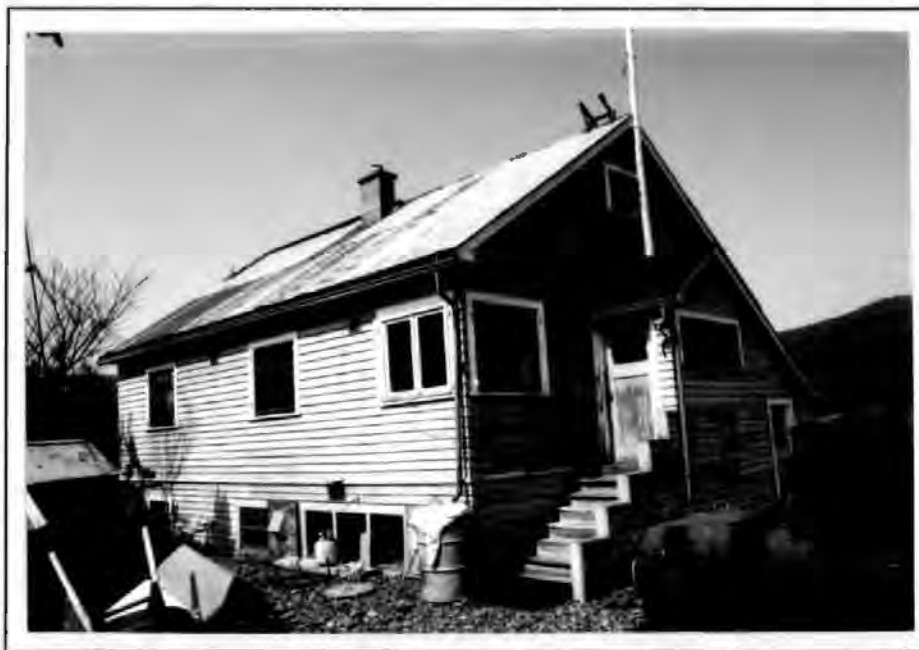
The Matheson House (IDT-102) is a rectangular, 1.5 story, wood frame residence (Figure 52). The foundation is concrete and includes a full basement. The gable roof is covered with corrugated metal. A roof dormer with a shed roof and a triple six-light, fixed sash window faces north. The building measures 25'x34'6". Clapboard covers the exterior walls. The main entry is the north elevation, which has two six-light, fixed sash windows. A gable roof arctic entry measuring 6'x8'8" is located on the east end of the north elevation. The arctic entry has a pair of six-light, fixed sash windows facing north and a six-light window facing east. A single-panel door with one-light faces west, but the exterior stairway to the door is missing. The west elevation has a six-light, fixed sash window on the ground floor and a six-light, fixed sash window under the gable. The south elevation has two six-light, fixed sash windows and a pair of single-light, casement windows. The east elevation has two six-light, fixed sash windows on the ground floor, a six-light, fixed sash window in the gable, and an arctic entry with a gable roof. The arctic entry measures 4'x14', has a pair of six-light, fixed sash windows facing east, and a single-panel door with one-light that accesses the basement. Stairs rise to a single-panel door with one-light that faces south. The basement has two six-light, fixed sash windows facing north and two six-light, fixed and four two-light, fixed sash windows facing south. Decorative features on the house include enclosed cornices with small returns, matching storm windows on many of the windows, a stair stepped wall adjacent to the steps leading up to the door of the east arctic entry. The house also has gutters and downspouts.

Figure 52. The Matheson House, 1993.  
The view is looking northwest.

A 10'2"x10'2" metal tower approximately 50' tall is located 5'2" southwest of the house. A Jacob Electric Windmill is located on top of the tower. A wood frame greenhouse measuring 15'5"x10'10" is located 6'10" south of the house. The roof and sides of the greenhouse are covered with multi-light windows. A large garden area measuring 57'x112' is located 5' south of the greenhouse. The garden is surrounded on the north, east and west sides by a rock wall that varies in height from 3' to 4'6".

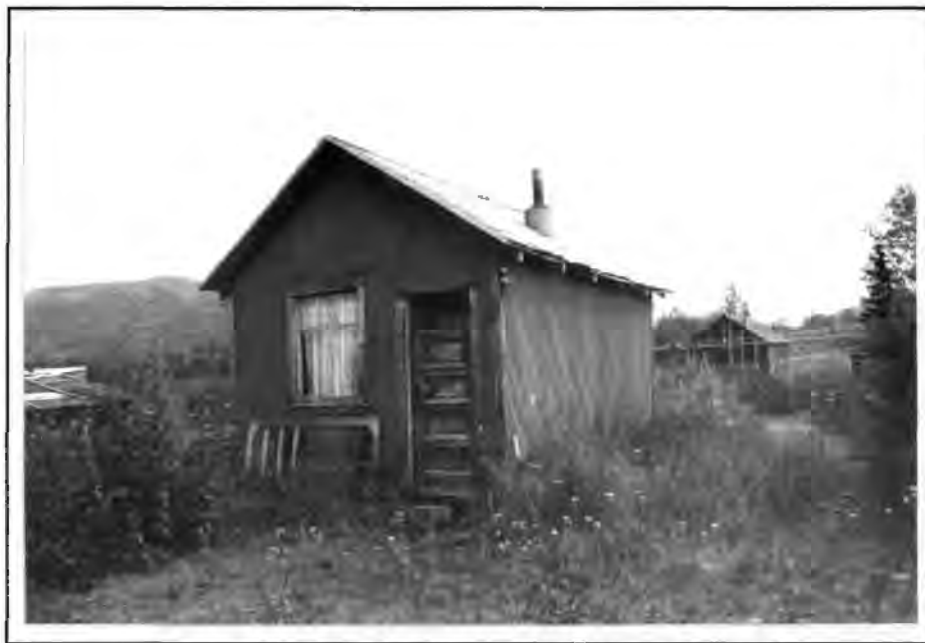
The **Matheson Guesthouse (IDT-103)** is a one-story, wood frame building (Figure 53) located 18'6" east of the Matheson rock garden. The foundation of the guesthouse consists of logs on grade. The gable roof is covered with corrugated metal. The guesthouse measures 12'5"x16'2". The exterior walls are covered with green asphalt roofing felt and have corner boards. The main entry is on the north elevation, which has a five-panel door and a four-light window. A screened window frame with no glass is centered on the south elevation.

**Figure 53. The Matheson Guesthouse, 1993.**  
The view is looking southeast.

The date and location where the guesthouse was built are unknown. John Stevens moved the house to its present location sometime after 1960. Stevens built the two wood sheds after he purchased the Matheson property in 1960. He used them to store fire wood for the furnace in the Matheson House (Mischovich 1995: III-33).

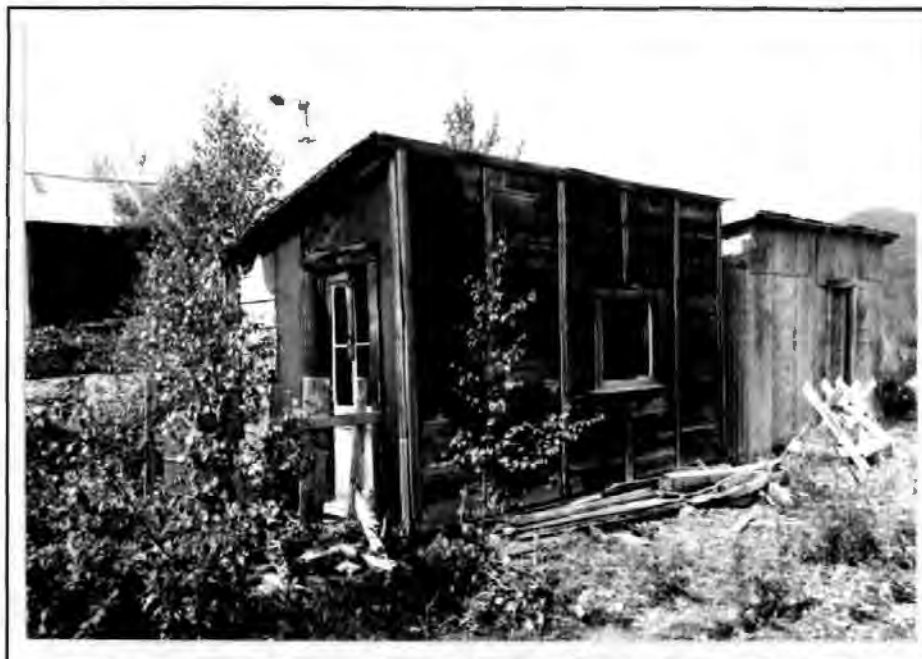
Two small rectangular, one-story, wood frame buildings (Figure 54) are located 30' east of the Guesthouse. The

northern most of the two buildings is Wood Shed #1. It measures 10'4"x14'2" and the

foundation is on grade. The siding and shed roof are covered with corrugated metal. A plank door covered with corrugated metal faces east. Wood Shed #2 measures 10'4"x14'2" and the

foundation is on grade. The exterior siding and shed roof are covered with roofing felt over wood siding, but weathering has stripped away most of the roofing felt. The east elevation has a single-light, fixed sash window. A four-panel door is located on the north elevation and a two-panel door with four lights is located on the south elevation. A boarded up window is located on the west elevation.

**Figure 54. The Matheson Wood Sheds, 1993.**  
The view is looking northwest.

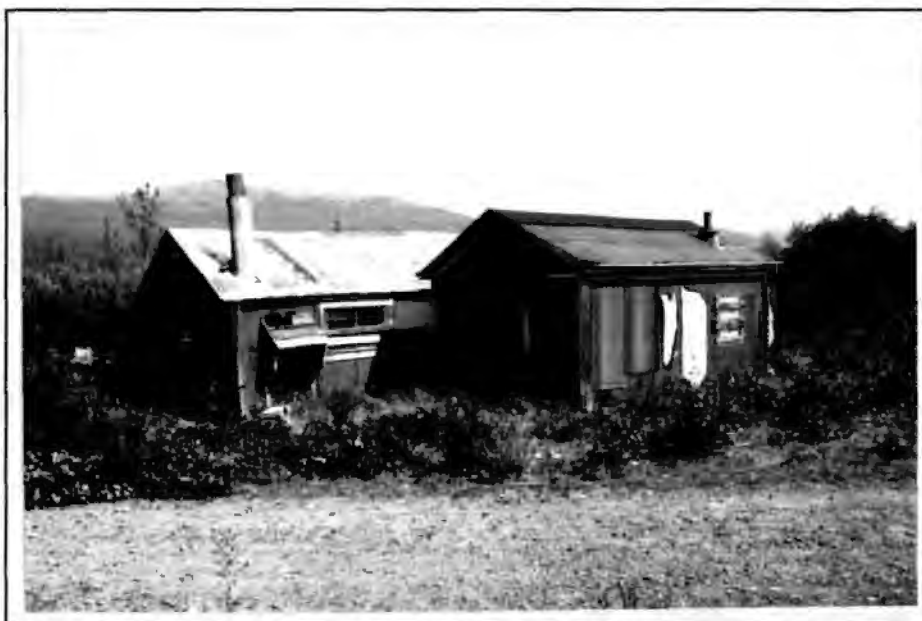
The Matheson Mess Hall (IDT-104) is a rectangular, one-story, wood frame building (Figure 55) with two additions. The foundation consists of logs. The gable roof is covered with corrugated metal and is oriented east-west. The building measures 18'3"x26'5". Asphalt rolled roofing covers the ex-

**Figure 55. The Matheson Mess Hall (left) and Cook's Quarters (right), 1993.** The view is looking northeast.

terior walls. The main entry is on the south elevation, which contains a 1/1 horizontal double-hung window and a five-panel door. The west elevation has a 1/1 horizontal double-hung window. The east elevation has a three-panel door, a 6/6 horizontal double-hung window, and a six-light, fixed sash window.

The cook's quarters is a rectangular, one-story, wood frame building located 4'2" south of the mess hall. The foundation is horizontal timbers on grade. Corrugated metal and roofing felt cover the gable roof, which is oriented east-west. The building measures 12'4"x18'4" and the exterior walls are covered with roofing felt. A two-panel door faces north and is covered by a corrugated metal porch which links the building to the Mess Hall entry. A single-light, fixed sash window is also located on the north elevation. A 1/1 horizontal single-hung window is located on the west elevation and a boarded up window is located on the south elevation. A shed roof addition located on the east end of the structure measures 8'2"x8'3". The roof and exterior walls are covered with roofing felt over wood siding.

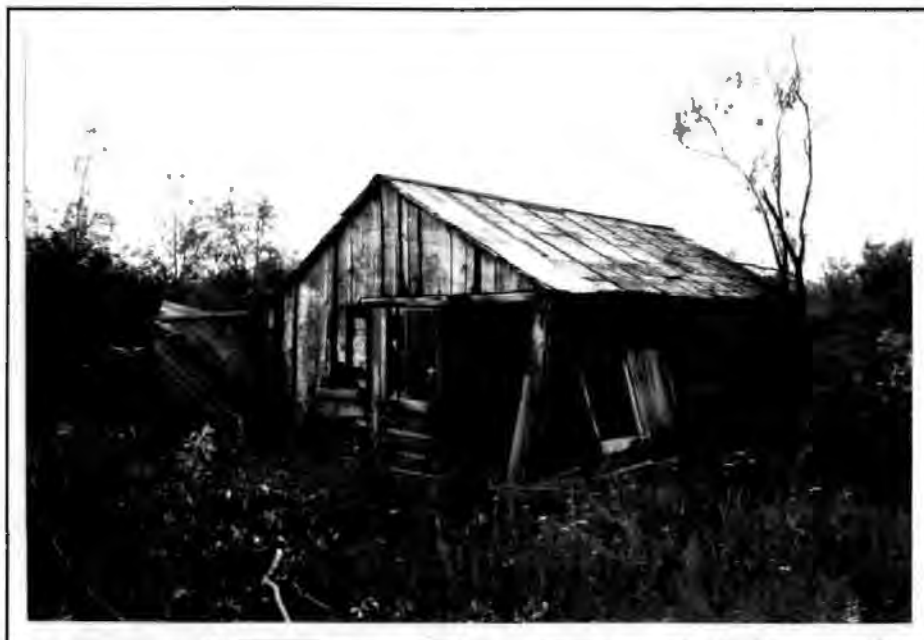
**The Matheson Storage Building (IDT-105)** is a rectangular, one-story, wood frame building (Figure 56) with an addition. The foundation consists of logs. The gable roof has corrugated metal on one-side and weathered roofing felt over wood decking on the other. The building measures 15'x23'11". The exterior is covered with roofing felt over vertical wood siding and features corner boards. The main entrance is on the east elevation, which features a pair of large plank doors, although one of the doors is missing. A boarded up window is located on the north elevation. A boarded up six-light, fixed sash window and a boarded up personnel door are located on the west elevation.

**Figure 56. The Matheson Storage Building, 1993. The view is looking southwest.**

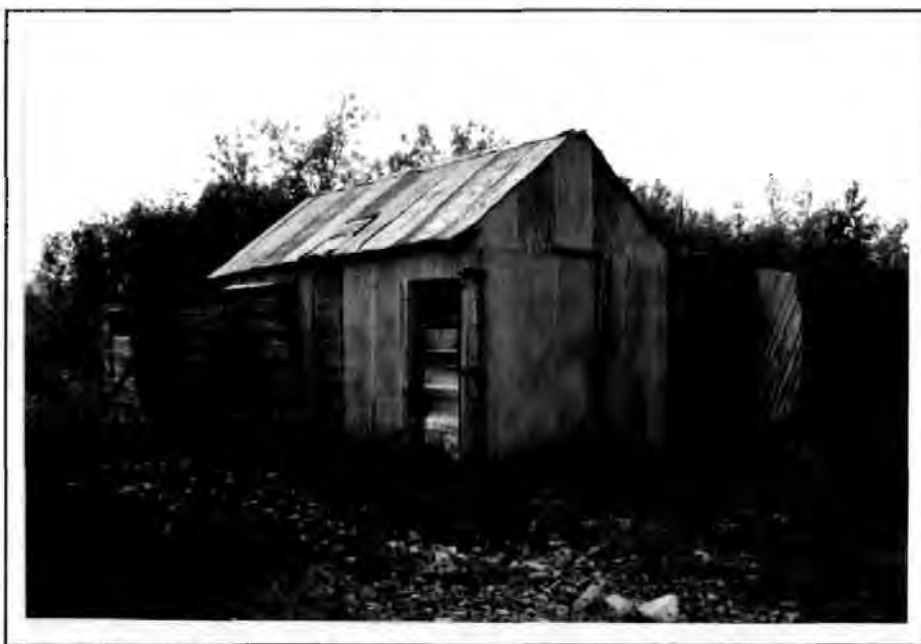
The Matheson Garage (IDT-106) is a rectangular, one-story, wood frame building (Figure 57) with two additions. The foundation consists of wood blocks. The gable roof and

exterior walls are covered with corrugated metal. The garage measures 12'x18'8". A pair of side opening utility doors are centered on the north elevation. A shed addition measuring 8'8"x12'2" is located on the west side of the building. Corrugated metal covers the shed roof. The exterior walls are covered with shiplap. A pair of side opening utility doors are centered on the north elevation of this addition. A four-panel door with one light is located at the north end of the east elevation. At the south end of the east elevation is a small 6'x6' shed addition. Corrugated metal covers the shed roof. The exterior walls are

**Figure 57. The Matheson Garage, 1993. The view is looking southwest.**

covered with shiplap. A small 3'3"x8' shed addition is centered on the south elevation of the garage. Corrugated metal covers the shed roof and the exterior walls are covered with horizontal siding.

The Matheson Garage is part of the Alex Matheson/NADC complex. The date of construction is unknown, but it likely dates to the late 1920s or early 1930s (Miscovich 19954:III-35).

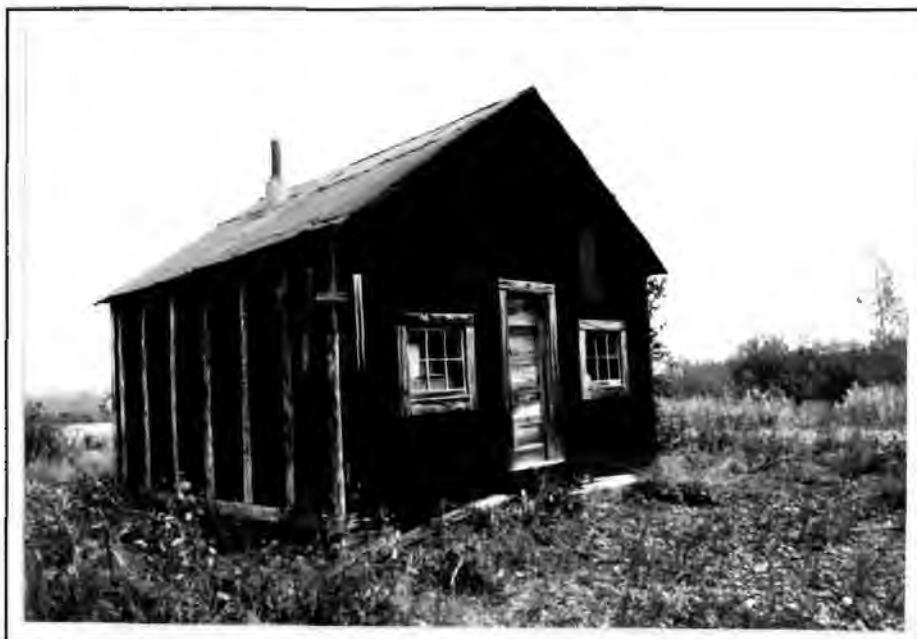
The **Byrd/Stevens Garage (IDT-107)** is a rectangular, one-story, wood frame building (Figure 58) located 17' east of Matheson Garage #1. The foundation of Garage #2 consists of wood blocks. Corrugated metal covers the gable roof. The building measures 18'3"x18'4" and the exterior walls are covered with roofing felt and batten. A five-panel door is centered on the south elevation and is flanked on each side

**Figure 58. The Byrd/Stevens Garage, 1993.**  
The view is looking northeast.

by a six-light, fixed sash window. A pair of side opening utility doors is located on the north elevation.

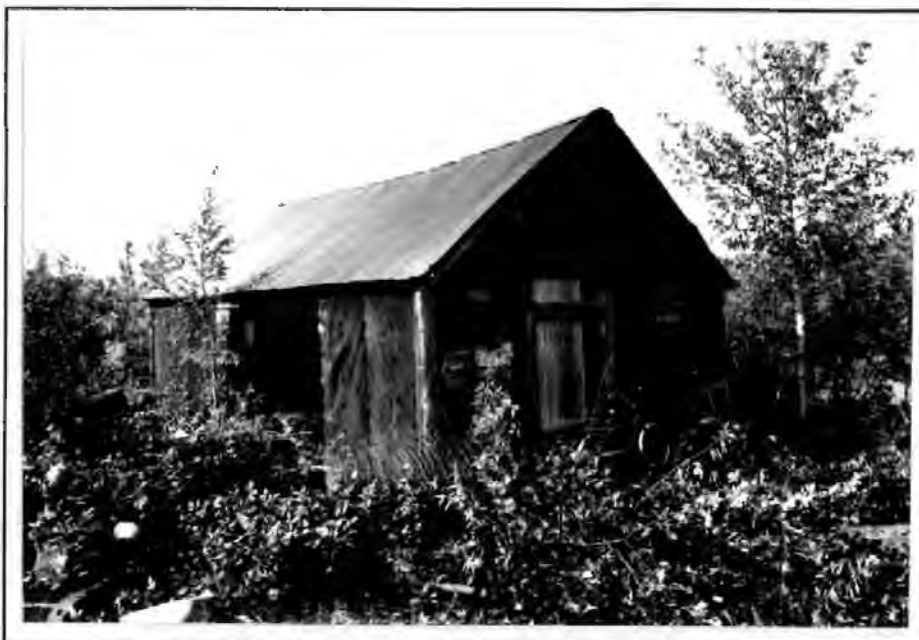
The **NADC Parts Warehouse (IDT-108)** is a rectangular, one-story, wood frame building (Figure 59). The foundation consists of timbers on grade. The gable roof is covered with corrugated metal. The building measures 16'5"x24'5". Roofing felt over horizontal siding covers the exterior walls. The main entry is on the east elevation, which features a vertical plank door covered with corrugated metal. A two-light, fixed sash window is located on the south elevation. The building is in fair condition. A small animal cage is located just outside the north wall of the building. A large pipe wagon in good condition is located 20' north of the building.

**Figure 59. The NADC Parts Warehouse, 1993. The view is looking northwest.**

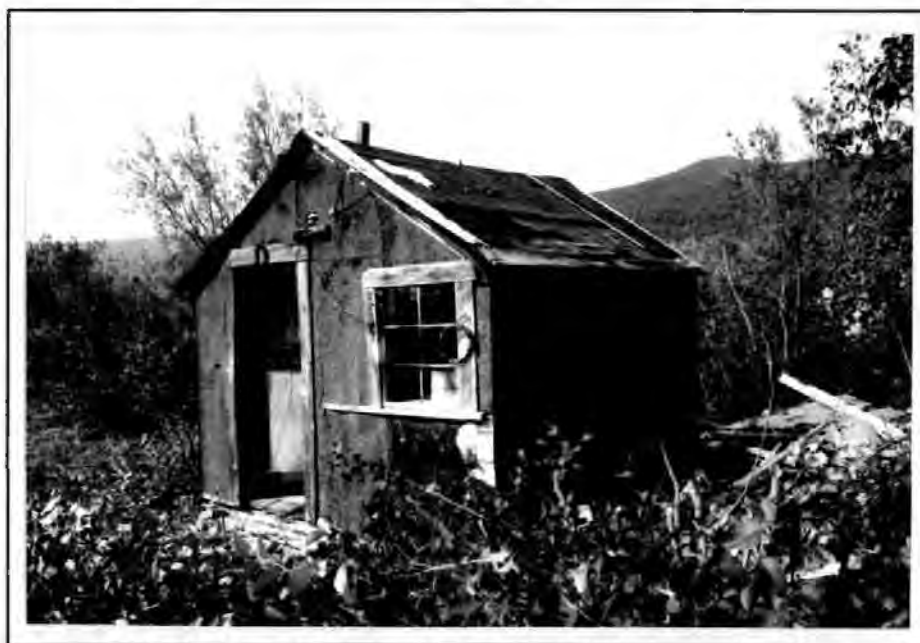
The NADC Washroom (IDT-109) is a rectangular, one-story, wood frame building (Figure 60). The foundation consists of timbers on grade. Roofing felt covers the gable roof. The building measures 10'4"x12'2" and the exterior walls are covered with roofing felt. The main entry is on the south elevation, which has a five-panel door and a six-light, fixed sash window. A boarded up window is located on the west end of the north elevation.

A rectangular, wood frame outhouse is located 28' north-east of the washroom. The building measures 4'11"x5'8". It is built out over a small slough and rests on a wood post foundation. The shed roof and exterior walls are covered with corrugated metal. The doorway faces south.

**Figure 60. The NADC Washroom, 1993. The view is looking northwest.**

The washroom and outhouse date

from the late 1920s or early 1930s and were part of the NADC complex. A bunkhouse (Site PP) was located southwest of the washroom. The bunkhouse was torn down in the late 1980s and parts of it were incorporated into the Kepler House (IDT-123) (Agoff 1995:236).

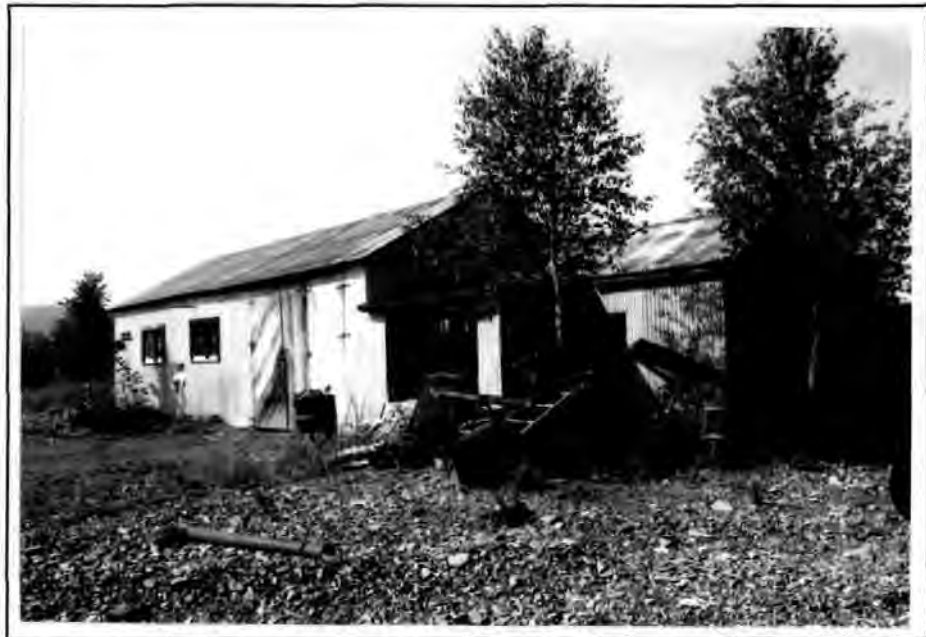
The **NADC Machine Shop (IDT-110)** is a rectangular, one-story, wood frame building (Figure 61). The foundation is on grade. Corrugated metal covers the gable roof and exterior walls. The machine shop measures 20'x40'. The main entry is on the south elevation, which features a pair of large side-opening doors and two 4/4 horizontal single-hung windows. Two 4/4 horizontal single-hung windows are located on the north elevation. The west elevation has a 4/4 horizontal single-hung window and a large plank door. A 6'x10'4" shed addition is located on south end of the east elevation.

The addition has a pair of side opening doors facing south. A gable roof addition is attached to the north end of the machine shop. The addition measures 14'x18'3". The roofs and exterior of these two additions are covered with corrugated metal. The north and south elevations of the gable addition have a six-light, fixed sash window. The east elevation has a small plank door. The power tools inside the shop are the original belt driven tools and they are in good condition.

**Figure 61. The NADC Machine Shop, 1993.**  
The view is looking northwest.

A small wood frame storage building measuring 10'3"x12'4" is located 2' northeast of the gable roof addition on the machine shop. The building rests on a block foundation and has a gable roof covered with corrugated metal. The exterior is covered with roofing felt and batten over horizontal wood siding. The south elevation has a plank door and a six-light, fixed sash window. The north elevation has a six-light, fixed sash window. Another storage building with a gable roof is located 9'4" north of the machine shop. The second storage building rests on a wood block foundation and measures 12'5"x16'2". It has a gable roof covered with corrugated metal and the exterior is covered with roofing felt. A four-panel door faces west. The east elevation has a two-light, fixed window and a plank door. Another workshop (Site SS) was located east of the machine shop (Agoff 1995:236), but nothing remains of that building.

The NADC Machine Shop and sheds date from the late 1920s or early 1930s. The machine shop was a central part of the NADC complex. Prior to the construction of the NADC machine shop, John Beaton and Alex Matheson took their equipment to the Riley Investment Company Machine Shop, owned by Harry Donnelley, for repairs. Matheson built the NADC Machine Shop to make his dredge operation independent of Harry Donnelley's enterprises. The small building directly north of the machine shop was used to store machine parts. The small building northeast of the machine shop was Matheson's blacksmith shop (Agoff 1995:236; Miscovich 1995:III-33).

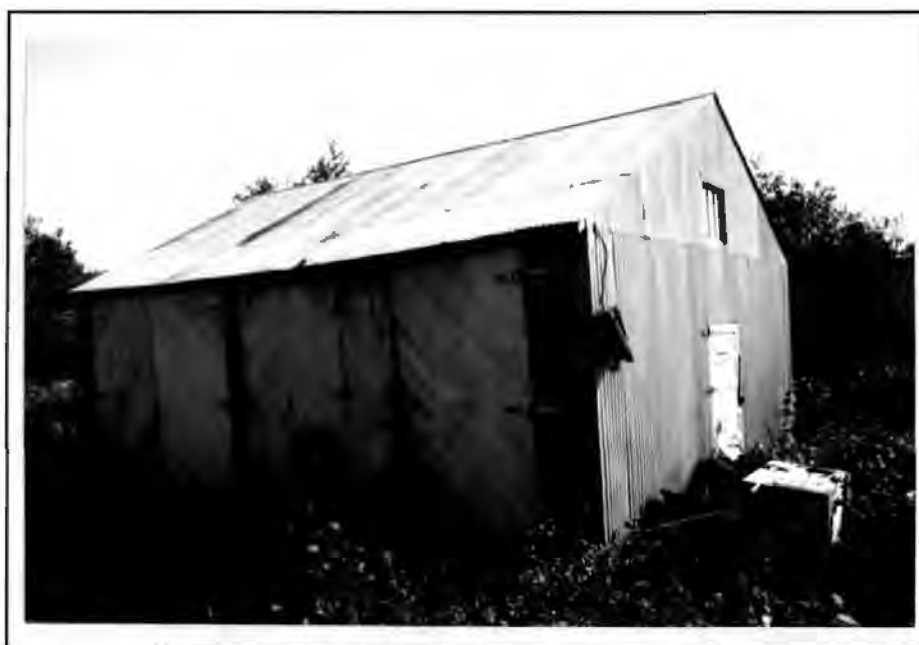
The **NADC Garage (IDT-111)** is a rectangular, one-story, wood frame building (Figure 62). The foundation is on grade. The gable roof and exterior walls are covered with corrugated metal. Two six-light, fixed sash skylights are evenly spaced on the south slope of the roof. The building measures 24'x29'3". The main entry is on the north elevation, which has two pairs of side opening utility doors. A five-panel door is centered on the west elevation and a six-light, fixed sash window is centered in the gable. Two six-light, fixed sash windows are evenly spaced on the south elevation.

**Figure 62. The NADC Garage, 1993.**  
The view is looking southeast.

The NADC Garage was a part of Alex Matheson's mining operation. Matheson bought a D-8 Caterpillar Tractor in 1945 and he built the garage in 1946 or 1947 to shelter and maintain the D-8 and other heavy equipment (Agoff 1995:236; Miscovich 1995:III-34).

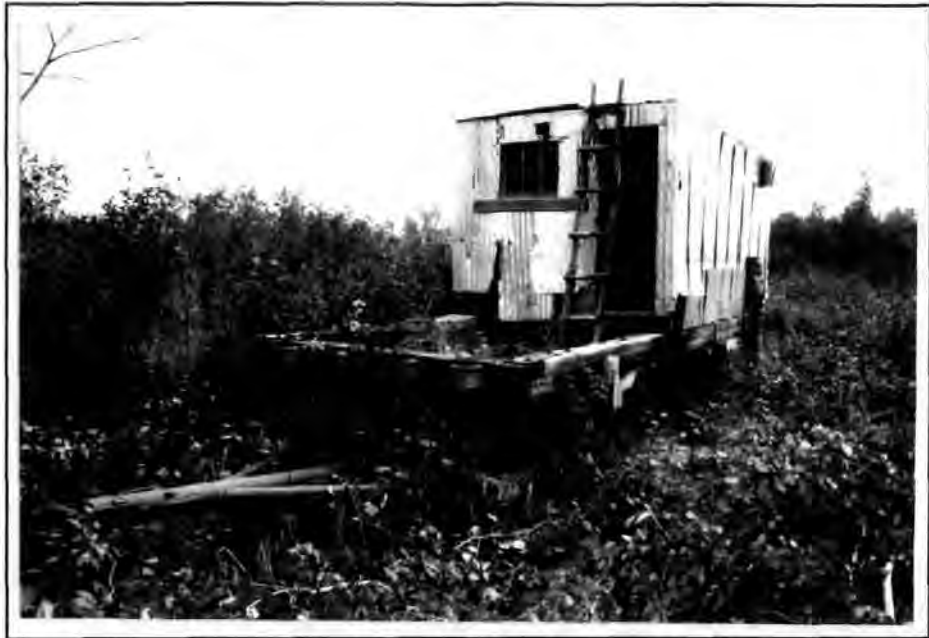
The **NADC Wanigan (IDT-112)** is a wood frame freight sled measuring 8'2"x 24'5" (Figure 63). The frame and floor are made of heavy timbers braced with metal plates. The tow bar is made of heavy metal pipe. A small rectangular, one-story, wood frame bunkhouse measuring 8'2"x16', is located on the back two-thirds of the sled. Corrugated metal covers the flat roof and exterior walls. A plank door and six-light, fixed sash window are located on the front (north) elevation of the bunkhouse. A four-light, fixed sash window is centered on the south elevation. A table, coffee pot, and bunks are located inside the structure. The sled is a

Figure 63. The NADC Wanigan, 1993.  
The view is looking southeast.

The wanigan and freight sleds were probably built in the 1930s. Alex Matheson used them from 1946 to 1951 to haul fuel and lumber in the winter from the mouth

of Crooked Creek on the Kuskokwim River to his headquarters in Flat. Matheson's crew used a D-8 Caterpillar tractor to haul the sleds. Matheson crews hauled 600-700 barrels of fuel a year plus the equipment needed to support his mining operation. This was part of Matheson's efforts to become independent of Harry Donnelley. The large number of metal barrels in the vicinity of the NADC complex are remnants of the fuel hauled from Crooked Creek (Agoff 1995:234, 236-237; Miscovich 1995:III-34).

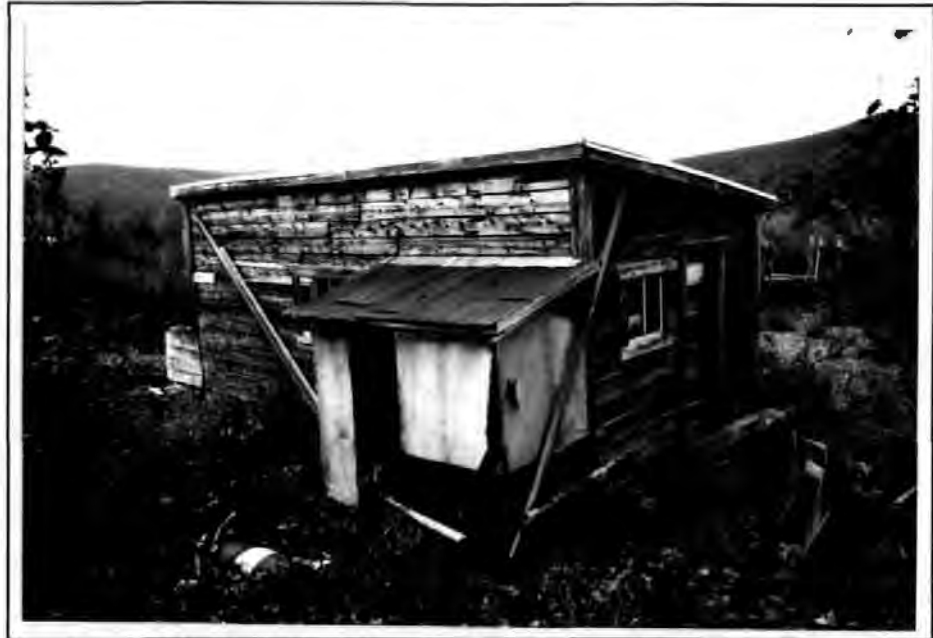
The **Balange Carpentry Shop (IDT-113)** is a rectangular, one-story, wood frame building (Figure 64). The foundation consists of three parallel beams (one along each side and one in the center) which serve as skids during towing. A tow cable is threaded through each of the three skids. Corrugated metal covers the shed roof. The building measures 12'2"x28'10". The exterior walls are covered with horizontal wood siding and corner boards. The north and south walls have diagonal bracing to give the building additional strength. The main entry is on the east elevation, which contains a five-panel door and a two-light, fixed sash window. A pair of fixed sash windows, one with two lights and the other with six lights, is centered on the south elevation. A small 4'x8' shed roof addition with celotex siding is located on the east end of the south elevation. The roof is covered with corrugated metal and a plank door faces west. A row of four storage boxes is located along the base of the west elevation. The boxes, which contained metal parts and fittings, are made of lumber. A shed roof covered with corrugated metal covers the boxes. The building held a set of carpentry tools in 1993.

**Figure 64. The Balange Carpentry Shop, 1993. The view is looking southeast.**

The date that the Balange's Carpentry Shop was built is unknown. Tommy Balange worked for Harry Donnelley from 1948 to 1951. Balange was a skilled carpenter and he made dog sleds in his spare time. In the late 1940s, the building was located near Balange's House (IDT-137). Balange

moved it across the road in the late 1940s. John Stevens moved the building to its present location about 1972 or 1973. The carpentry shop was not part of the NADC support facilities (Agoff 1995:228, 237).

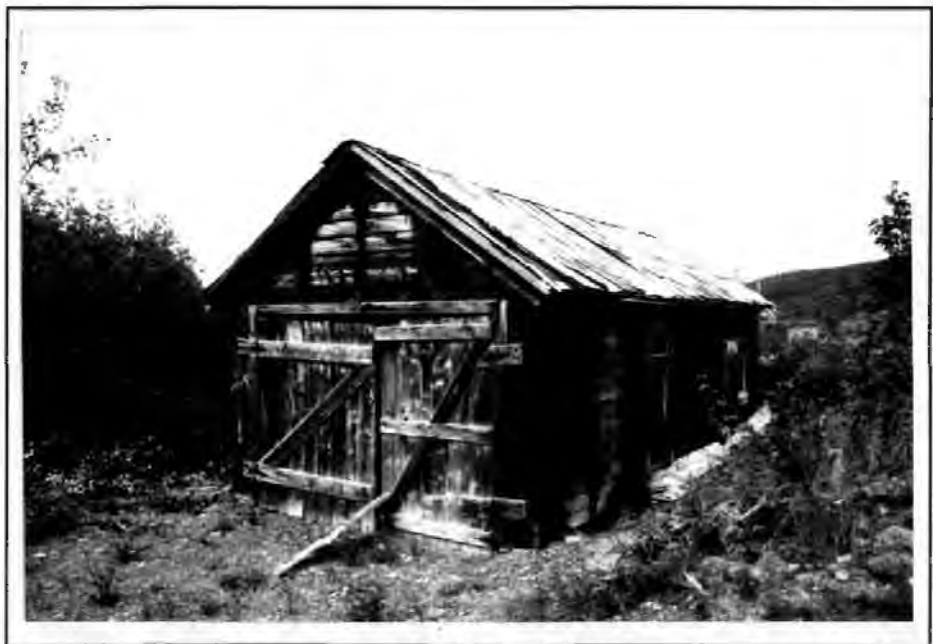
The **Applebaum House/Stevens Garage (IDT-114)** is a rectangular, one-story, wood frame building (Figure 65). The foundation is on grade. The gable roof is covered with corrugated metal. The culled (double) roof has 1"x1" sleepers between the decking. This is the only culled roof observed in Flat and one of only a handful of buildings (all residential) that have rain gutters. The

**Figure 65. The Applebaum House/Stevens Garage, 1993. The view is looking northwest.**

building measures 14'x30' and the exterior is covered with roofing felt over wood siding. The walls have been cut off at the base and there are no sill plates. The main entry is on the south elevation, which features a pair of large side-opening plank doors. A plank door is centered on the north elevation. The east elevation has a 2/1 single-hung window and a 1/1 double-hung window. The west elevation has a 1/1 double-hung window and a single-light, fixed sash window. Small strips of three layers of decorative wall paper are located inside the building near the ceiling. Stove pipe is located in the north end of the west slope of the roof. A 1935 model T-40 International Harvester Tractor is parked inside the structure and appears to be in good condition.
