BLM-Alaska Open File Report 64  
BLM/AK/ST-97/022+8111+040  
April 1997

## HISTORIC BUILDING SURVEY REPORT FLAT, ALASKA

by Rolfe G. Buzzell and Darrel L. Lewis

# **Historic Building Survey Report Flat, Alaska**

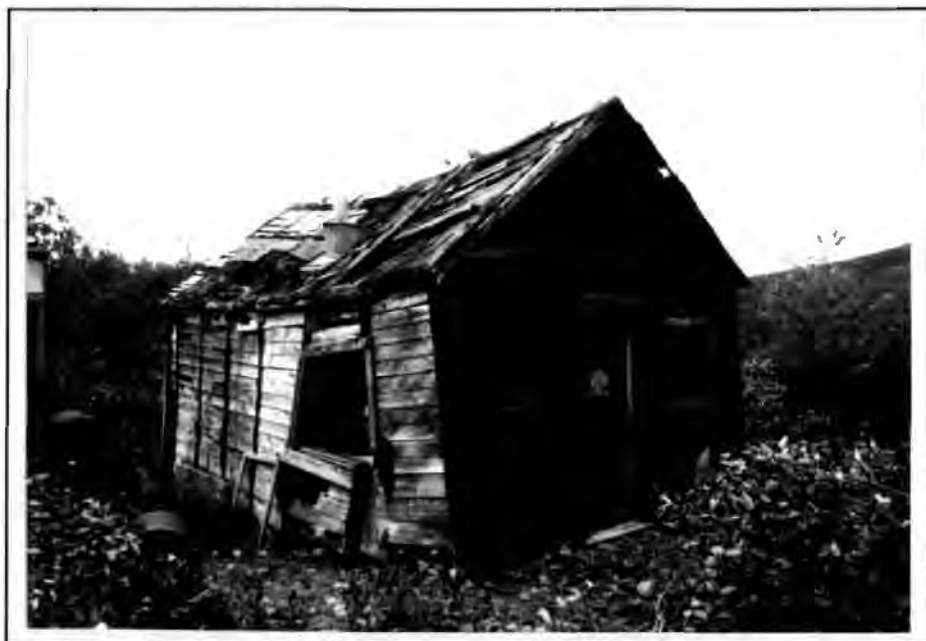
The **Joe Mitchell Cabin (IDT-115)** is a rectangular, one-story, wood frame building (Figure 66). The foundation is on grade and weathered tar paper covers the gable roof. The building measures 14'4"x18'. The exterior walls are covered with rolled roofing over shiplap. The main entrance faces east and has a three-panel door with a one-light door and a boarded up window. A two-light, fixed sash window is located on the north elevation. A five-panel door is located on the west elevation and a window opening is located on the south elevation.

An 8'1"x8'1" wood frame workshop with a shed roof is located 5'11" south of the cabin. The foundation is logs on grade. The roof is covered with corrugated metal

**Figure 66. The Joe Mitchell Cabin, 1993.**  
The view is looking northwest.

and the exterior is sided with celotex. A four-panel door with one-light and a six-light, fixed sash window are located on the west elevation. A 6'3"x6'9" wood frame building with a shed roof is located 16'9" southeast of the Workshop. The foundation is on grade. The roof and north, east and south elevations are covered with corrugated metal. The exterior of the west elevation is covered with horizontal wood siding. A plank door is on the west elevation. An 8'2"x8'3" wood frame shed is located 1'6" west and south of the small shed. The foundation is on grade. The shed roof and north, east, and west elevations are covered with corrugated metal. The south elevation is covered with horizontal wood siding. A five-panel door is on the west elevation. A shed roof outhouse, laying on its side, is located 29'6" northeast of the cabin. The outhouse measures 4'x4'. The roof and exterior walls are covered with wood siding.

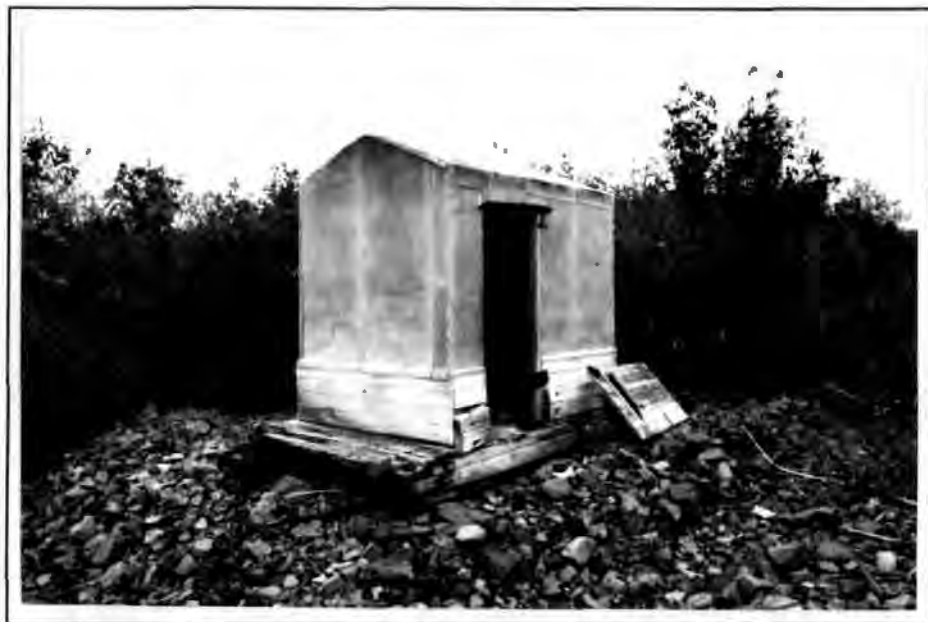
The **Shed on Skids (IDT-117)** is a rectangular, one-story, wood frame building on skids (Figure 68). The foundation consists of two 15'2" timber skids lined on the bottom with metal. A tow cable at each end of the sled runs through the end of the skids. Planks cover the skids, creating a floor for the sled. A rectangular, one-story, wood frame building rests on 4"x8" timbers running lengthwise along the floor. The enclosed building measures 5'6"x8'. The gable roof and exterior walls are covered with galvanized metal over shiplap. A 12" high band of shiplap is exposed along the base of the building. A doorway is located on the front (north) side. A plank door with one light is resting against the structure. A window opening without glass is located on both the south and west sides.

Figure 68. Sled on skids, 1993.  
The view is looking southwest.

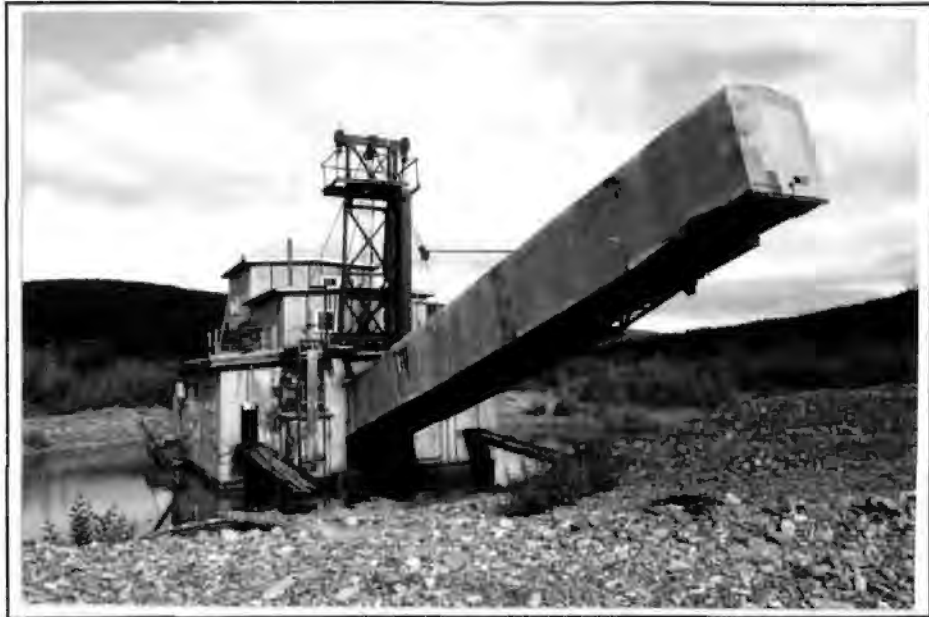
The Matheson Dredge (IDT-118) is a two-story, steel frame structure (Figure 70). The steel hull measures 39'x84' and rests on a shelf in a dredge pond. Galvanized metal covers the flat roof and exterior walls. The enclosed first floor structure measures 39'x57'. The second floor consists of a 20'x20'10" structure, a 20'x21'5" addition on the east end, and a 15'x16'2" addition (the bridge or control room) in the northwest corner. The gantry and the bucket line support structure are located on the west side of the dredge. A five-panel personnel door and an eight-light, fixed sash window are located on the first floor on each side of the gantry. A triple 1/1 single-hung window is located on the bridge on the second floor. The stacker, which is approximately 100' long and enclosed in galvanized metal, extends out the back or east end of the dredge. A five-panel door, a utility door, and an eight-light, fixed sash window are located on either side of the stacker on the first floor. Two four-light, fixed sash windows are

located on the second floor of the east elevation. The first floor of the north elevation has a large utility door, four 4/4 horizontal single-hung windows, and a 1/1 horizontal single-hung window. The second floor has a five-panel door and two 4/4 horizontal single-hung windows. The first floor of the south elevation has a five-panel personnel door, four 4/4 horizontal single-hung windows, and a 1/1 horizontal

**Figure 70. The Matheson Dredge, 1993.**  
The view is looking northwest.

single-hung window. The second floor has a five-panel personnel door, two 4/4 horizontal single-hung windows, and a pair of 4/4 horizontal single-hung window on the bridge. A three-cylinder gasoline engine located on the first floor of the dredge drives most of the machinery. The tumbler, crushing, stacking equipment, and the bridge are located on the second floor. The bucket line, which has been removed and is located about 100' west of the dredge, consists of 70 3.5 cubic foot buckets.

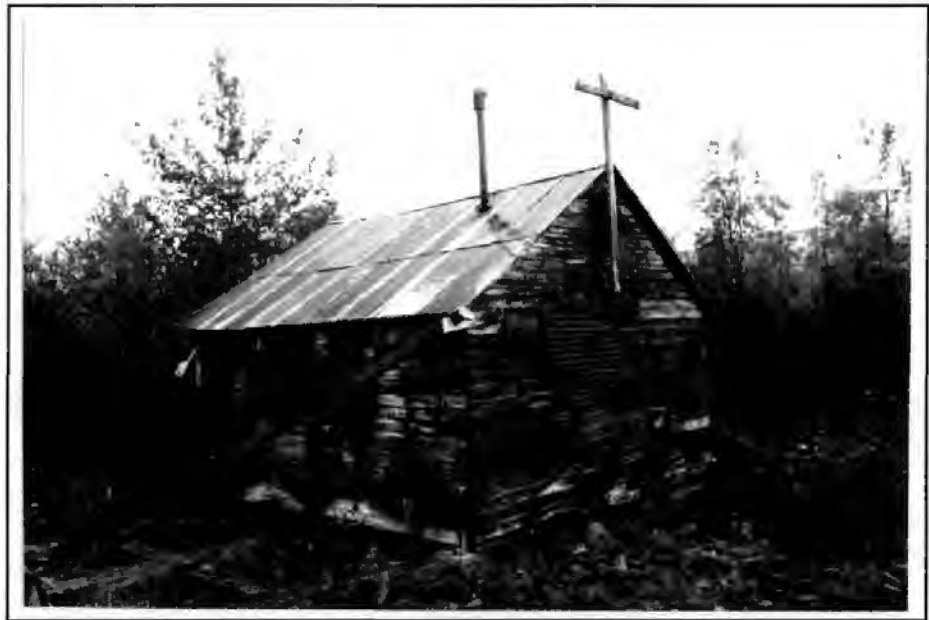
The **Jensen/NADC Pump House (IDT-119)** is a rectangular, one-story, wood frame building (Figure 71) located on the south bank of Otter Creek. The foundation consists of four 12"x12" skids. Corrugated metal covers the gable roof. The building measures 16'8"x 16'11", while the skid frame structure extends another 19' to the south. The exterior walls are covered with shiplap. The south elevation includes a five-panel door and a pair of single-light windows that are covered with corrugated metal. A six-light, fixed sash window is centered on the west elevation. The north elevation has a pair of boarded

**Figure 71. The NADC Pump House, 1993.**  
The view is looking northwest.

up single-light, fixed sash windows and a five-panel door. A boarded up two-light, fixed sash window is centered on the east elevation. A 12" metal water pipe extends from the east side of the building. A Washington Diesel engine is located in the center of the building. A large belt connects the engine to a drive shaft that turns the pump. A work bench is located along the south wall.

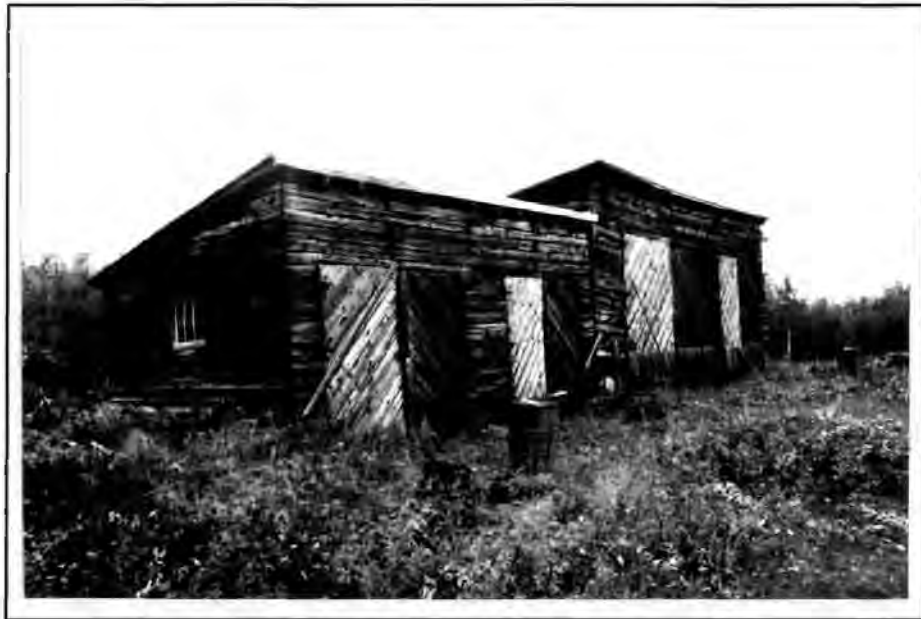
The **Turner/Hatten/Agoff Catsheds (IDT-120)** consists of two attached rectangular, one-story, wood frame buildings (Figure 72). Both buildings rest on wood blocks on grade and have shed roofs covered with corrugated metal. The first building measures 22'7"x31'4" and has exterior walls covered with shiplap. Two pairs of side-opening utility doors are evenly spaced

on the south elevation of the building. The east elevation contains a six-light, fixed sash window and a plank door with a two-light, fixed sash transom window. Two six-light, fixed sash windows are located on the north elevation. The second building is joined to the west side of the first structure, which is taller. A space of 2'2" separates the buildings. The two buildings are connected on the south elevation (main entry) by an exterior wall. On the north side, a small utility door connects the two buildings. A vertical plank door connects the first building with a five-panel door in the second building. The second building measures 18'1"x24'4" and the exterior is covered with shiplap. Two pairs of side opening utility doors are evenly spaced on the south elevation. A six-light, fixed sash window is centered on the west and north elevations. A third

building, known as the parts shed, is located about 8' northeast of the first catshed. The parts shed is a rectangular, one-story, wood frame building. The foundation is blocks on grade. Corrugated metal covers the shed roof. The building measures 8'10"x 18'4". The exterior walls are covered with wood siding. The south elevation has a plank door and a pair of six-light, fixed sash windows. A two-light, fixed sash

**Figure 72. The Turner/Hatten/Agoff Catsheds, 1993. The view is looking northeast.**

window is located on the west and north elevations. Metal barrels and engine parts are scattered on the east side of the Catshed and Parts Shed.

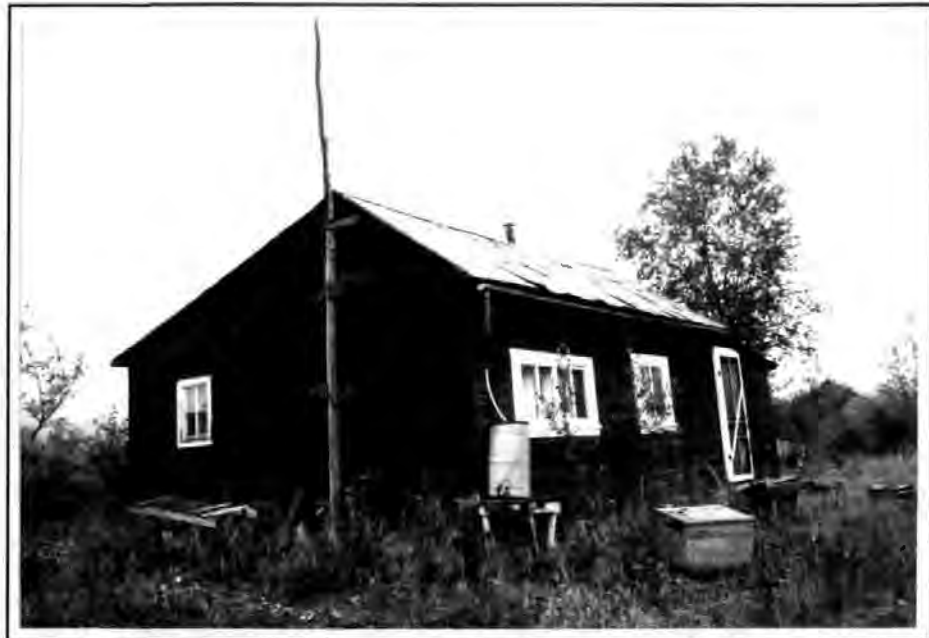
The **Sagoff/Demientieff/Wintz House (IDT-121)** is a rectangular, one-story, wood frame building (Figure 73). The foundation is hidden by corrugated metal skirting. The gable roof is covered with corrugated metal. The house measures 12'3"x 19'11" and the exterior is sided with shiplap. The south elevation has a pair of two-light, fixed sash windows and a separate two-light, fixed sash window. The east elevation has a two-light, fixed sash window and a small shed roof arctic entry. The arctic entry has a five-panel door facing south and a single-light, fixed sash window facing east. A shed roof addition on the north elevation joins the gable roof at the apex. The addition measures 12'x19'11" and wood siding covers the exterior. The east elevation of the addition has a pair of single-light, fixed sash windows. The north elevation has two single-light, fixed sash windows and the west elevation has a four-light, fixed sash window.

**Figure 73. The Sagoff/Demientieff/Wintz House, 1993. The view is looking northeast.**

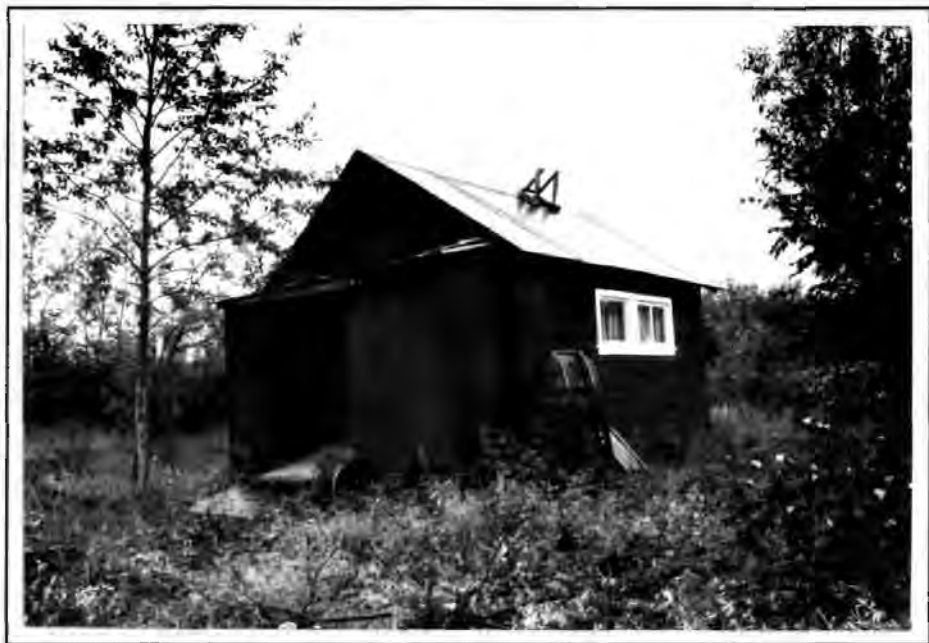
A rectangular, one-story, wood frame workshop building (Figure 74) is located 52'6" east of the wood shed. The foundation is not visible. Roofing felt covers the gable roof. The building measures 16'1"x18'1" and the exterior is covered with wood siding. The main entry is the north elevation, which has a pair of side opening doors covered with celotex. The north elevation is covered by an enclosed porch.

**Figure 74. Dave Wintz's Workshop, 1993.**  
The view is looking southeast.

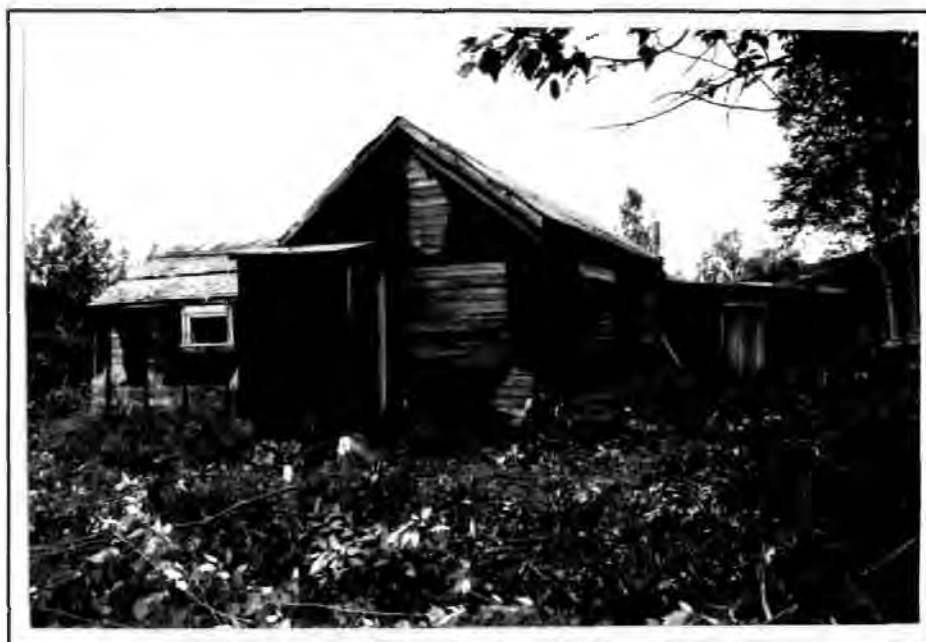
The Fullerton/Durand/Roper/Byrd House (IDT-133) is an "L" shaped, one-story, wood frame building (Figure 76). The foundation consists of logs on a raised rock pad. Wood shingles cover the gable roof. The house measures 12'2"x22'9". The exterior walls are covered with roofing felt over wood shingles. The main entry is on the east elevation, which contains a boarded up four-light, fixed sash window and a shed roof arctic entry measuring 4'2"x5'2". A four-panel door with one light is located on the north elevation of the arctic entry. The north elevation has two boarded up windows. The south elevation has a boarded up window and a gable roof addition extending south from the main portion of the building. The addition measures 12'2"x14'3" and has a boarded up window centered on the south elevation. A single-light, fixed sash window on the east elevation. This addition gives the house an "L" shape.

A gable roof addition measuring 10'6"x12'2" is located at the west or back side of the house. A boarded up window faces west and a two-light, fixed sash window faces south. A shed roof addition measuring 11'5"x14'8" is located on the north side of house. The shed roof and exterior walls are covered with corrugated metal. A two-light, fixed sash window faces east and a boarded up window faces north. An entry

**Figure 76. The Fullerton/Durand/Roper/Byrd House, 1993. The view is looking southwest.**

on the west elevation has no door. A shed roof arctic entry measuring 3'4"x3'11" is located on the west end of the south side of this addition. The arctic entry abuts the west side of the west gable addition. The south elevation of this arctic entry has a five-panel door.

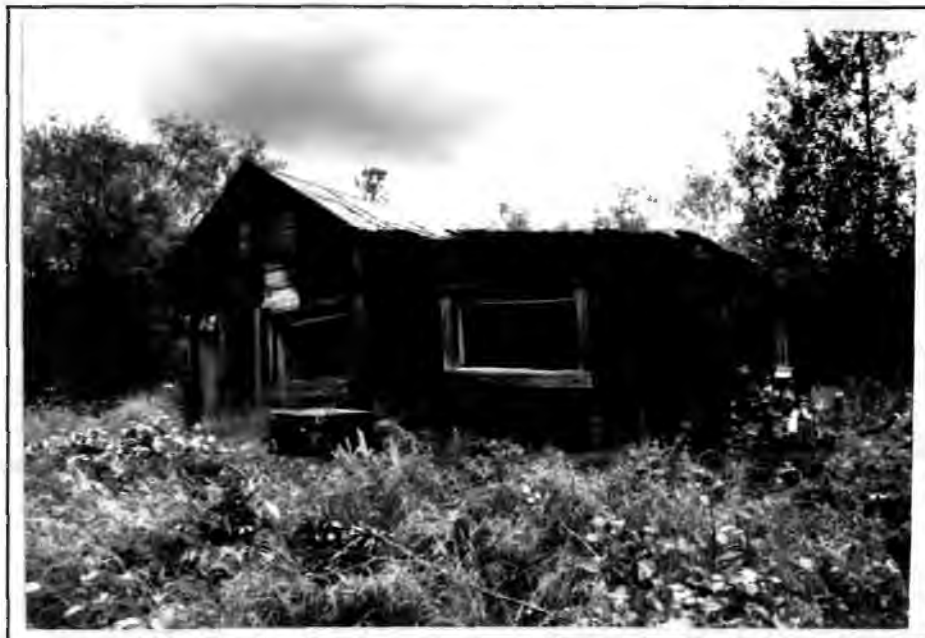
The Remington/Duffy/Baquir House (IDT-134) is a rectangular, one-story, wood frame building partially in ruins (Figure 77). The foundation is timbers on grade. The gable roof is

covered with corrugated metal over wood decking. The main part of the building measures 12'x12'2". The exterior is covered with roofing felt over wood siding. The main entry is on the east elevation, which includes a doorway with no door and a window opening with no window. The south elevation also has a window opening. A shed roof addition measuring 11'8"x 20'10" is located on the north side of the house. A

**Figure 77. The Remington/Duffy/Baquir House, 1993. The view is looking southwest.**

window opening is located on the east and north elevations. A shed roof addition is located on the west side of the house and measures 9'x12'. The shed roof is missing and the west wall is collapsed. Another addition measuring 12'1"x20' extends to the south from the west addition. The shed roof and east and west walls are missing. The west wall has collapsed. A door way, now missing, faced south.

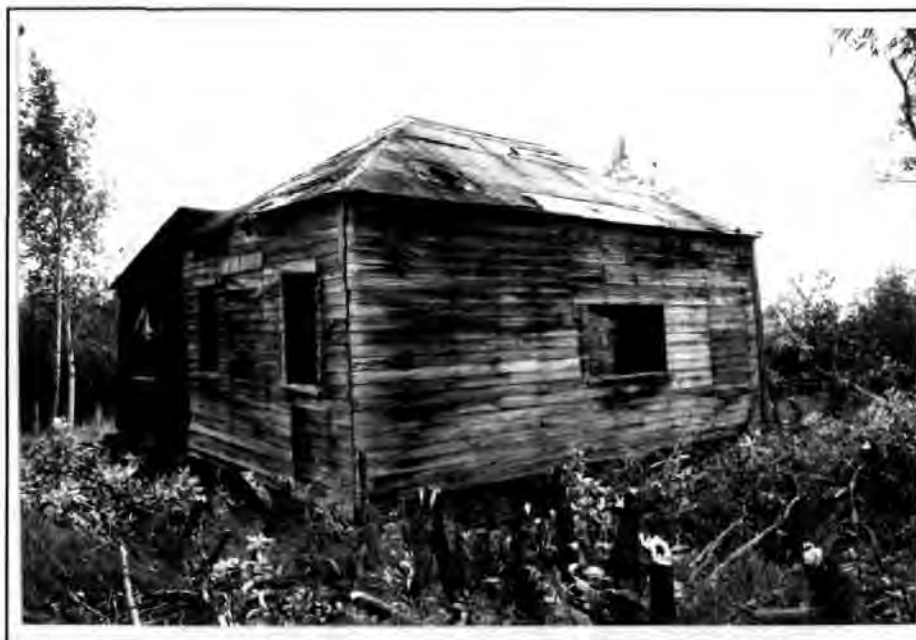
The **Harry Agoff House (IDT-135)** is a rectangular, one-story, wood frame building (Figure 78). The foundation is log and wood blocks on grade. Roofing felt covers the hipped roof. The building measures 15'10"x24'5". The exterior is covered with shiplap and features corner boards. The main entry is on the west elevation, which includes a decorative single-light, fixed sash window and a shed roof arctic entry. The roof of the arctic entry is covered with roofing felt and the exterior is covered with horizontal wood siding. The south wall of the arctic

entry is missing. A two-light, decorative fixed sash window is on the west elevation. The upper light is a band of diamond lights. The north elevation of the house has a window opening with no frame and another window that has been permanently boarded up. The east elevation has two window openings. One was formerly a door and a third window has been permanently boarded up.

A 14'11"x24'5" addition on the south side of the house rests on a wood block foundation. The shed roof is covered with roofing felt over wood decking. The exterior is sided with roofing felt over shiplap. A window opening is present on the east, west and south elevations. A door opening is located near the middle of the wall between the house and the addition. The building is in poor condition.

Figure 78. The Harry Agoff House, 1993.  
The view is looking northwest.

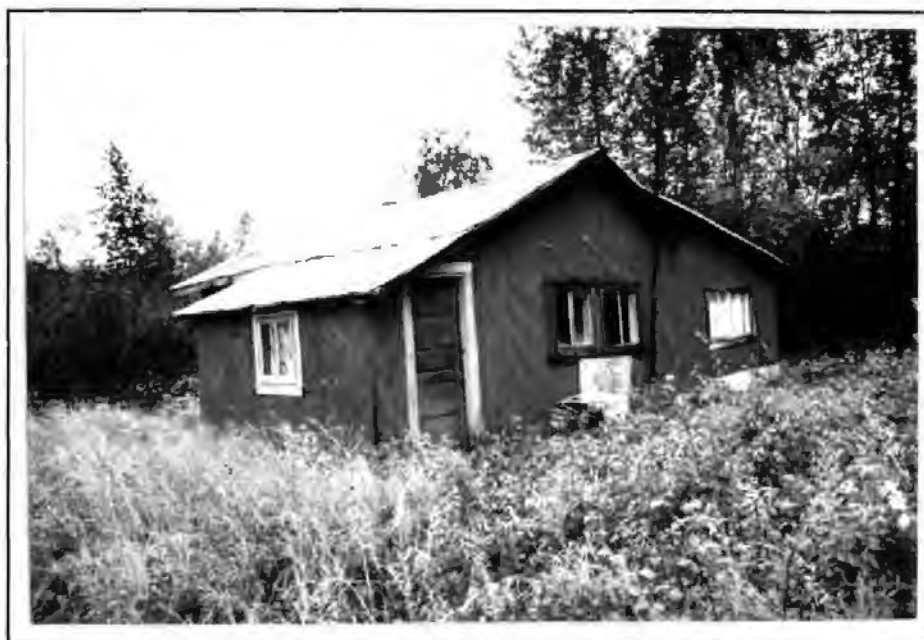
The **Ogriz House (IDT-132)** is a rectangular, one-story, wood frame, building with three additions (Figure 79). The foundation is not visible. Corrugated metal and roofing felt cover the gable roof. The house measures 14'2"x22'4" and the roof line is oriented north-south. The exterior walls are covered with roofing felt. The three additions have the same roof covering and exterior siding as the house. The main entry is on the west elevation, which includes a shed roof addition measuring 5'4"x12'4". This addition has a five-panel door facing south, a two-light, fixed sash window facing west and a four-light, fixed sash window facing north. The south elevation of the house has a pair of two-light, fixed sash windows. The north elevation has a two-light, fixed sash window and a boarded up window in the gable. A shed addition on

the east side of the building measures 12'x 22'4". A pair of two-light, fixed sash windows are located on the south elevation. A five-panel door and a two-light, fixed sash window are located on the north elevation. A two-light, fixed sash window and a shed addition measuring 7'2"x18'4" are located on the east elevation. This third addition has two six-light, fixed sash windows on the east elevation and a four-light, fixed sash window on the north elevation.

**Figure 79. The Ogriz House, 1993.**  
The view is looking northeast.

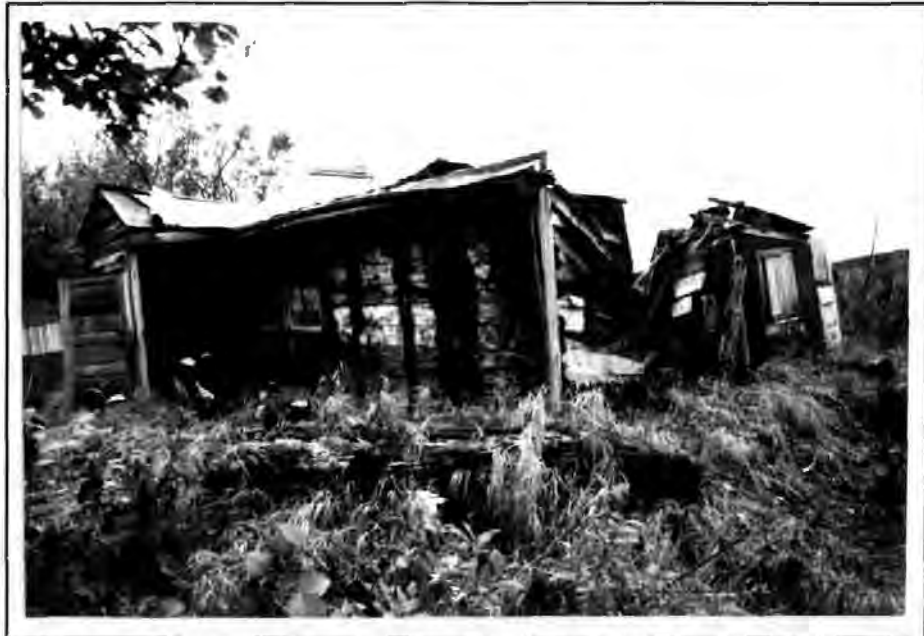
The **Kardanoff/Hatten/Stuver House (IDT-131)** consists of the ruins of a rectangular, one-story, wood frame building (Figure 80). The log foundation is on grade. The gable roof is covered with corrugated metal. The house measures 11'x21'8". Weathered roofing felt over wood siding covers the exterior walls. The east wall and roof on the east end of the house have collapsed. The main entry is on the south elevation, which includes a four-light, fixed sash window and a gable roofed arctic entry measuring 5'x6'. The arctic entry has a four-light, fixed sash window facing west and a door opening facing south. A five-panel door is leaning against the entry just outside the building. A window opening is centered in the east and west elevations

of the house. A 11'6"x20'4" shed addition is located on the north elevation. The roof, which was covered with roofing felt, has collapsed into the addition. A two-light, fixed sash window is located on the east elevation and a six-light, fixed sash window is on the ground below a window opening on the west elevation. An entry without a door and a boarded up window are located on the north elevation of the addition. Flooring on the ground just north of the addition suggests that another shed was attached to the north.

The ruins of a partially collapsed shed are located 7'4" west of the house. The shed roof is missing. The shed measured 12'6"x21'. Corrugated metal over wood siding covers the exterior walls. The corrugated metal is stripped in areas exposing the siding. Part of the east wall is missing and the other walls are warped. The south elevation contains a door opening and a two-light, fixed sash window. A

**Figure 80. The Kardanoff/Hatten/Stuver House, 1993. The view is looking northwest.**

boarded up window opening and a doorway with no door is located on the west elevation. A pair of single-light, fixed sash windows are located on the north elevation of the shed.

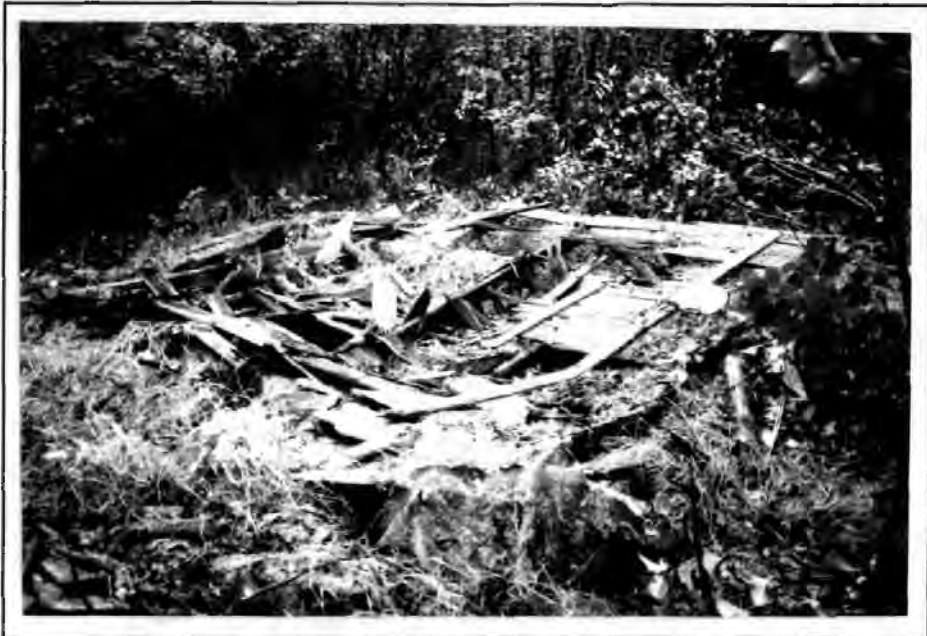
**The Anderson/Stuver House Ruins (IDT-136)** consists of the remains of a rectangular, one-story, wood frame building (Figure 81). The walls and roof are missing. The foundation is horizontal logs on grade. The building covered an area measuring 10'x15'4". The flooring consisted of 1"x2" lumber on 2"x4" joists. Small scraps of corrugated metal and linoleum are located around the building. Artifacts present at the site include small sections of cable, glass

**Figure 81. The Anderson/Stuver House Ruins, 1993. The view is looking northeast.**

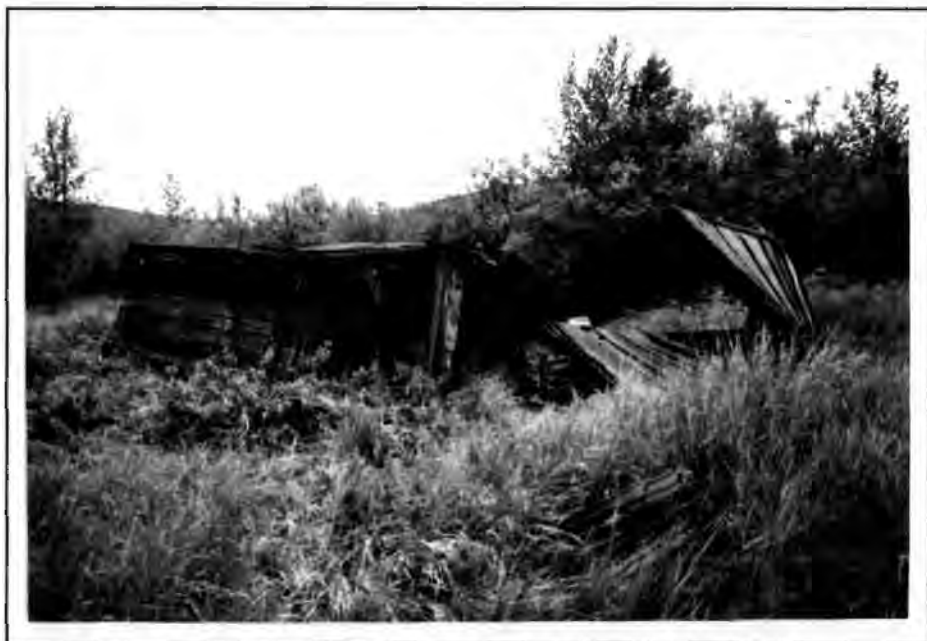
The McCon-  
eghy/Balange House  
(IDT-137) consists of  
the ruins of a square,  
one-story, log building  
(Figure 82). The  
foundation is horizontal  
log on grade and the  
building, which has  
collapsed, measures  
15'5" per side. Roofing  
felt and corrugated  
metal cover the hip  
roof. The exterior is  
log. A partially  
collapsed shed addition  
is lo-

**Figure 82. The McConeghy/Balange House Site, 1993. The view is looking northeast.**

cated on the south side of the house. The addition measures 11'x15'5" and the exterior is covered with wood siding. The shed roof, which has partially collapsed into the structure, is covered with roofing felt. A plank door is located on the south elevation. Another addition is located on the east side of the south addition. The east addition, which has become separated from the rest of the house, measures 9'x11'. The addition has tipped over, with the shed roof facing east.

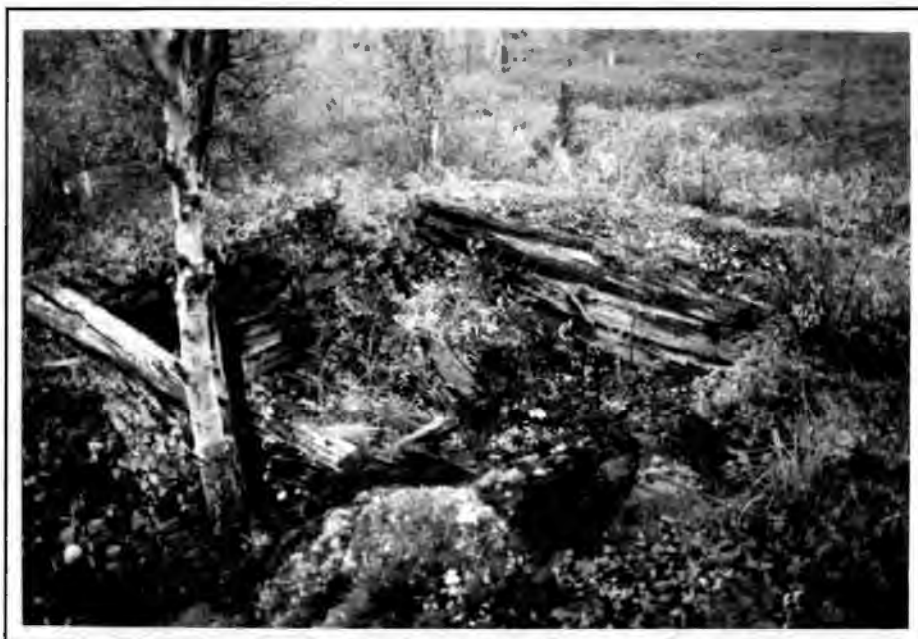
The remains of an **Underground Cold Storage Facility (IDT-244)** are located 78' west the McConeghy house ruins (Figure 83). All that is visible of the cold storage facility on the surface is the entryway, which is caved in. The entry consists of a circular berm surrounding a rectangular log structure. The rectangular entryway measures 8'5"x 9'5" and is 4' deep. The roof is missing and the entryway is partly filled with earth and brush growing on top.

**Figure 83. The entry to the Underground Cold Storage Facility, 1993. The view is looking north.**

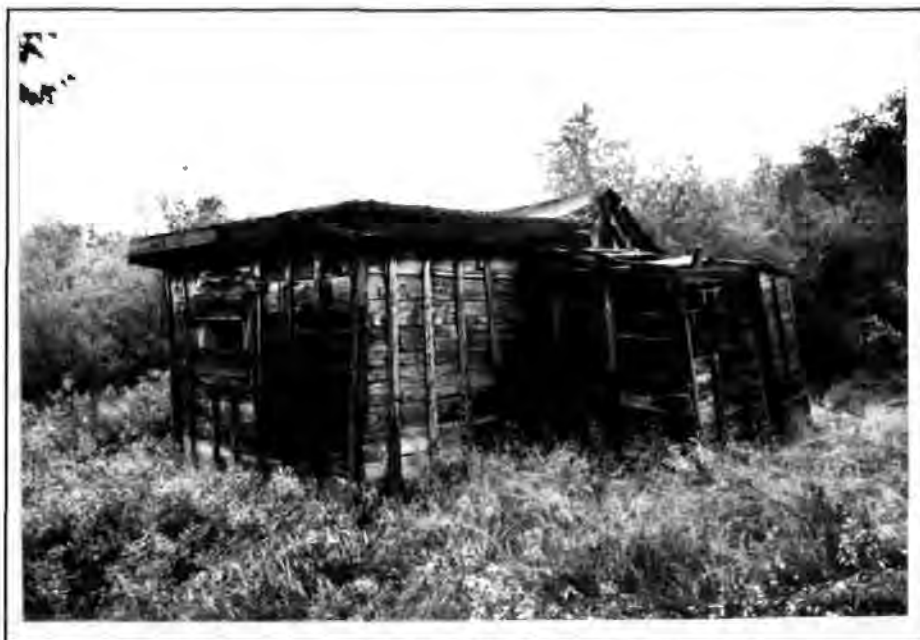
The **Bassoff/Sakow House (IDT-138)** is a rectangular, one-story, wood frame building (Figure 84). The foundation is log on grade. The building measures 7'x10'2". The gable roof is covered by roofing felt over wood decking, although most of the roofing felt has blown off. The east side of the gable roof is partially collapsed. The exterior walls are covered by deteriorated wood siding. A boarded up window is located on the east elevation and a shed roof addition measuring 4'5"x8'2" covers the south elevation. The roof is covered with wood decking and has partially collapsed. The addition has a six-light, fixed sash window and a door opening facing south. A four-panel door is leaning against the wall just inside the entry. Another shed addition measuring 9'x10'2" is located on the west side of the

Figure 84. The Bassoff/Sakow House, 1993.  
The view is looking northeast.

building. A window opening is located on the north and west elevations of the addition. The building and its additions are in poor condition.

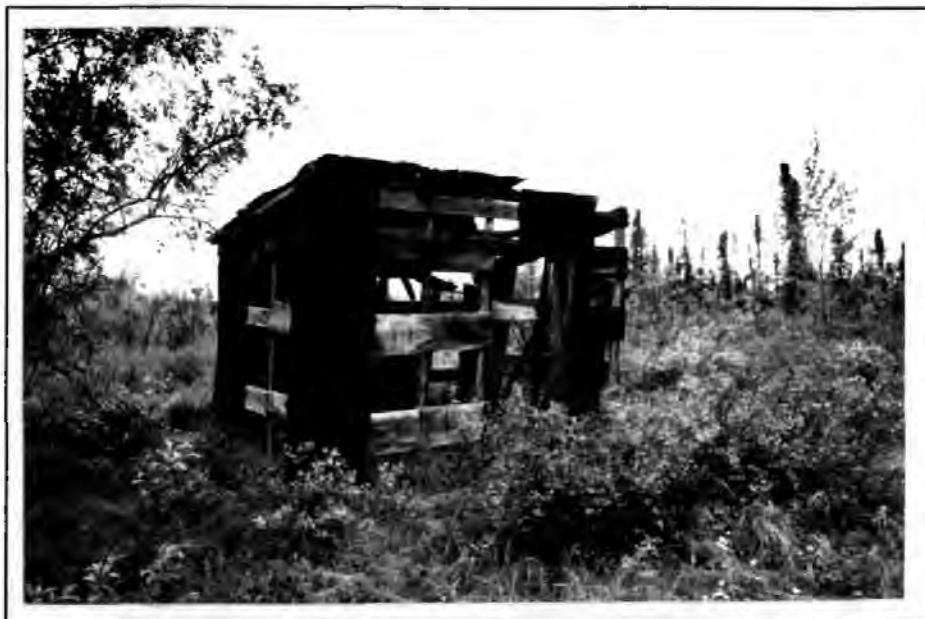
A rectangular pole and wood frame shed is located south and west of the Becker House ruins and 80' west of Flat Creek Road (Figure 85). The foundation is on grade. Corrugated metal covers the exterior walls. The building measures 7'2"x10'6". The shed roof is covered with corrugated metal, but the west half of the roof is missing. A screen mattress frame and an enamelware pitcher are located inside the building. A four-panel door is laying on the ground northwest of the building. A scatter of scrap metal, gas cans and barrels are located east of the building.

**Figure 85. Cap Becker's log and wood frame shed, 1993. The view is looking northeast.**

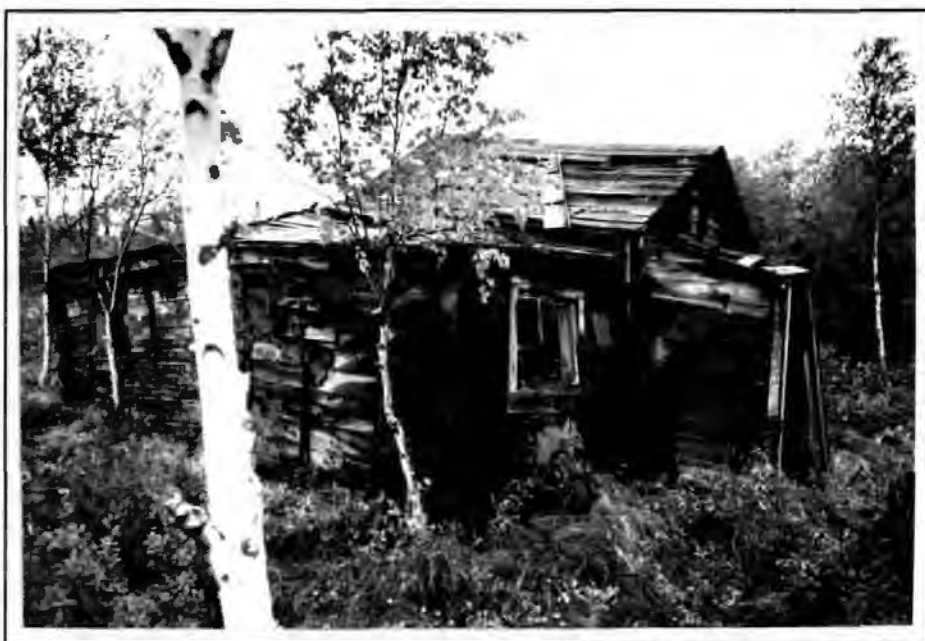
is a rectangular, one-story, log and wood frame building with five additions (Figure 86). The foundation consists of beams on grade. The gable roof and exterior siding is covered with roofing felt over wood siding, although most of the roofing felt on the roof is missing. The house measures 12'x 15'. The main entry is on the east elevation, which includes a window opening and a 4'x5'10" shed roof arctic entry. The arctic entry has a doorway facing east. A shed addition on the south side of the house measures 7'7" x12'. Unlike the roof of the house and other additions, the roof addition is covered with corrugated metal. A single-light, fixed sash window faces east and a small boarded up window faces south. Another shed addition is located on the west end of this addition and measures 7'7"x 12'. A window opening faces south. Another shed addition is located on the west end of the house. This

**Figure 86. The Crook/Caughrean/Demientieff House, 1993. The view is looking northwest.**

addition measures 7'x11'10". The west wall is made of logs and has a window opening. A shed addition on the north side of the building measures 10'6"x14'7". A window opening is located on the north and east elevations. At the west end of this addition is another shed roof addition measuring 10'5"x10'6". A doorway faces north, and most of the wood siding has been removed from the north, west and south walls. The house is in poor condition.

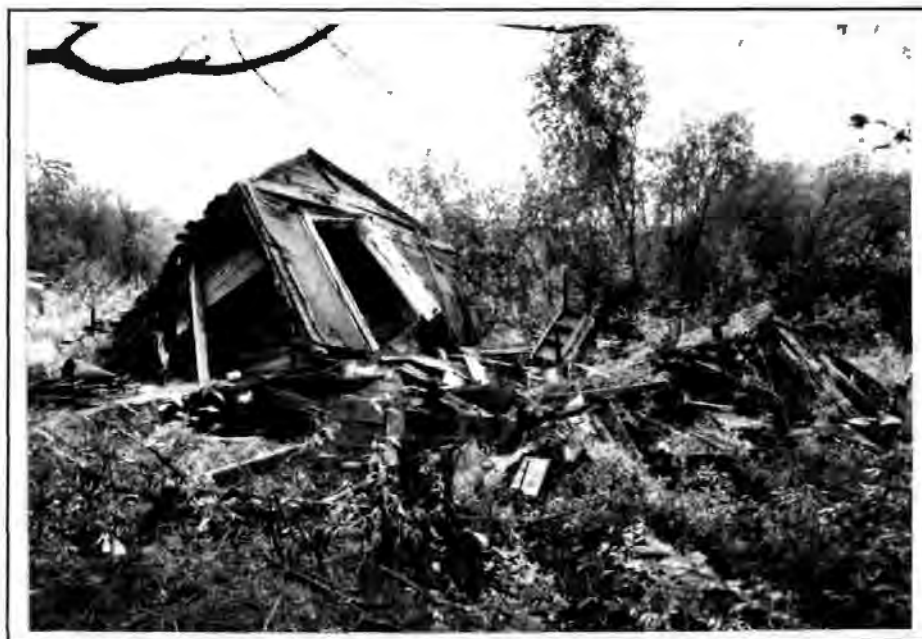
The Nash/Miller House Ruins (IDT-141) consist of a collapsed rectangular, one-story, wood frame building (Figure 87). The foundation is log on grade. Weather torn roofing felt over wood decking covers the gable roof and exterior walls. The building measures 12'4"x12'10". The house collapsed toward the west elevation, which had a centered doorway. Only the roof and east elevation have nominal structural integrity. The east elevation had a door opening and a boarded up window. The ruins of an addition are located on the east side of the building. The shed roof and exterior were covered with roofing felt over wood decking. The addition measured 10'10"x19'3". The north and south walls and part of the east wall of the addition lay outside the foundation. Artifacts include box springs, a wood stove, two wooden trunks, a table, bottles, jars, eating utensils, baby toys and other domestic items.

Figure 87. The Nash/Miller House, 1993.  
The view is looking northwest.

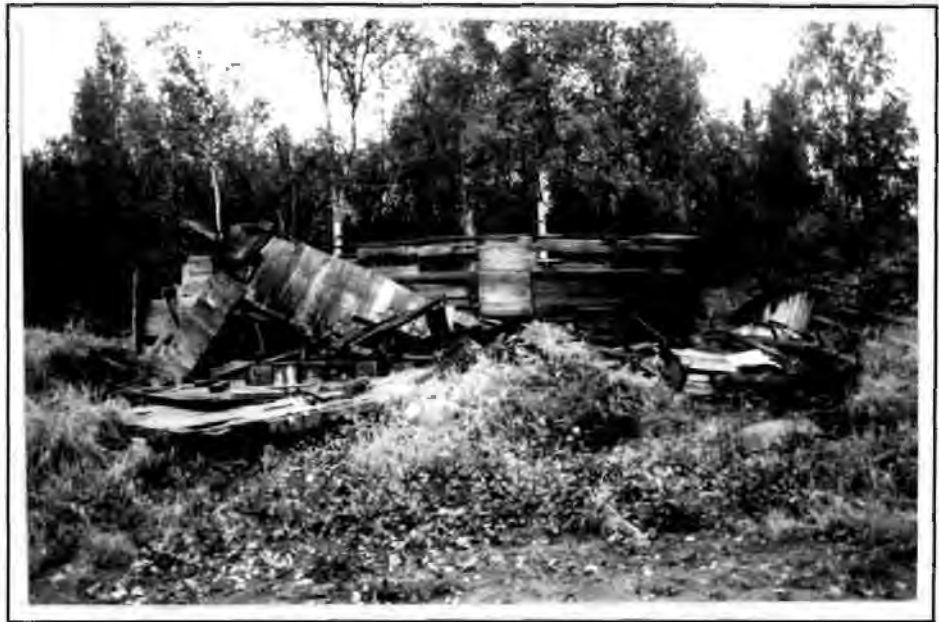
The **Guggenheim Machine Shop (IDT-143)** consists of the ruins of a large, rectangular, one-story, wood frame and log warehouse building (Figure 88). The foundation is on grade. The gable roof, which has collapsed, was covered with corrugated metal. The outline of the building measures 23'x47'. The exterior was covered with wood siding. Most of the west wall is standing. The other walls have collapsed. A 6/6 single-hung window, two boarded up windows, and a boarded up door are located in the west elevation. Portions of the north elevation, including a section of wall and part of the gable, are laying on the ground. The wall section contains a plank door. Another section of the north wall contains log framing. A portion of the west end of the south elevation is still standing and contains a plank door. Another section of the west wall containing a plank door is laying in the ruins. A shed roof addition was attached to the south end of the warehouse. The addition measured 14'x23'. A portion of the addition's west elevation is standing and contains a boarded up window. Another section of the west elevation has collapsed and contains a partial window opening. The south and east walls of the addition are collapsed.

The building ruins include structural debris such as timbers, wood siding, small sections of the roof, and pieces of corrugated metal. Many of the timbers and some of the siding from collapsed portions of the building have been salvaged. There are also a large number of artifacts in the ruins which include crates and bins filled with machine parts and metal barrels. Domestic items, such as pans and dishes, are located among the ruins of the south addition.

**Figure 88. The Guggenheim Machine Shop, 1993. The view is looking west.**

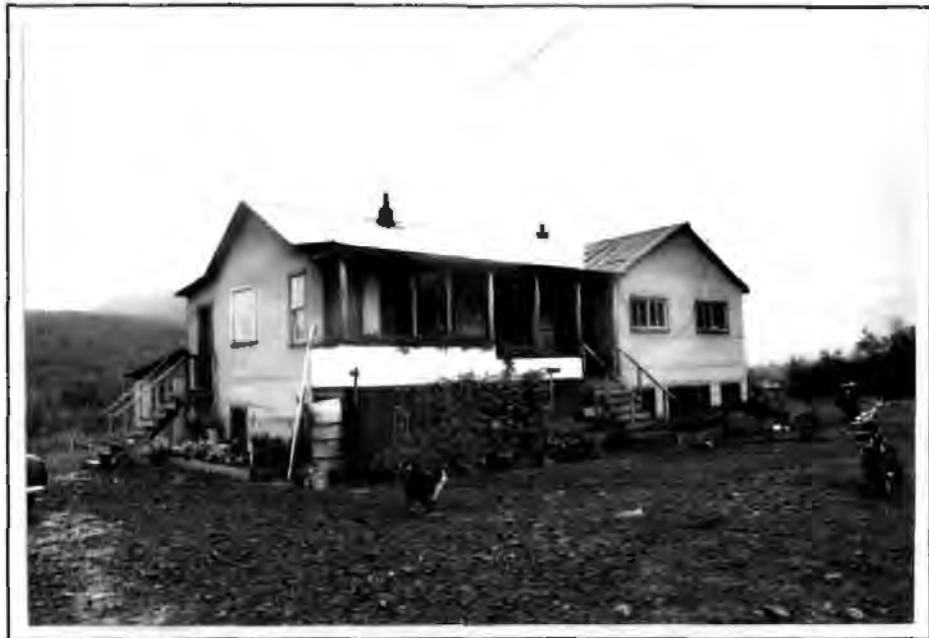
The **Kepler House (IDT-123)** is a modified rectangular, one-story, wood frame building with a day-light basement (Figure 90). This structure consists of two buildings which have been combined to create a single residence. The foundation is treated timbers on grade. Corrugated metal covers the gable roof and grey roofing felt covers the exterior walls. The main section of the house (the old Matheson Bunkhouse) measures 20'x26'2" and the gable roof is oriented north-south. The south elevation has two 2/2 horizontal single-hung windows on the main floor and a pair of six-light, fixed sash and two six-light, fixed sash windows on the basement level. The east elevation has a triple 4/4 horizontal double-hung window and a 2/2 horizontal single-hung window on the main floor and pair of side opening planks doors flanked on each side by a nine-light, fixed sash window. The north elevation has a 2/2 horizontal single-hung window and a six-light, fixed sash window on the main floor and two six-light, fixed sash windows on the basement level.

A gable roof addition (the old NADC Steam Bath) on the west side of the house measures 18'2"x26' and is oriented east-west. The south elevation has a one-panel door with one light, a two-light, fixed sash window, and bay window with four 4/4 single-hung windows on the main

floor. A 4' wide porch with a shed roof runs the length of the south elevation. The main floor of the west elevation has a 4/4 single-hung window and a decorative two-light window in which the upper light has a row of diamond lights. A six-light, fixed sash window is located on the basement level. A 4' wide shed roof addition runs the length of the west addition. A one-panel door with one light faces west and a six-light, fixed sash window faces

**Figure 90. The Kepler House, 1993.**  
The view is looking northeast.

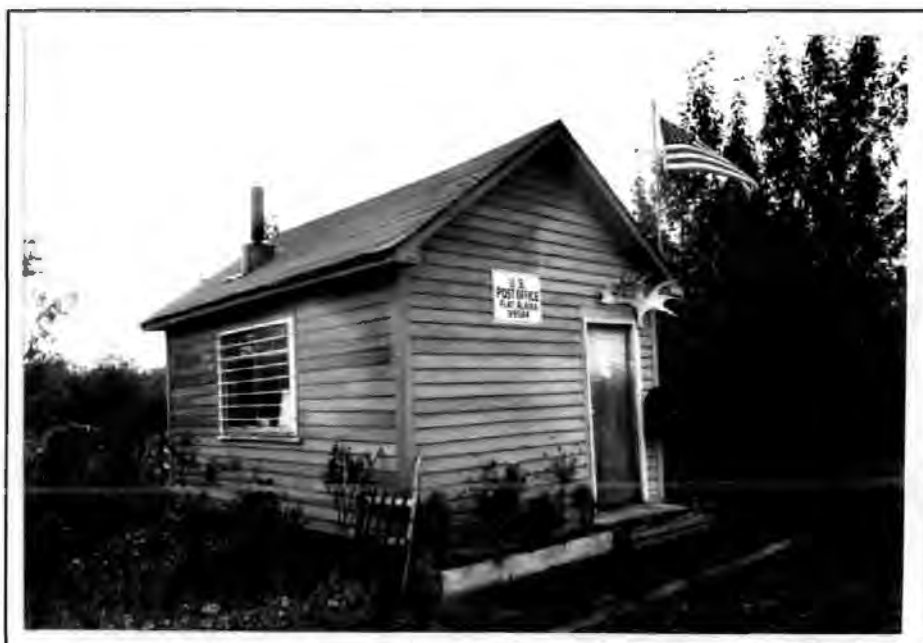
The **NADC Office/Flat Post Office (IDT-124)** is a rectangular, one-story, wood frame building (Figure 91). The foundation consists of logs on grade. Roofing felt covers the gable roof. The exterior is sided with clapboard and corner boards. The building measures 11'6"x15'8". The main entry faces east and has a slab door. A six-light, fixed sash window covered with metal bars is centered on the north and south elevations. The building has enclosed cornices.

**Figure 91. The Post Office Building, 1993. The view is looking northwest.**

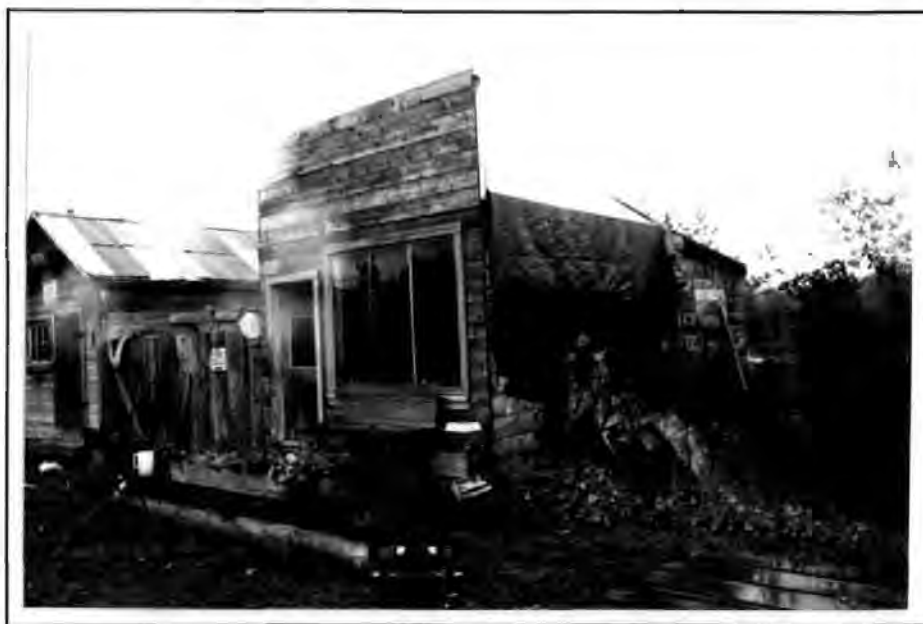
The **Kepler Library/Darkroom (IDT-125)** is a rectangular, one-story, wood frame, false front building (Figure 92). The foundation is wood beams on grade. Plastic tarp over roofing felt covers the gable roof. The building measures 11'6"x12'3". The exterior is covered with shiplap. The main entry is on the east elevation, which includes a two-panel door with eight lights and a large three-light, fixed sash store front window. A shed roof addition measuring 8'10"x11'6" is located on the west side of the building. The roof is covered with roofing felt. The exterior is covered with horizontal wood siding on the north and south sides and plywood on the west side.

**Figure 92. The Kepler Library/Darkroom, 1993. The view is looking southwest.**

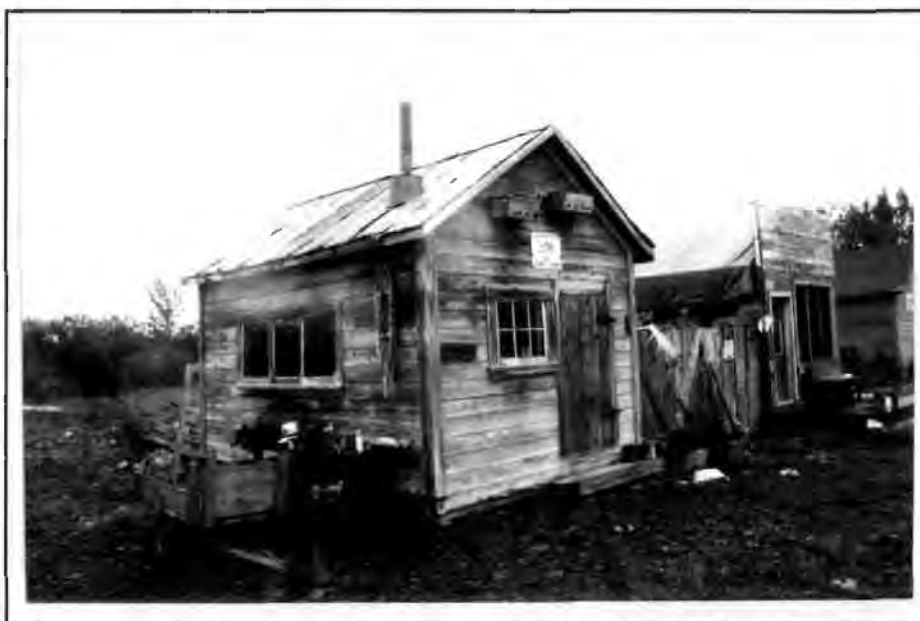
The **Burns/ Kepler Workshop** (IDT-126) is a rectangular, one-story, wood frame, building (Figure 93). The foundation is wood blocks on grade. Corrugated metal and roofing felt cover the gable roof. The building measures 12'3"x 16'3". The exterior walls are covered with shiplap with corner boards. The main entry is on the east elevation, which has a plank door and a six-light, fixed sash window. The south elevation has a three-light, fixed sash window.

**Figure 93. The Burns/Kepler Workshop, 1993. The view is looking southwest.**
