BLM-Alaska Open File Report 64  
BLM/AK/ST-97/022+8111+040  
April 1997

## HISTORIC BUILDING SURVEY REPORT FLAT, ALASKA

by Rolfe G. Buzzell and Darrel L. Lewis

# **Historic Building Survey Report Flat, Alaska**

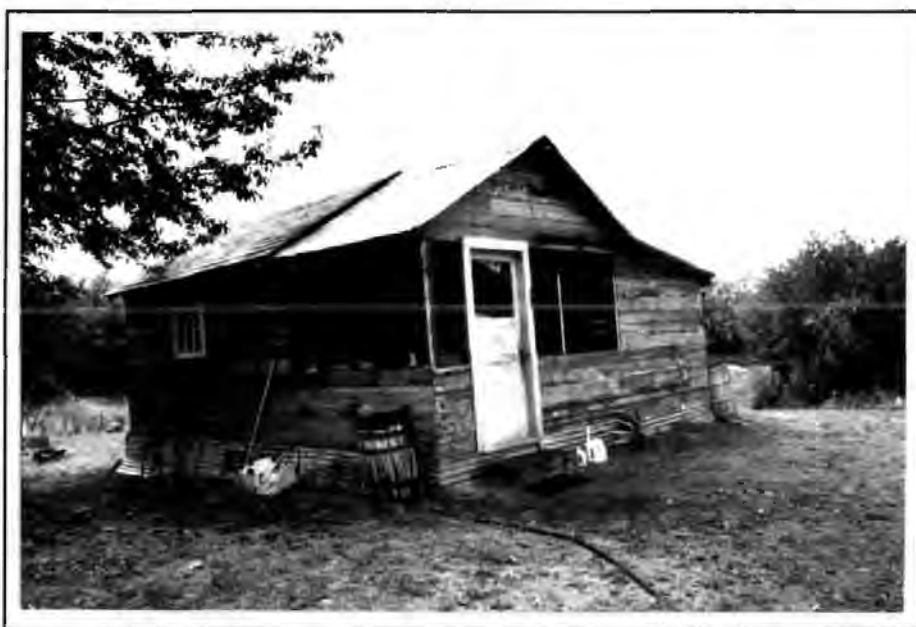
The Parker/Miller/Kepler Guesthouse (IDT-127) is a rectangular, one-story, wood frame building with two additions and a porch (Figure 94). The foundation of the house and additions is concrete blocks on grade. The gable roof is covered with shingles and corrugated metal. The building measures 12'x16'. Shiplap covers the exterior walls of the house and additions. The main entry is on the north elevation, which includes a one-panel door with a single-light and a six-light, fixed sash window. A gable roof porch covers the north elevation. The porch measures 8'1"x12' and the gable roof is covered with corrugated metal. The lower part of the porch is sided with shiplap and the upper portion is screened in. A three-panel door with one-light faces north. The east elevation of the house has a six-light, fixed sash window. The south elevation has a decorative four-light, fixed sash window. The fourth light has ten diamond lights. A shed addition on the west side of the house measures 8'2"x24'. The roof is covered with corrugated metal and roofing felt. A six-light, fixed sash window faces west and a three-panel door with one-light and a boarded over window face south. A small shed roof arctic entry covers the south elevation of the addition. The arctic entry measures 4'5"x8'2" and the shed roof is covered with corrugated metal. A three-panel door with one-light faces south.

**Figure 94. The Parker/Miller/Kepler Guesthouse, 1993. The view is looking southwest.**

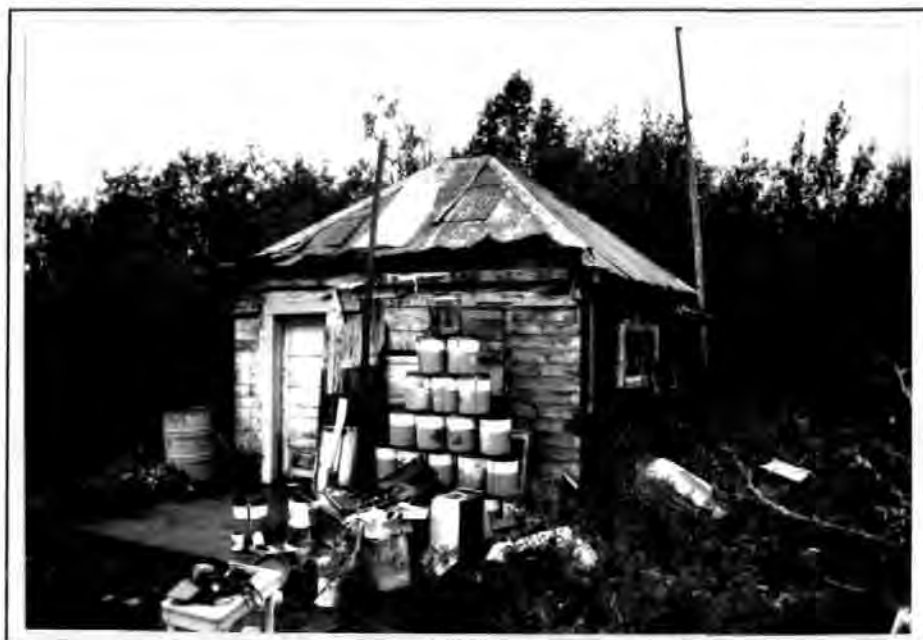
The **Finn Annie/Burns House (IDT-128)** is a square, one-story, wood frame building (Figure 95). The foundation consists of wood beams on grade. Corrugated metal covers the hipped roof. The building measures 14'3" per side. The exterior walls are covered with shiplap and roofing felt. The main entry is on the east elevation, which has a five-panel door and a boarded up window. A pair of single-light, fixed sash windows are located on the north elevation. A three-light, fixed sash window is located on the west elevation. An open porch measuring 4'5"x14'3"

is located on the east side of the house. This deck is made of tongue and groove flooring. A 55 gallon barrel, about 20 round metal fuel cans, and a number of boxes are stacked on the deck. A snow machine, a stove, stove pipe, window frames, and various domestic items are located outside of the building. A large cleared area measuring 70'x70' is located south and east of the building.

**Figure 95. The Finn Annie/Burns House, 1993. The view is looking southwest.**

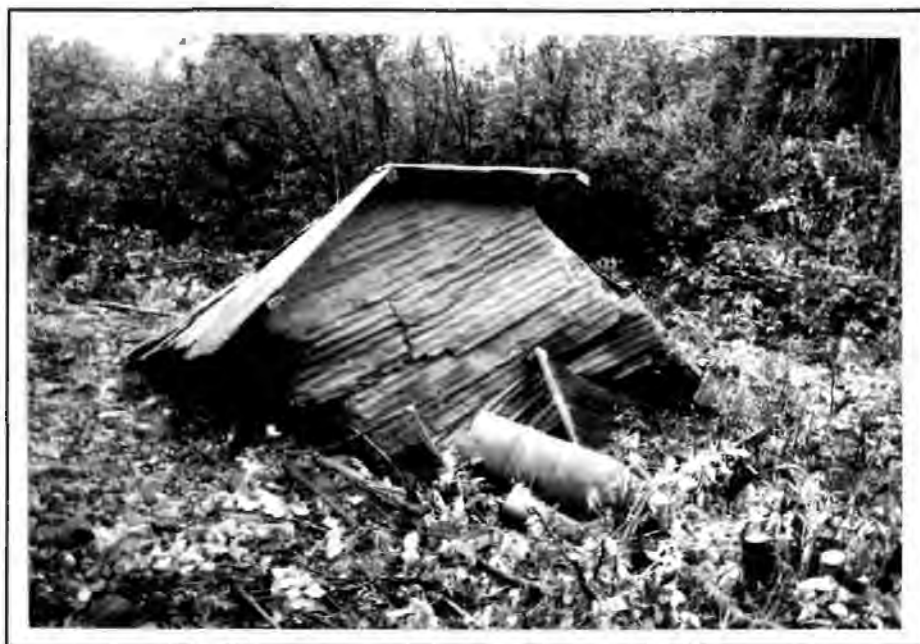
**The Anderson Shed Ruins (IDT-129)** are located about 100' northwest of the Finn Annie/Burns House. The feature consists of the ruins of a rectangular, one-story, log frame structure (Figure 96). The structure was elevated 4' on poles and access was by ladder (Agoff 1995:239). Corrugated metal covers the gable roof and exterior walls. The building measures 7'6"x7'10". The building collapsed on to the north and east walls. The roof

**Figure 96. The Anderson Shed ruins, 1993. The view is looking southeast.**

and south and west walls are still nominally intact. Artifacts around the building ruins include a 55 gallon metal barrel, a bed frame and mattress, a suit case, and shoes.

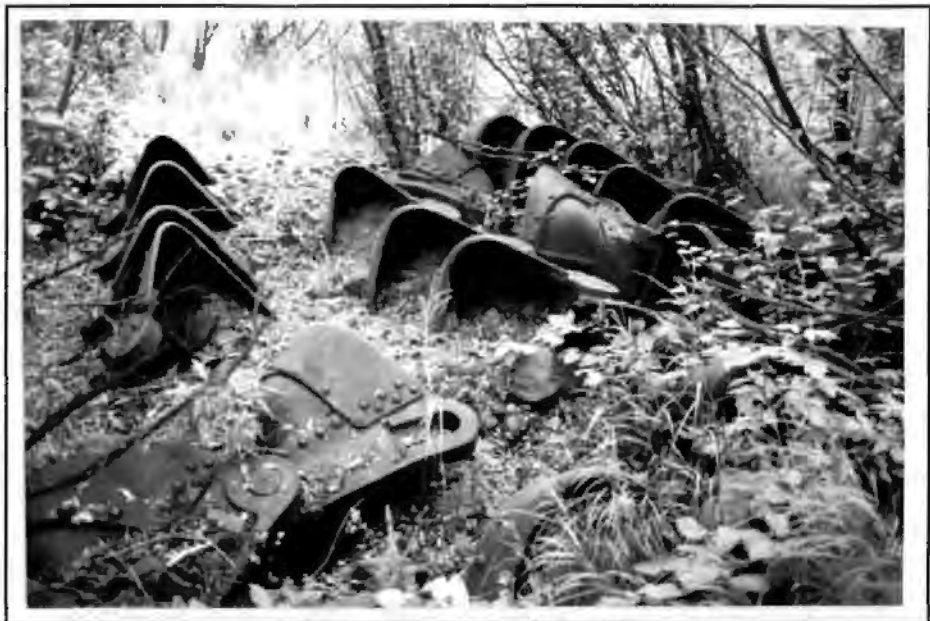
The **Guggenheim Dredge Bucket Line (IDT-236)** consists of 25-30 cast iron dredge buckets (Figure 97). The buckets are located in an area measuring 20'x50'. Each bucket held six cubic feet of material. The feature consists of lines of four to six attached buckets and single buckets in a confined area.

**Figure 97. The Guggenheim Dredge Buckets, 1993. The view is looking south.**

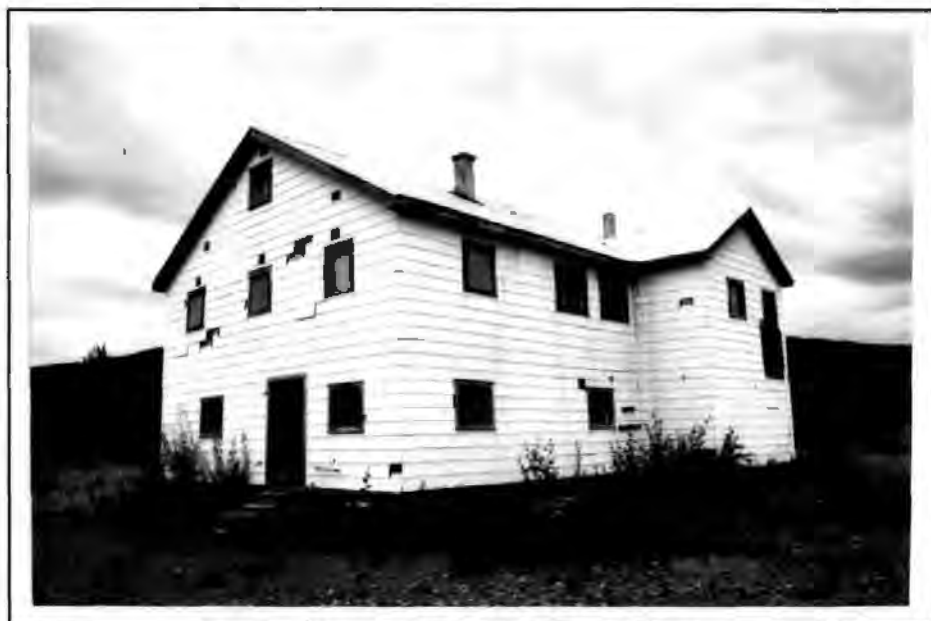
The **Signal Corps Building (IDT-130)** is a modified rectangular, 2.5 story, wood frame building (Figure 98). The foundation consists of wood blocks, logs, and metal barrels on grade. Corrugated metal covers the gable roof. The building measures 29'4"x45'11". The exterior walls are covered with asbestos shingles. The main entry is on the east elevation, which has a three-panel door, a six-light, fixed sash window, and a gable roof arctic entry on the first floor. The arctic entry has a boarded up panel door facing east. The second floor has three single-light, fixed sash windows and a single-light, fixed sash window in the gable. Two six-light, fixed sash windows are located on the first floor of the south elevation. Four single-light, fixed

A wood frame outhouse is located 70' west of the building. The outhouse measures 3'2"x3'7" and has a shed roof covered with corrugated metal. The exterior is covered with vertical wood siding and the south facing door is covered with canvas.

**Figure 98. The Signal Corps Building, 1993. The view is looking northeast.**

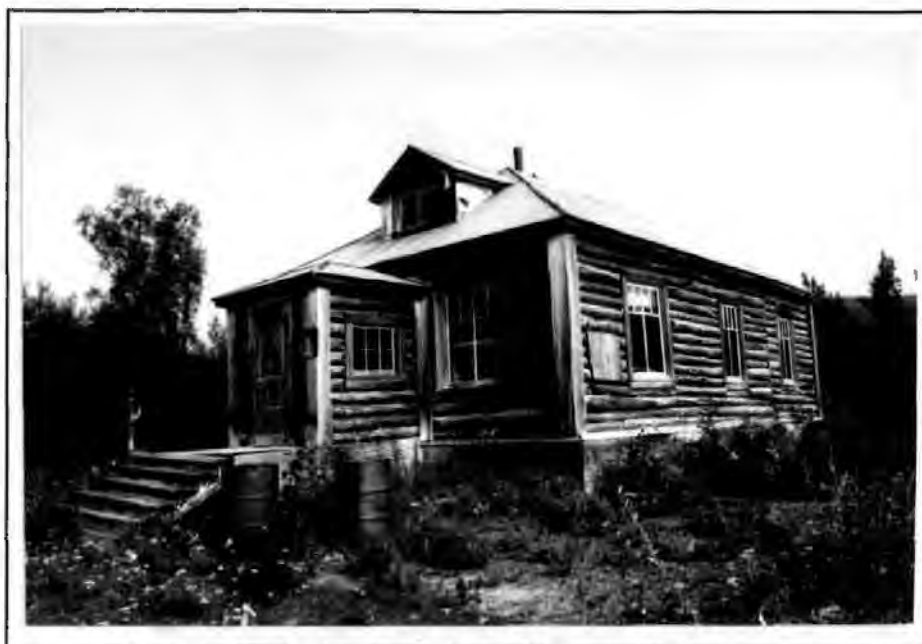
The **Shaffrick House (IDT-145)** is a rectangular, 1.5 story, log building (Figure 100).

The foundation consists of vertical posts on grade. Corrugated metal covers the hipped roof and gable roof dormer. The building measures 25'3"x35'4". The exterior walls are made of logs and have corner boards. The main entry is on the south elevation, which features a hipped roof arctic entry. A five-panel door is centered on the south side of the arctic entry. A six-light, fixed sash window flanks each side of the arctic entry on the south elevation of the building. A gable roof dormer is centered on the south slope of the hipped roof. The dormer has a four-light, fixed sash window. Three six-light, fixed sash windows are evenly spaced on the east elevation. The north elevation has a five-panel door and a four-light, fixed sash window. A pair of three-light, fixed sash windows and two six-light, fixed sash windows are located on the west elevation. Three six-light, fixed sash windows are evenly spaced on the east and west elevations along the crawl space below the house. The building is in good condition except for the center of the north wall, which is rotting from water damage.

**Figure 100. The Shaffrick House, 1993.**  
The view is looking northwest.

Dredge. He also served as the janitor and bull cook for the Community Hall (IDT-070). The house had electricity, a well, indoor plumbing, and modern appliances such as a washing machine. Shaffrick died in 1955 and the building remained vacant for many years. John Miscovich purchased the building in the 1980s and put a new roof on it (Miscovich 1995:II-26-27).

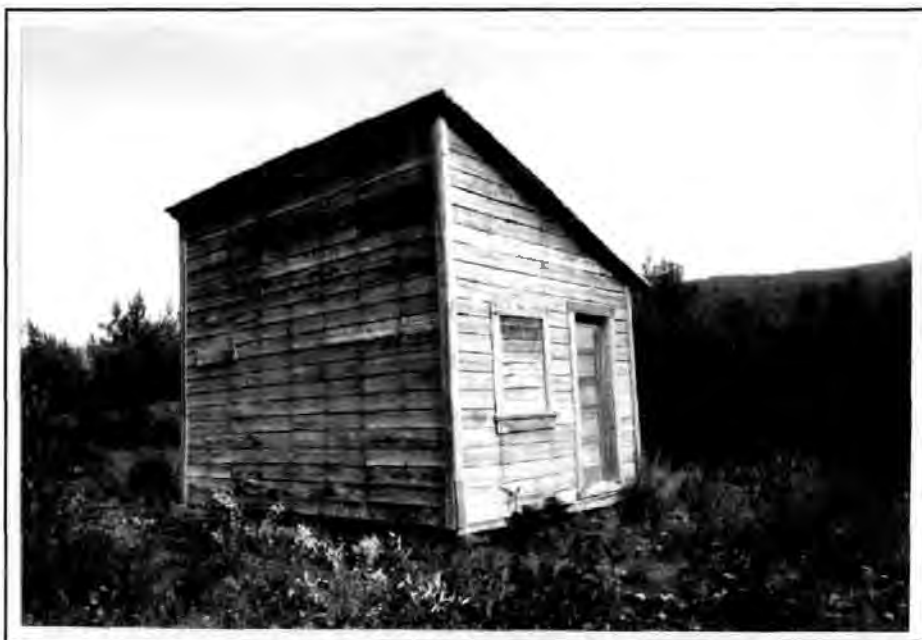
The Shaffrick Power Shed (IDT-146) is a rectangular, one-story, wood frame building (Figure 101) located 108' northeast of the Shaffrick House. The foundation is logs on blocks. Corrugated metal covers the shed roof. The shed measures 12'4"x16'4" and the exterior walls are covered with wood siding and corner boards. A five-panel door and a boarded up window are located on the east elevation.

**Figure 101. The Shaffrick Power Shed, 1993.** The view is looking northwest.

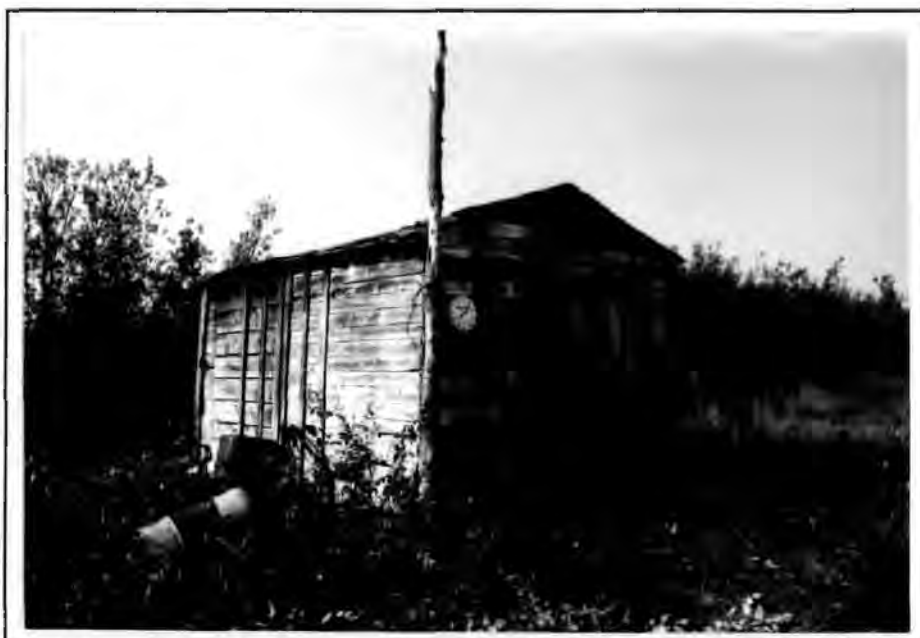
The **Airstrip Storage Shed (IDT-147)** is a rectangular, one-story, wood frame building (Figure 102). The foundation is on grade. Corrugated metal covers the gable roof. The building measures 12'2"x14'2". The exterior walls are covered with weather stripped roofing felt over horizontal wood siding. The main entry is on the north elevation, which has a large plank door. Two six-light, fixed sash windows are evenly spaced on the west elevation. A six-light, fixed sash window is located on the east end of the south elevation. A tall pole with a weather vane on top is attached to the north-east corner of the building.

Figure 102. The Airstrip Storage Shed, 1993. The view is looking southwest.

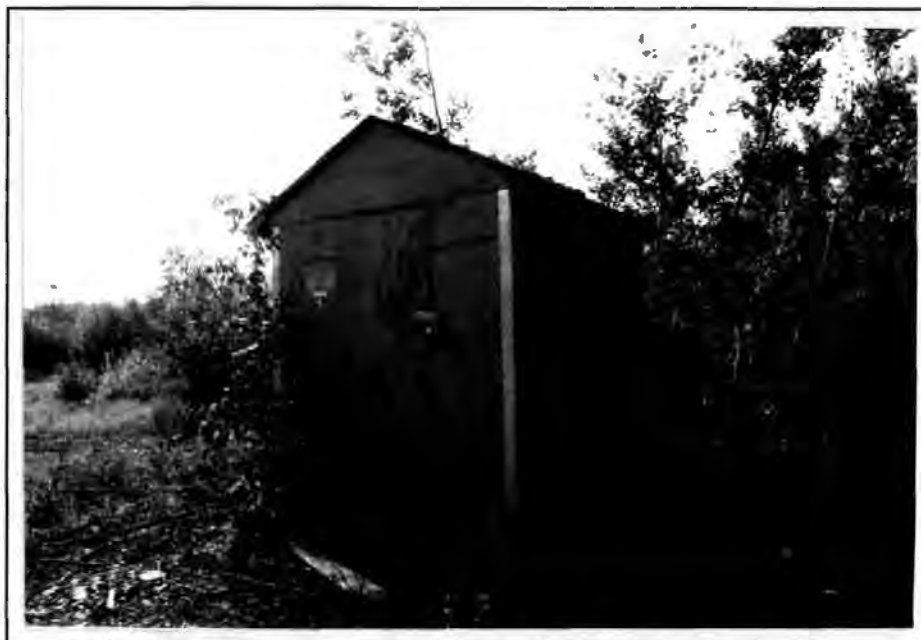
The **BLM Airstrip Storage Building (IDT-148)** is a rectangular one-story, wood frame building (Figure 103). The foundation consists of logs on grade. The building measures 6'x7'10". Asphalt shingles over roofing felt cover the gable roof. The exterior walls are covered with plywood. A plywood door is centered on the north elevation.

**Figure 103. The BLM Airstrip Storage Building, 1993. The view is looking northeast.**

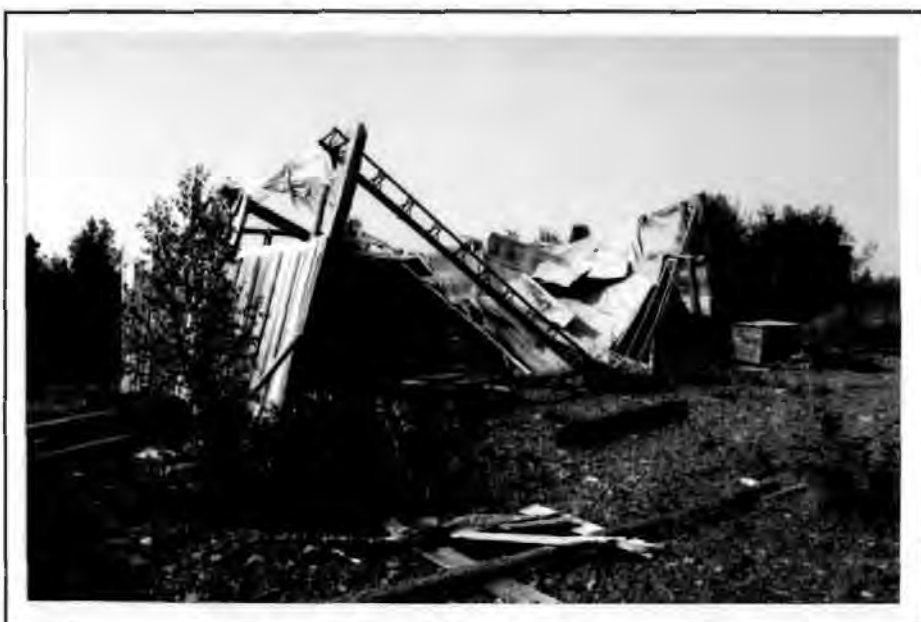
The Fullerton Hanger (IDT-149) is an irregular shaped, one-story, wood frame, collapsed building (Figure 104). The foundation is on grade. The shed roof was covered with corrugated metal. The building measures 26'7"x41'. The exterior walls are covered with wood siding, except for the north side which is open. The roof was supported in the middle by metal pipe and on the north side by a section of metal truss radio antenna from the Signal Corps facility.

John and Richard Fullerton and John Ogriz built this hanger in 1956 or 1957 of materials salvaged from local buildings and structures. The Fullertons used the hanger to maintain and shelter their airplane. The roof collapsed during the winter of 1992 or 1993 (Mischovich 1995:II-28).

**Figure 104. The Fullerton Hanger, 1993. The view is looking southwest.**

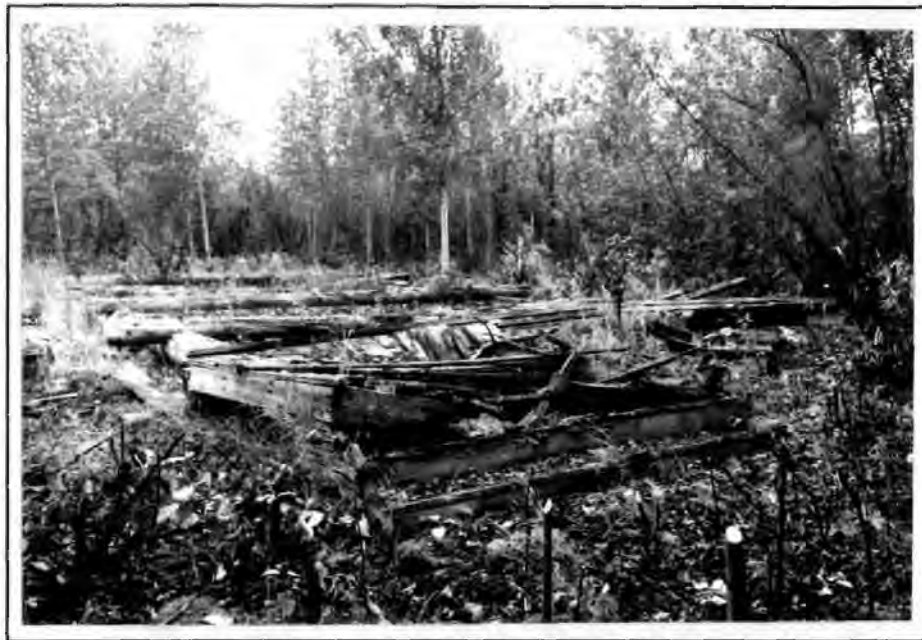
The Wadsworth House Ruins (IDT-150) consist of a log foundation measuring 25'x45', wood decking from the floor, and remnants of wood siding from the walls (Figure 106). No wall or roof sections are present in the debris. An 8'x8' set of collapsed wooden stairs is located at the south end of the east wall. Debris present at the site includes rolled roofing, linoleum scraps, bed springs, a metal bucket, and celotex. A wooden cabinet is located 14'6" south of the building ruins. A 1950s aerial photograph indicates the building was one-story with a gable roof. A shed roof addition extended the length of the west elevation.

**Figure 106. The ruins of the Wadsworth House, 1993. The view is looking west.**

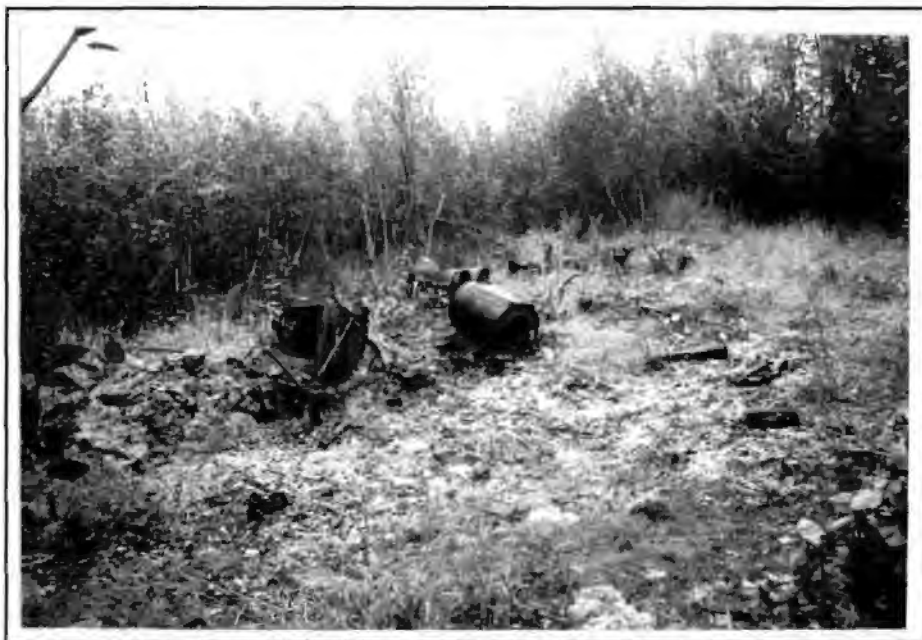
The Winters/Teddy House Ruins (IDT-151) are a scatter of artifacts and structural debris (Figure 107). No foundation or wall sections remain. The house covered a 20'x34' area. Artifacts and debris are scattered over an area measuring 28'x60'. Artifacts include two barrel stoves, stove pipe, fire cracked rock, a safe, a radio, bed frames, a fire extinguisher, a metal water pitcher, a can opener and lids, a bucket, a shovel blade, a metal box, a bed pan, a meat slicer made by "General Manufacturing", dishes, dinner ware ("Netherlands Universal Cambridge, made in USA"),

**Figure 107. The ruins of the Winters/Teddy House, 1993. The view is looking southwest.**

spoons, metal cans, broken and melted glass, ceramic fragments, a charred timber, and a sheet of corrugated metal.

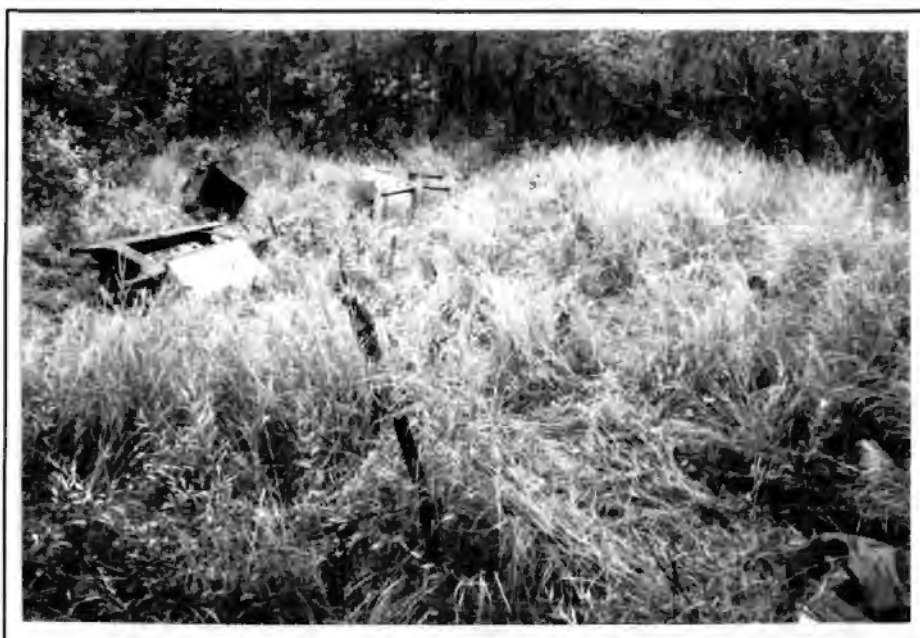
The Teatoff/Menzoff/Scott/Baker Cabin Site (IDT-152) is the ruins of a log cabin (Figure 108) measuring 32'x35'. No roof, wall sections, or foundation are visible in the debris. Artifacts at the site include a "Trukold" oil burning refrigerator, a heater, a stove top, stove pipe, metal gas cans, a sink, and part of a metal barrel. Domestic artifacts include enamel ware, metal cans, glass jars, a coffee can, a frying pan, and a teapot. Just outside the perimeter of the house foundation is a roll of barbed wire, a sheet of corrugated metal, a rubber shoe, and several large metal cans.

**Figure 108. The Teatoff/Menzoff/Scott/Baker Cabin Site, 1993. The view is looking west.**

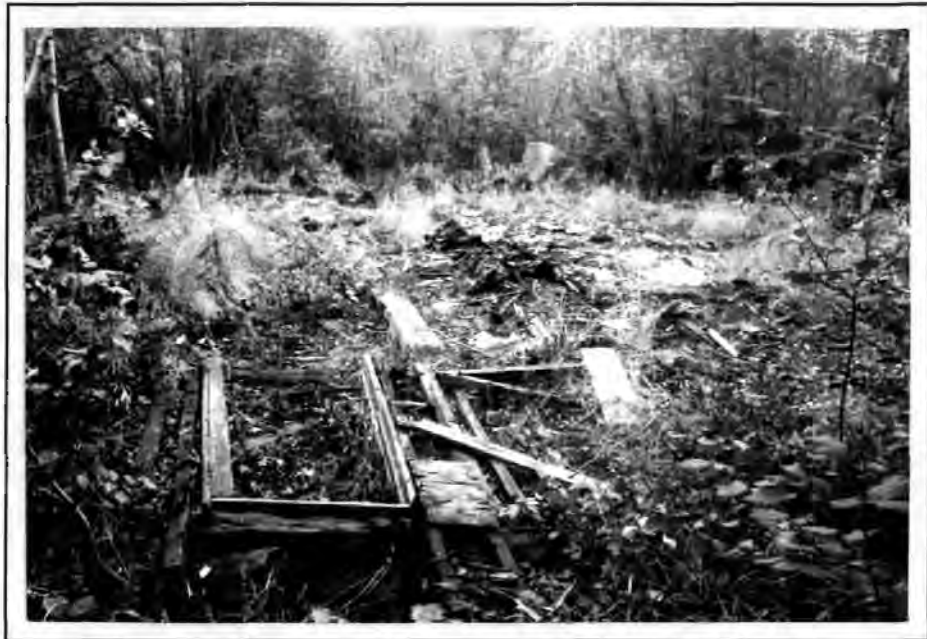
The Emil "Paprika" Jensen House Ruins (IDT- 153) consist of the ruins of a rectangular, one-story, wood frame building (Figure 109). The foundation consisted of logs. The building outline measures 32'4"x35'. A wall section with a door is located north of the foundation. Part of another wall section is located south of the foundation. The building had a gable roof, but no portion of the roof remains. Black and white checkered linoleum covers the floor in the north-

west corner. A record player, shoes, a mirror, a solder top can, an ice skate, bed springs, a battery, spark plugs and various domestic artifacts are present. A 1966 aerial photograph indicates that the building had a gable roof oriented north-south and a shed addition running the length of the east elevation. The aerial photograph shows that the house had four other additions but the type of roofs on the additions is not clear.

Figure 109. The Emil "Paprika" Jensen House, 1993. The view is looking north.

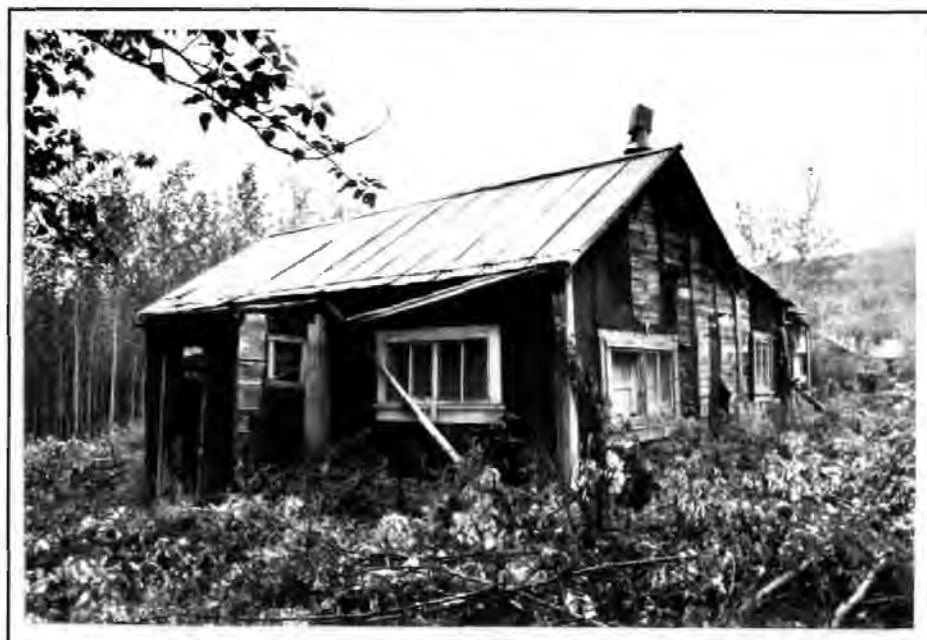
The Scott/Parker House (IDT-154) is a rectangular, one-story, wood frame building with three shed roof additions (Figure 110). The foundation is not visible. The gable roof and shed roofs are covered with corrugated metal. The house measures 16'x23'10". The exterior

is sided with board and batten and weathered roofing felt. The main entry is on the south elevation, which includes a pair of two-light, fixed sash windows and a shed roof arctic entry measuring 4'2"x5'11". There is a pair of two-light, fixed sash windows on the east elevation and a two-light, fixed sash window on the west elevation. The north elevation of the house has a shed roof addition measuring 9'4"x23'10". The addition has a two-

**Figure 110. The Scott/Parker House, 1993.**  
The view is looking northwest.

light, fixed sash window on the east elevation and a boarded up window on the west elevation. The north elevation of this addition contains an arctic entry measuring 4'5"x5'10", a two-light, fixed sash window, and a small shed addition measuring 6'5"x8'1". The arctic entry has a shed roof, a five-panel door facing north and a boarded up window facing east. The small north addition has a five-panel door on the east elevation and a four-light, fixed sash window on the west elevation. The north elevation is covered by another addition measuring 13'8"x 17'8". A short plank door is located on the east elevation, a plank door is located on the north elevation, and a boarded up window is located on the south elevation.

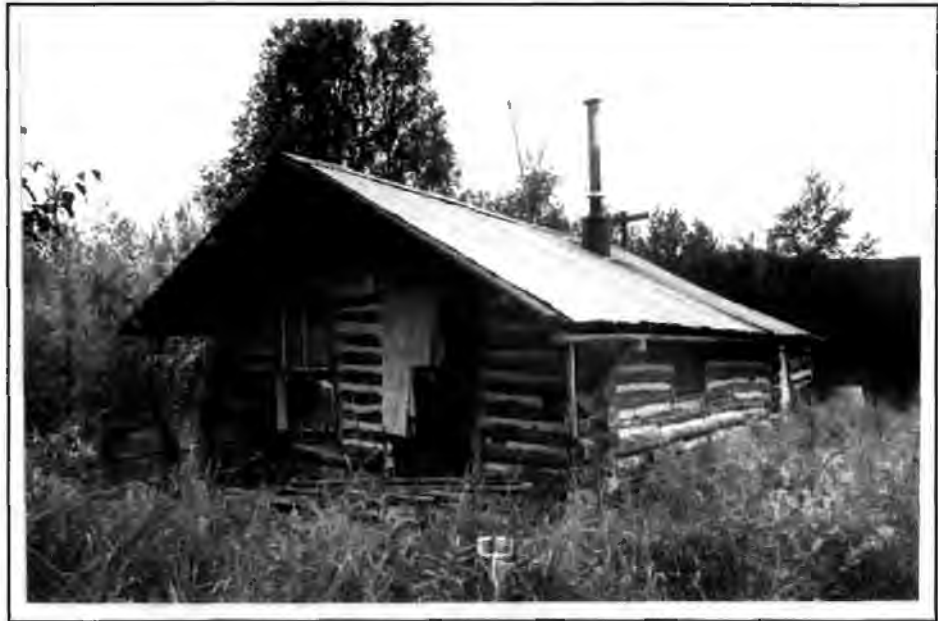
The Brink/Flemings Cabin (IDT-155) is a rectangular, one-story, log building with two wood frame additions (Figure 111). The foundation is on grade. The gable and shed roofs on the additions are covered with corrugated metal. The log building measures 16'x18'. A 2/2 single-hung window and three-panel door with one light, are located on the south elevation. A two-light, fixed sash window is centered on the west elevation and a six-light, fixed sash window is centered on the east elevation. The exterior of the two shed roof additions are covered with

rolled roofing over wood siding. The north addition measures 10'1"x16'. The addition has a pair of four-light, fixed sash windows on the east elevation and a six-light, fixed sash window covered with corrugated metal on the north elevation. A small addition measuring 4'5"x5'7" is located on the west side of the north addition. The west addition has a small window opening facing south that is covered with transparent plastic. The ruins of a collapsed wood frame outhouse is located 6' west of the west addition.

**Figure 111. The Brink/Flemings Log Cabin, 1993. The view is looking northwest.**

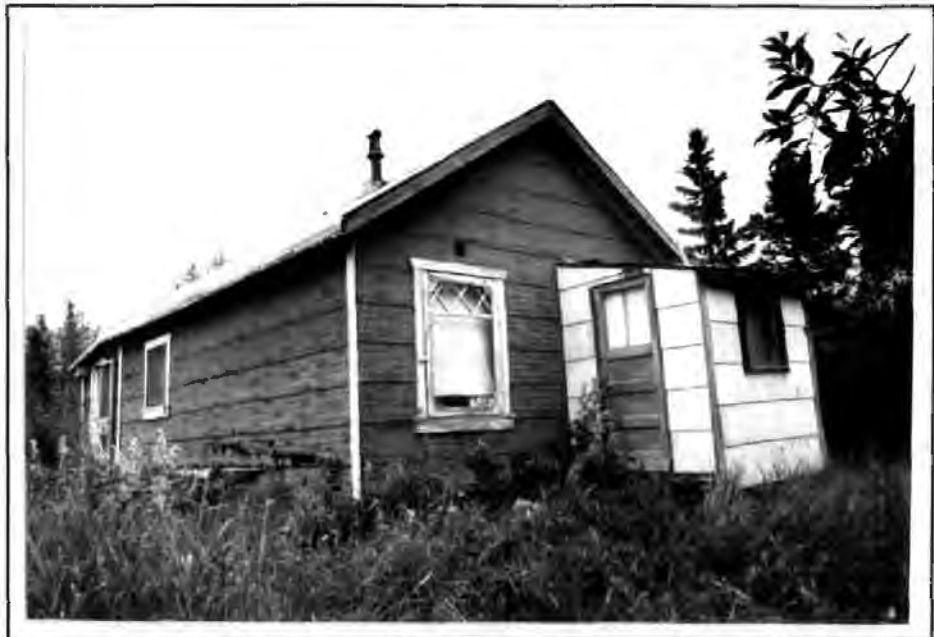
The Awe/Weber/Gularte/Hubbard/Brink House (IDT-156) is a rectangular, one-story, wood frame building (Figure 112). The foundation is timbers on grade and corrugated metal covers the gable roof. The building measures 17'x23'8". The exterior is covered with asphalt shingles. The main entry is on the north elevation, which includes a two-light, fixed sash decorative window with diamond lights in the upper light and an arctic entry. The arctic entry, which measures 5'10"x7'4", has a shed roof covered with corrugated metal and wood shingles covering the exterior walls. The south elevation of the arctic entry has a single-light window and the west elevation has a three-panel door with one light. The west elevation of the house has a single-light, fixed sash window and the east elevation has a single-light, fixed sash window and a decorative two-light, fixed sash window in which the upper light has ten diamond lights. A shed roof addition on the north elevation of the house measures 8'3"x17'. Corrugated metal

covers the roof of the addition and asphalt shingles cover the exterior walls. A one-light, fixed sash window is on the north elevation of the addition and a five-panel door is on the west elevation. A shed roof addition measuring 8'5"x9' is located on the east side of the north addition. Corrugated metal covers the roof and roofing felt covers the exterior walls. A single-light, fixed sash window is located on the north elevation and a six-light, fixed sash window is located on the east elevation.

**Figure 112. The Awe/Weber/Gularte/Hubbard/Brink House, 1993. The view is looking northeast.**

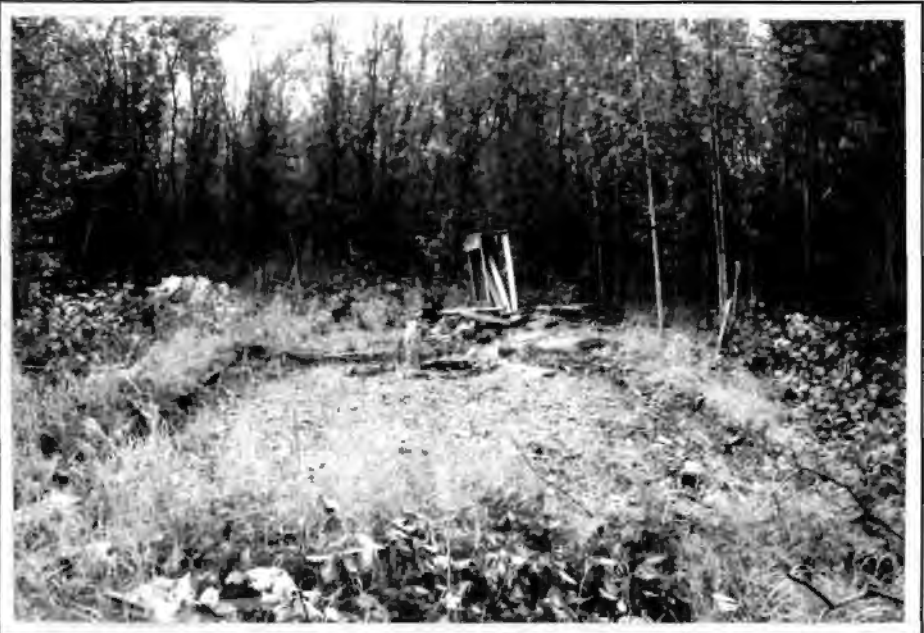
The Marshall/Loranger/Norman House Site (IDT-157) consists of a gravel foundation, structural debris and artifacts from a building that once stood at the site (Figure 113). The gravel foundation measures 15'x18'2". A pile of artifacts and structural debris, including a broom, a five-panel door, logs, wood siding, a metal bucket and a wooden box are located at the south-west corner of the foundation. Another pile of debris, including metal barrels and lumber, is located in a small clearing 9' west of the foundation. A third scatter of debris, including a collapsed wooden dog house, window frames, a screen door frame, a broken table, a wooden bench, and wooden siding, is located about 30' southeast of the foundation.

**Figure 113. The Marshall/Loranger/Norman House Site, 1993. The view is looking south.**

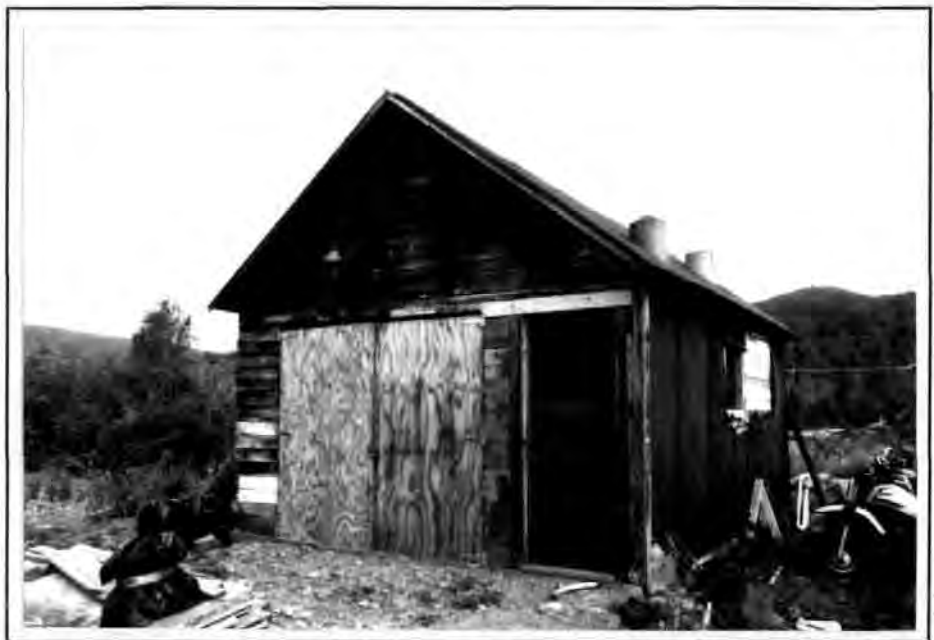
**The Marshall/Loranger/Norman Garage (IDT-158)** is a rectangular, one-story, wood frame building (Figure 114). The foundation is on grade. Corrugated metal covers the gable roof. The garage measures 14'6"x18'. The exterior walls are covered with roofing felt over shiplap. The main entry is on the south elevation, which has a pair of large plywood utility doors. A three-panel door with one light is located on the east

**Figure 114. The Marshall/Loranger/Norman Garage Building, 1993. The view is looking northwest.**

side of the utility doors. A single-light, fixed sash window is centered on the east elevation. A door on the north side of the building has been covered over with roofing felt.

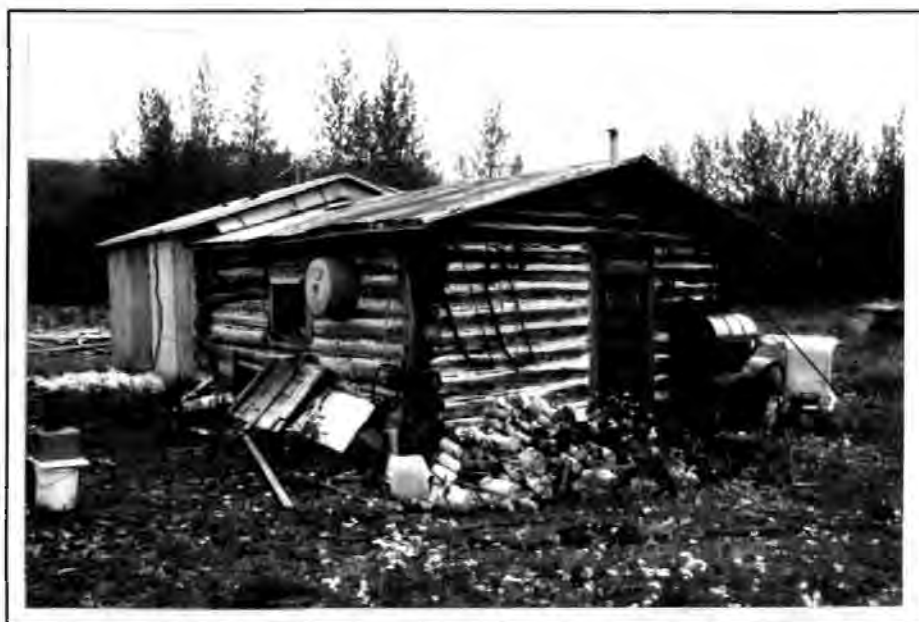
The Cummings/Popavich/Loranger Cabin (IDT-159) is a rectangular, one-story log building (Figure 115). The foundation consists of logs on grade. Corrugated metal covers the gable roof. The building measures 15'9"x17'8" and the exterior is made of logs. The main entry is on the south elevation, which has a five-panel door. A six-light, fixed sash window is centered on the west elevation. A pair of two-light, fixed sash windows are centered on the east elevation. A gable roof addition on the north elevation measures 16'1"x16'3". Corrugated metal covers the roof and the exterior is covered with plywood. A single-light, fixed sash window is located on the north elevation of the addition.

**Figure 115. The Cummings/Popavich/Loranger Cabin, 1993. The view is looking northeast.**

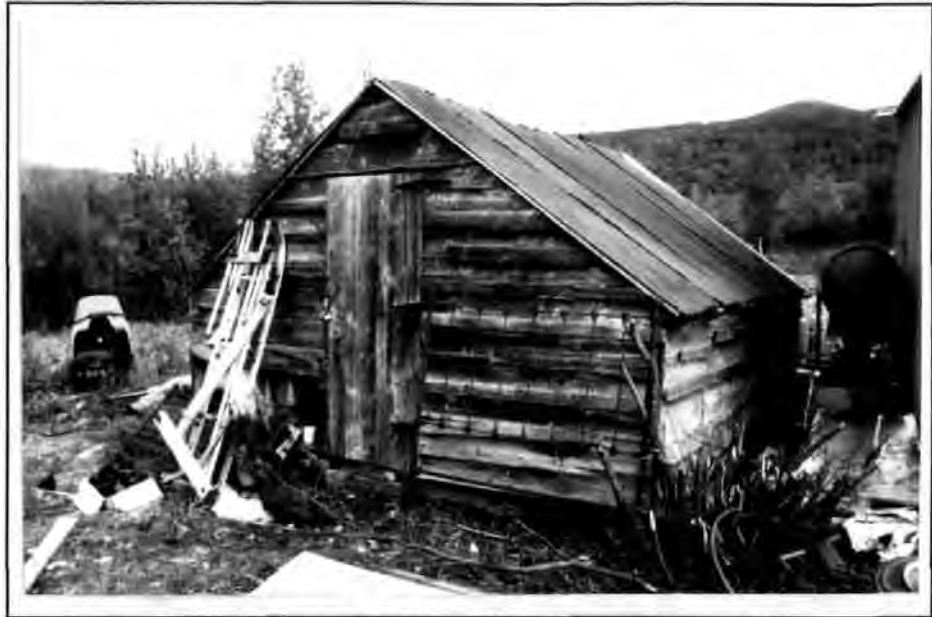
A rectangular, one-story, wood frame storage building is located 20' west of the log cabin (Figure 116). The foundation is wood blocks on grade. Corrugated metal covers the gable roof. The building measures 12'3"x 14'2". The exterior is covered with shiplap siding. A plank door is located on the south elevation. The Marshall/Norman Garage is located 12' to the south-west. A modern shed roof storage building is located between the cabin and the gable roof shed. The new shed measures 8'6"x 12'6". The exterior and roof are covered with aluminum siding and the only door faces south.

**Figure 116. The Cummings Dog Barn, 1993.**  
The view is looking northwest.

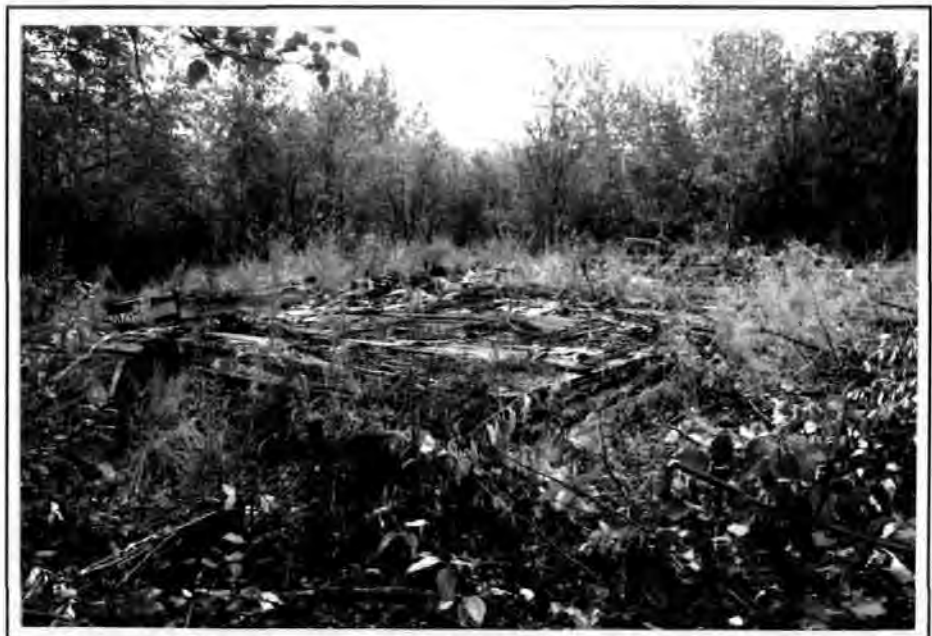
The ruins of the **Finn Annie/Billie Harding House Ruins (IDT-160)** consist of a log foundation and tongue and groove flooring (Figure 117). The roof and walls are missing. The foundation measures 20'6"x41'6". The

**Figure 117. The Finn Annie/Billie Harding House ruins, 1993.** The view is looking northeast.

foundation of an addition measuring 14'x16' is located on the east end of the north elevation. Aerial photos of Flat taken in 1966 and 1976 show a large structure with three gables at this location. A cot frame and springs are laying in the foundation. Parts of the building and artifacts located outside of the foundation include a five-panel door, a four-light, fixed sash window frame, a heater, and bed posts.

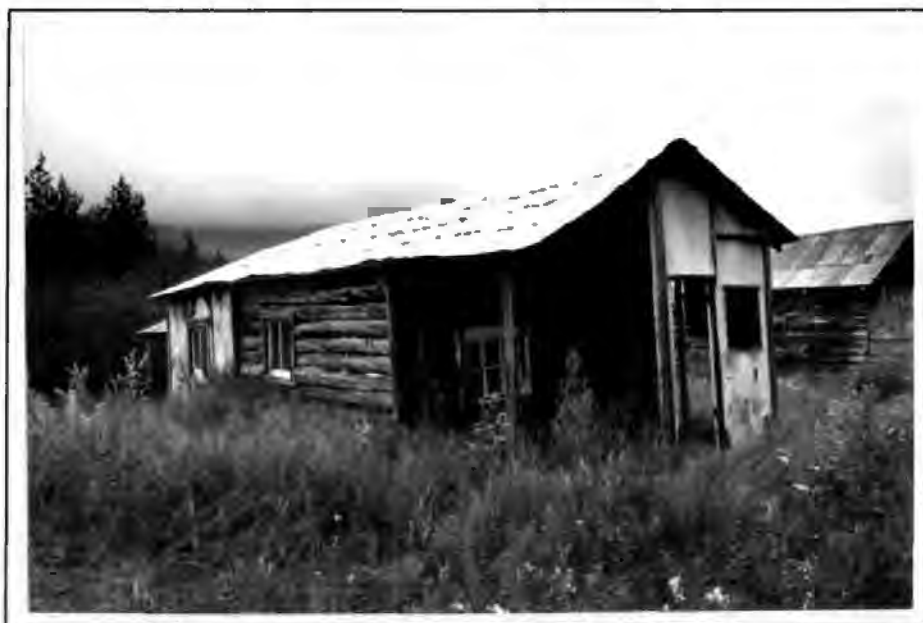
The **Jensen/Miller/Stuver Cabin (IDT-161)** is a rectangular, one-story, log building (Figure 118). The foundation is not visible. Sheet metal covers the gable roof. The cabin measures 13'x15'. The walls are made of logs with open trough corner treatment. The main entry is on the south elevation, which has a six-light, fixed sash window and a five-panel door. A gable roof porch covers the south facade. The east half of the porch is an enclosed arctic entry measuring 6'6"x6'7". The exterior walls of the enclosed porch are covered with celotex. The west half of the porch is open. A two-light, fixed sash window is centered in the east and west elevations of the cabin. A one-story addition with a gable roof is located on the north end of the cabin. The addition measures 10'8"x 13' and the roof is covered with corrugated metal. Celotex covers the exterior walls. A two-light, fixed sash window is centered on the east and west elevations of the addition. Another one-story addition measuring 10'1"x14'6" is located north of this addition. Corrugated metal covers the gable roof and exterior walls. This addition has a single-light, fixed sash window centered on the north elevation and a plank door at the south end of the east elevation.

**Figure 118. The Jensen/Miller/Stuver Cabin, 1993. The view is looking northeast.**

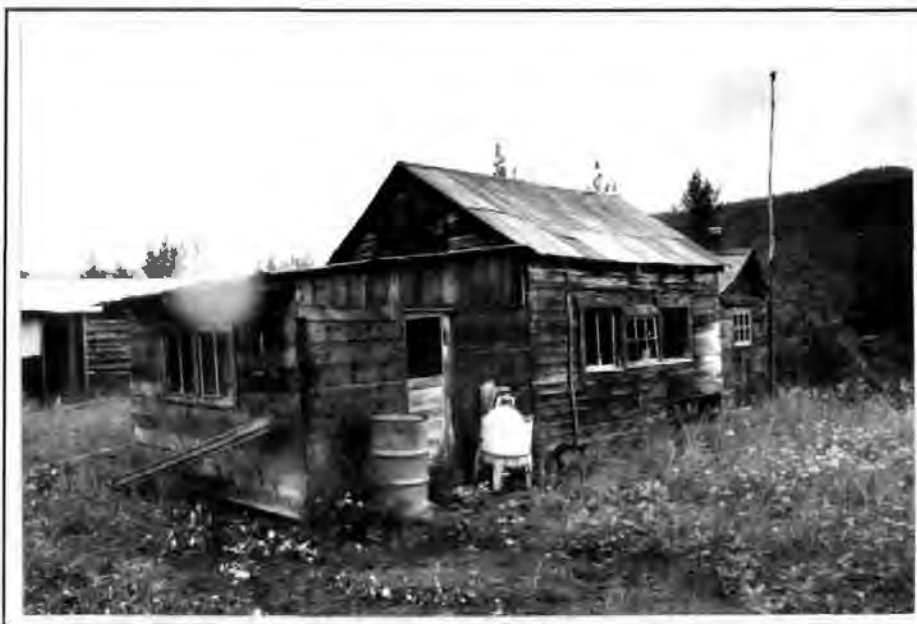
The Stuver Shop/Shawn Flemings House (IDT-162) is a rectangular, one-story, wood frame building (Figure 119). The foundation is logs on grade. Corrugated metal covers the gable roof, which is oriented north-south. The building measures 14'2"x16'. The exterior walls are covered with shiplap. A six-light, fixed sash window is centered on the west elevation. Three fixed sash windows, including a two-light, a six-light, and a single-light, are located on the east elevation. A shed addition measuring 10'7"x14'2" is located on the south elevation. Corrugated metal covers the roof. The exterior walls are covered with horizontal and vertical wood siding. A pair of two-light, fixed sash windows are centered on the south elevation. A one-light, fixed sash window is centered on the west elevation and

Figure 119. The Stuver Shop/Shawn Flemings House, 1993. The view is looking northwest.

a three-panel door with one light is centered on the east elevation. A one-story, wood frame addition measuring 7'4"x13'4" is located on the north side of the building. The gable roof is covered with corrugated metal and is oriented east-west. The exterior is covered with horizontal wood siding. A plank door covered with roofing felt is centered on the west elevation. A three-light, fixed sash window is centered on the north elevation and a six-light, fixed sash window is centered on the east elevation.

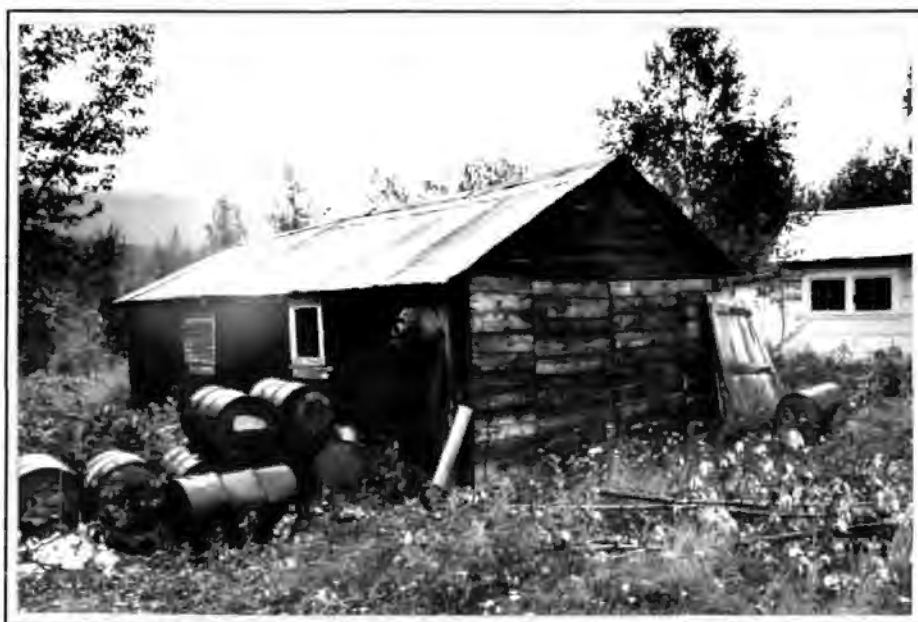
The **Jensen/Parker/Stevens/Stuver Garage (IDT-163)** is a rectangular, one-story, wood frame building (Figure 120). The foundation is on grade. The gable roof is covered with corrugated metal. The garage measures 15'x30'7" and is sided with shiplap and horizontal wood siding. The main entry is on the south elevation, which has a pair of large side opening plank doors. Two single-light, fixed sash windows are located on the east and west elevations. A personnel door and a window opening on the north elevation are covered with corrugated metal. A stove pipe insulator is sticking out the south end of the west elevation.

**Figure 120.** The Jensen/Parker/Stevens/Stuver Garage, 1993. The view is looking northeast.

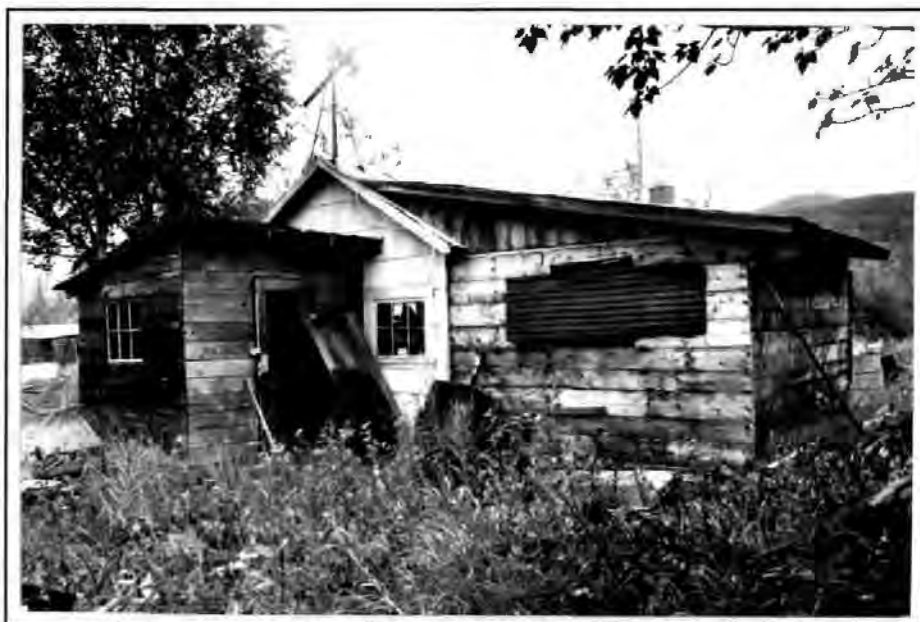
The **Dukich/Parker/Jimmy Flemings House (IDT-164)** is a rectangular, one-story, wood frame building with three additions (Figure 121). The foundation is not visible. Corrugated metal covers the gable roof of the house and roofs of the three shed additions. The building measures 12'2"x14'1". The exterior walls are covered with wood shingles. The main entry is on the south elevation, which contains a six-light, fixed sash window and a shed roof addition. The addition measures 2'10"x7'8". The exterior is covered with shiplap. The east elevation contains a three-panel door with one light. The south and west elevations each have a six-light, fixed sash window. The west elevation of the house contains a pair of two-light, fixed sash windows. A shed roof addition on the east side of the house measures 11'2"x14'1". The exterior walls of the east addition are covered with shiplap. A boarded up window is located on the north and south elevations of this addition. Another shed roof addition measuring 9'11"x12'2" is located on the north side of the house. Corrugated metal covers the exterior walls. A four-panel door is located on the west elevation of the north addition.

**Figure 121. The Dukich/Parker/Jimmy Flemings House, 1993. The view is looking northwest.**
