BLM-Alaska Open File Report 64  
BLM/AK/ST-97/022+8111+040  
April 1997

## HISTORIC BUILDING SURVEY REPORT FLAT, ALASKA

by Rolfe G. Buzzell and Darrel L. Lewis

# **Historic Building Survey Report Flat, Alaska**

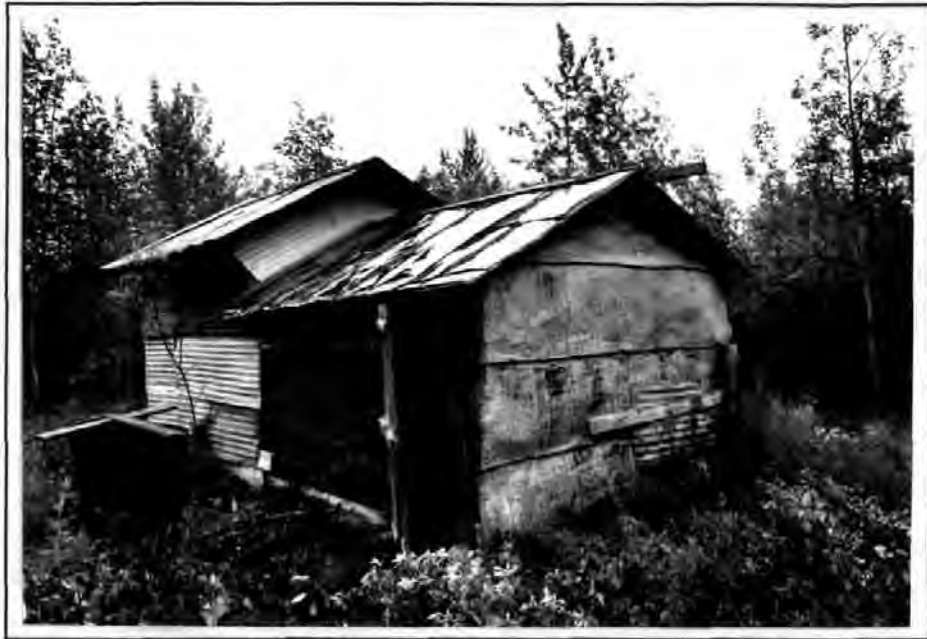
The **Parker/Flemings Meat Shed (IDT-165)** is a rectangular, one-story, wood frame building and addition (Figure 122). The foundation is on grade and the building has a dirt floor. The building and addition have gable roofs positioned end to end. Corrugated metal covers the roof and exterior walls of the building except for the screening under the eaves and gables. The main portion of the building measures 9'10"x10'6"

**Figure 122. The Parker/Flemings Meat Shed, 1993. The view is looking southeast.**

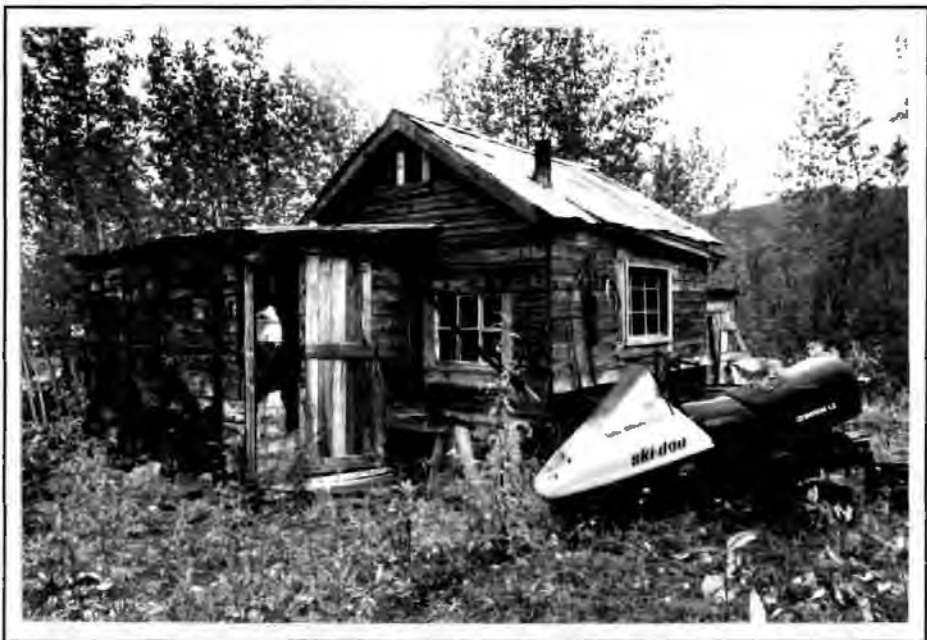
The **Nevella/Johnson/Flemings/Crammer House (IDT-166)** is a rectangular, 1.5 story, wood frame building (Figure 123). The

**Figure 123. The Nevella/Johnson/Flemings/Crammer House, 1993. The view is looking northwest.**

foundation is not visible. Corrugated metal covers the gable roof. The house measures 10'6"x12'6". The exterior walls are covered with roofing felt over shiplap on the north and west elevations, and shiplap on the south and east elevations. The main entry is on the south elevation, which includes a six-light, fixed sash window, a single-light, fixed sash window in the south gable, and a shed roof arctic entry measuring 6'6"x 8'11". The roof of the addition is covered with corrugated metal and the exterior is covered with roofing felt over wood siding. The east elevation of the addition has a plank door and the west elevation has a single-light, fixed sash window. A six-light, fixed sash window is centered on the west elevation of the house and a nine-light, fixed sash window is centered on the east elevation.

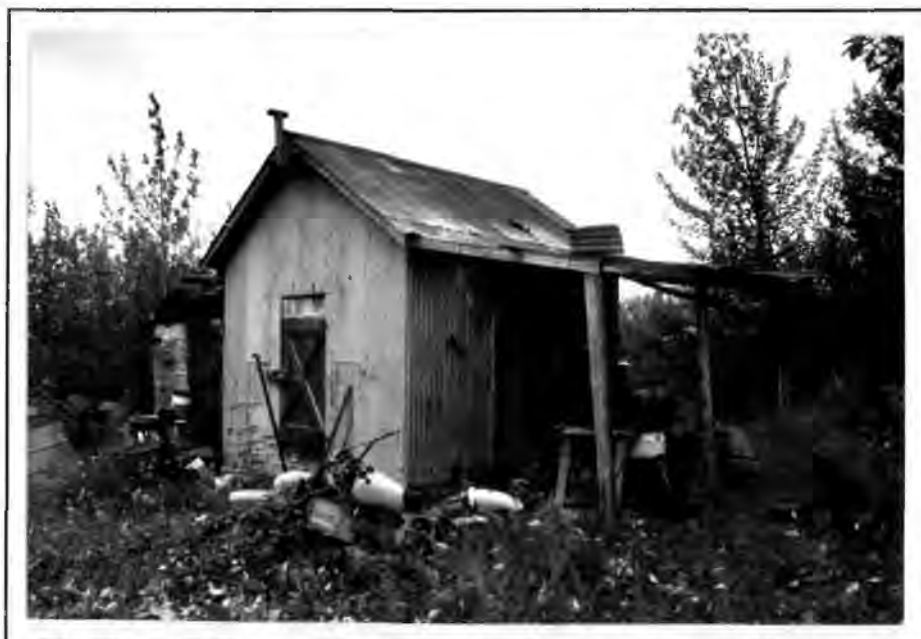
The Turner/Floyd/Stevens/Olsen Shop (IDT-167) is a rectangular, one-story, wood frame building (Figure 124). The foundation is wood blocks on grade. Corrugated metal covers the gable roof and exterior walls. The building measures 11'11"x12'. A vertical plank door is centered on the east elevation. A shed addition on the south side of the building is open on the west elevation. Corrugated metal covers the roof. Shiplap siding covers the south and east walls. A shed roof addition on the north side has no walls. Corrugated metal covers the roof. A row of metal fuel drums is located on the west side of the building.

Figure 124. The Turner/Floyd/Stevens/Olsen Shop, 1993. The view is looking southwest.

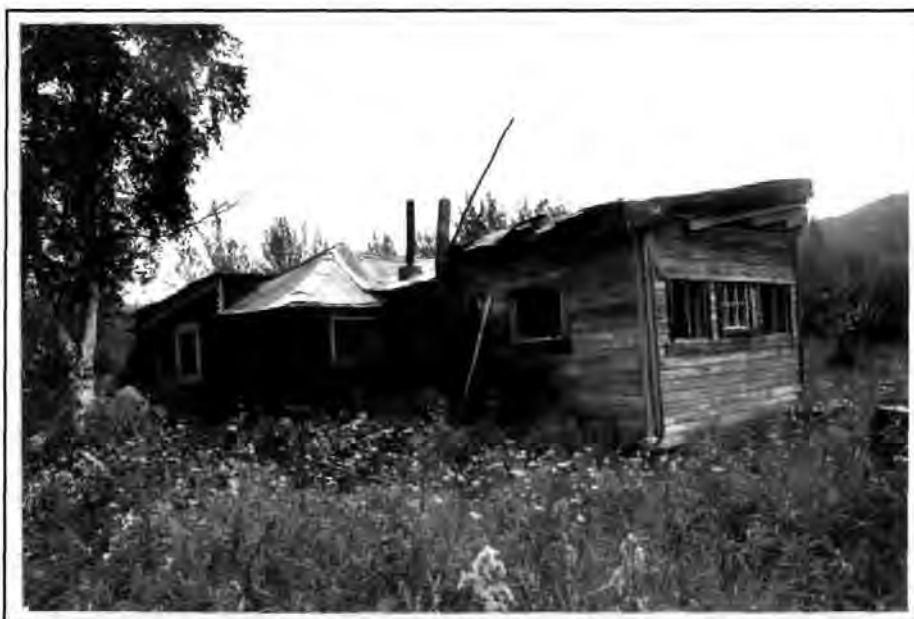
The **Marcell/Dahl/Stevens/Friend/Olsen House (IDT-168)** is an irregular shaped, one-story, wood frame building with four additions (Figure 125). The foundation consists of wooden blocks on grade. The roofs of the house and the four additions are covered with corrugated metal. The oldest section of the house measures 12'x12'8" and had a gable roof. The original house appears to have been "L" shaped with a shed roof addition in the northeast corner. Roofing felt covers the exterior walls. The main entry is on the south elevation, which includes a one-light, fixed sash window and a hipped roof addition measuring 6'5"x8'. The exterior of the addition is covered with roofing felt. The south addition has a two-panel door with one light facing south and a six-light, fixed sash window facing east. A shed roof addition on the west side of the house measures 11'5"x18'4". Roofing felt covers the exterior walls. The south elevation has a single-light, fixed sash window and the west elevation has two six-light, fixed sash windows. A shed addition on the north side of the house measures 7'1"x23'9" and the exterior is covered with roofing felt. The north addition has a single-light, fixed sash

**Figure 125. The Marcell/Dahl/Stevens/Friend/Olsen House, 1993. The view is looking northwest.**

window on the west side, and a door way and a six-light, fixed sash window on the north elevation. On the east side of the building is an addition with a shed roof. The east addition measures 10'11"x13' and the exterior is sided with scalloped shiplap with corner boards. The south elevation has a single-light, fixed sash window and the north elevation has a four-panel door. The east elevation has a six-light, fixed sash window flanked on each side by a two-light, fixed sash window.

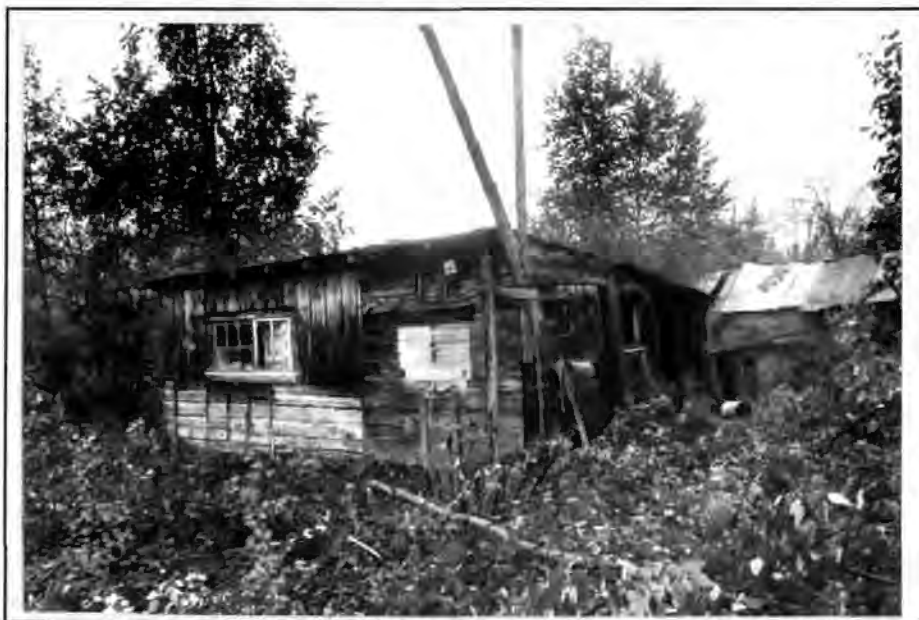
**The Stenberg/  
Gustafson/Olsen  
Shed (IDT-169)** is a rectangular, one-story, log and wood frame building with two additions (Figure 126). The foundation is logs on grade and the shed roof is covered with corrugated metal. The oldest (northwest) portion of the building measures 11'10"x13'7". The lower walls are made of logs and the upper walls are framed and covered with vertical wood siding. A six-light, fixed sash window and

**Figure 126. The Stenberg/Gustafson/Olsen Shed,  
1993. The view is looking northeast.**

a two-light, fixed sash window are centered on the west side. A shed addition on the south side measures 7'x11'10". The roof is covered with corrugated metal and the exterior is covered with wood siding. The south elevation contains a pair of utility doors and a window frame. A boarded up window is located on the west elevation. A shed addition on the east side of the building measures 7'10"x20'7". The exterior walls of the addition are covered with shiplap. A double-wide entry with the remains of two plank doors are on the north elevation and there is a door opening on the south elevation.

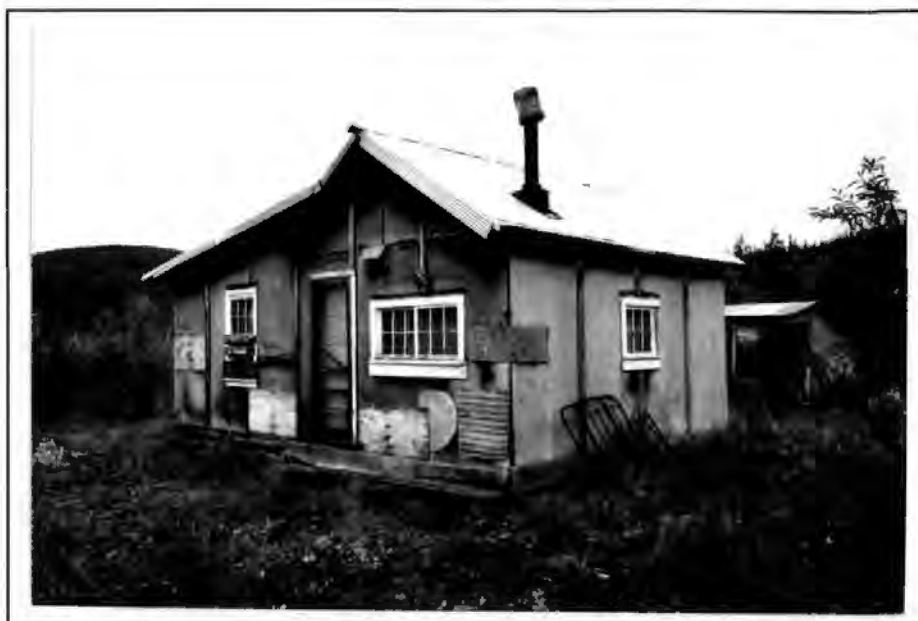
(Figure 128). The foundation is logs on grade. Corrugated metal covers the gable roof and the shed roof addition. Celotex covers all of the exterior walls. The house measures 12'x16'. The main entry is on the south elevation, which includes a five-panel door and a 6/6 horizontal double-hung window. A six-light, fixed sash window is centered on the east elevation. A shed addition on the west side of the house measures 12'x16'. A 6/6 double-hung window is centered on the south elevation. A 2/2 horizontal double-hung window is located on the west elevation and a five-panel door is located on the north elevation.

**Figure 128. The Williams/Bacstrom/Blackwell/Pierson House, 1993. The view is looking northwest.**

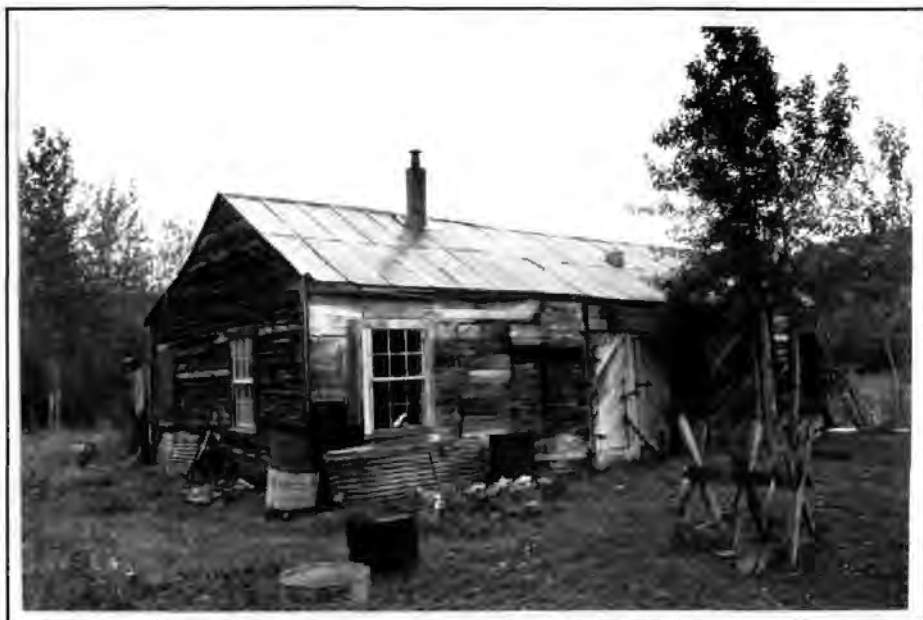
The Alaska Road Commission (ARC) Repair Shop (IDT-171) is a "L" shaped, one-story, wood frame building (Figure 129). The foundation is not visible. Corrugated metal covers the gable roof. The building measures 19'10"x39'10". The exterior walls are covered with shiplap except the north wall which is covered with corrugated metal. The main entry is on the south elevation, which features two pairs of large, side opening plank doors, a 6/6 single-hung window, and a boarded over door. A 6/6 single-hung window is located on the south elevation and a six-light, fixed sash window is located on the north elevation. A small 6'8"x8'10" shed roof addition is located on the north end of the west elevation. The roof is covered with corrugated metal and the exterior is sided with shiplap. This addition has a six-light, fixed sash window facing north. A plank door and a six-light, fixed sash window faces west. A 5'1"x6'4" shed roof addition is located on the south end of the west elevation of the building. The roof is covered with corrugated metal and the exterior is sided with shiplap. A 6/6 single-hung window faces south. A large gable roofed addition on the west side of the building gives the complex an "L" shape. The west addition measures 18'x31'7". Corrugated metal covers the roof and exterior walls. The addition has a two-light, fixed sash window facing south and a window frame with no glass facing west. An arctic entry measuring 5'2"x6'4" is located on the east end of the south side of this addition. The arctic entry has a shed roof

covered with corrugated metal and the exterior is covered with roofing felt. A five-panel door faces west and a boarded up window faces south. A shed roofed addition measuring 8'x20'2" is located on the north side of the west addition. The roof and exterior walls are covered with corrugated metal. The north elevation of the addition has two window openings without glass and a plank door.

**Figure 129. The ARC Repair Shop, 1993.**  
The view is looking northwest.

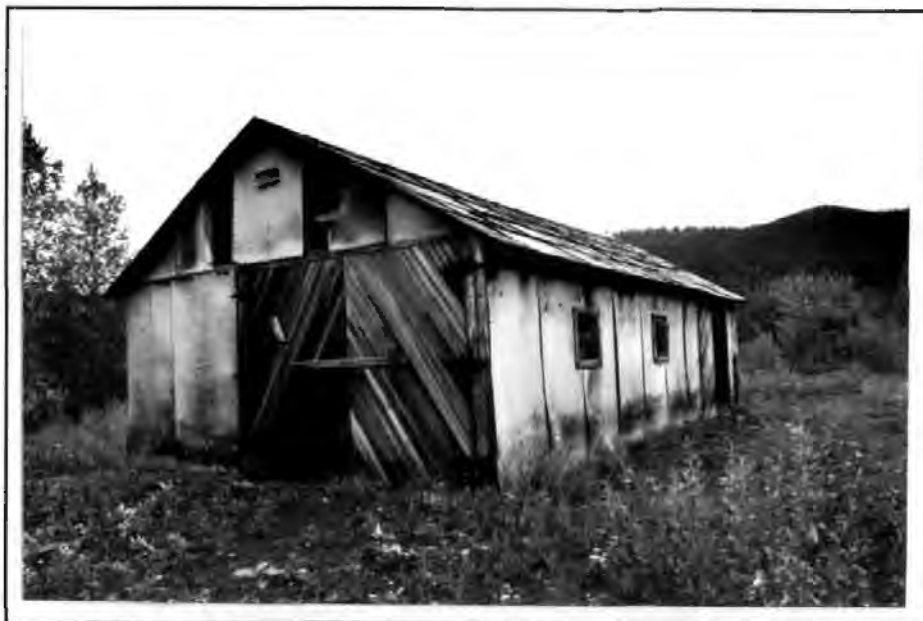
The **Alaska Road Commission Garage (IDT-172)** is a rectangular, one-story, wood frame building (Figure 130). The foundation is on grade and roofing felt covers the gable roof. The building measures 20'x40' and the exterior walls are covered with celotex. The east elevation contains a pair of large, side opening plank doors and two single-light, fixed sash windows. Another pair of large, side opening plank doors is located on the south elevation. A personnel door made of vertical tongue and groove boards and a window frame with no glass are located on the north elevation. Two window openings without glass are located on the west elevation.

**Figure 130. The ARC Garage, 1993.**  
The view is looking northwest.

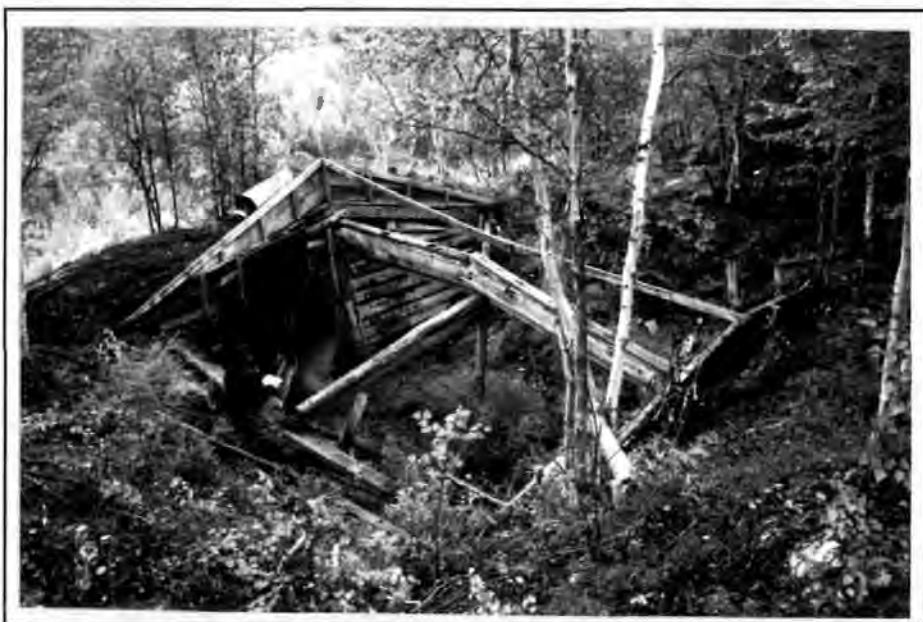
consists of the ruins of a rectangular, one-story, semi-subterranean, log building (Figure 131). The structure was built into the hillside just north of the Flat-Iditarod Road at the northwest edge of Flat. With the exception of the roof and south facing entry, the building is underground. The foundation is below grade. The gable roof has collapsed and the roofing material, except for the log ridge pole, a ridge board and two rafters, have been salvaged. The building measures 24'2"x25'7". The south wall is standing, but the north, east, and west walls are partially collapsed. The only entry to the building is on the south side facing the road. The log lined entry, which was excavated out of the hillside facing the road, measures 4'x6' and is the only part of the structure visible from the road.

**Figure 131. The Gularte/Donnelley and Sheppard Warm Storage Building, 1993.** The view is looking southwest.

The ruins of the Gularte/Donnelley and Sheppard Warm Storage Building constitute one of the oldest sites in Flat. The building was constructed in the early 1910s, but the builder and the date of construction are unknown. Manuel Gularte used the structure as a warehouse for his grocery store in Flat during the 1910s and early 1920s. Donnelley and Sheppard bought Gularte's business in the early 1920s and used the Warm Storage Building to store perishables such as potatoes and onions. Donnelley and Sheppard used the building until the 1930s (Bagoy 1995:139; Miscovich 1995:IV-68; Gularte, personal communication 1991).

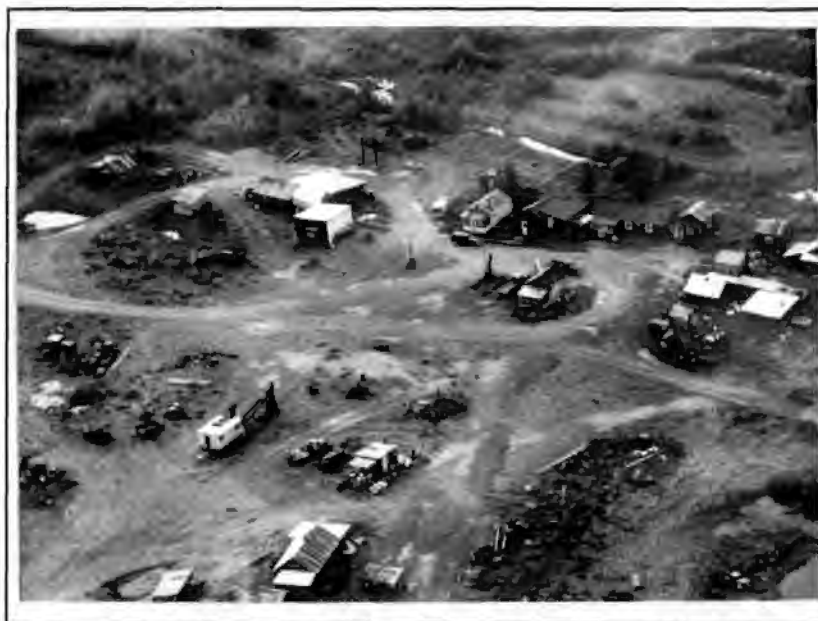
The Riley/Otter Creek Dredging Company Mining Camp (Riley/Otter Creek Camp) (IDT-201) is located about one mile east of the town of Flat. The camp consists of a complex of buildings, structures, and equipment associated with the Riley Dredge. The complex (Figure 132) is made up of twenty buildings, including bunk-houses, a mess hall, garages, workshops, sheds, and offices, and one structure, a steam shovel (Figure 133). All of the buildings are one-story, wood framed structures in good condition. The camp also includes early mining equipment collected by John Miscovich.

**Figure 132. Aerial view of the Riley/Otter Creek Mining Camp. The view is looking northwest.  
Photo courtesy of John Miscovich, ca 1990.**

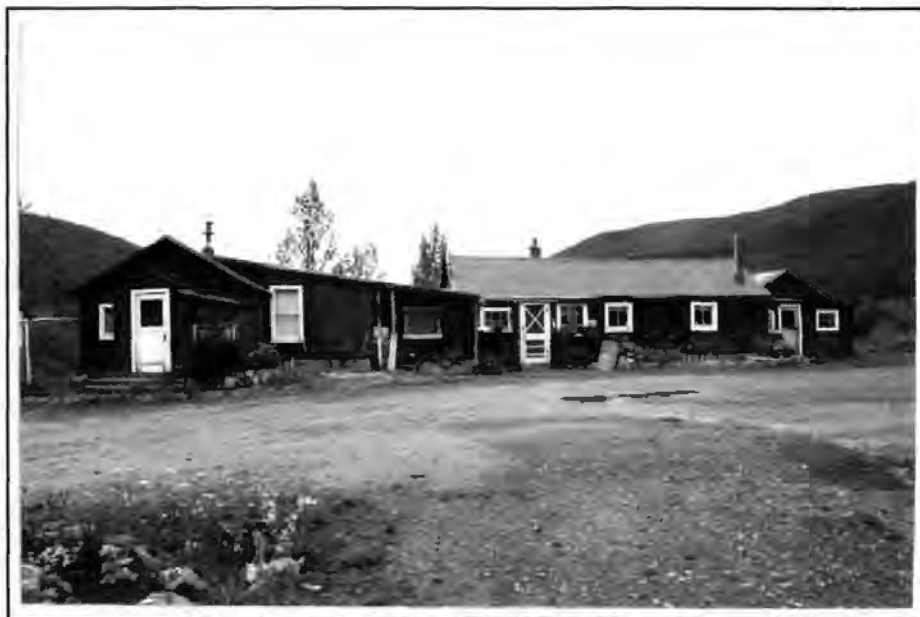
The **Mess Hall Building (IDT-202)** is a one-story, wood frame building with six additions (Figure 134). The foundation is wood blocks. The exterior of the Mess Hall and the five additions are covered with roofing felt. The gable roof is roofing felt covered with corrugated metal. The Mess Hall measures 24"x38'7". The main entry is on the south elevation, which has two two-light, fixed sash windows and a three-panel door with one light. The door is covered by an arctic entry with a shed roof. The entry measures 7'x15' and the roof is covered with corrugated metal. The south elevation of the entry has a three-panel door with one light, a six-light, fixed sash window, and a nine-light, fixed sash window. The north elevation of the Mess Hall has a two-light, fixed sash window, a 2/2 double-hung horizontal window, and a window that is covered with corrugated metal.

A one-story shed roof addition measuring 14'4"x24' is located west of the Mess Hall. The shed roof is covered with roofing felt and canvas. A single-light, fixed sash window faces

north and a single-light, fixed sash window faces south. Another one-story shed roof addition to the west measures 10'x26'. The roof is covered with corrugated metal. The south elevation has a one-light, fixed sash window. A one-story, rectangular gable roof addition at the west end of the building measures 18'x19'3". The south elevation has a two-light, fixed sash window and a five-panel door. An

**Figure 134. The Mess Hall Building at the Riley/Otter Creek Camp, 1993. The view is looking north.**

arctic entry with a gable roof measuring 5'1"x6'3" covers the door. The arctic entry has a one-panel door with one light. A shed roof addition on the east side of the arctic entry measures 4'11"x7'9". It has a one-light, fixed sash window facing south. The roofs of the arctic entry and the shed addition are covered with roofing felt.

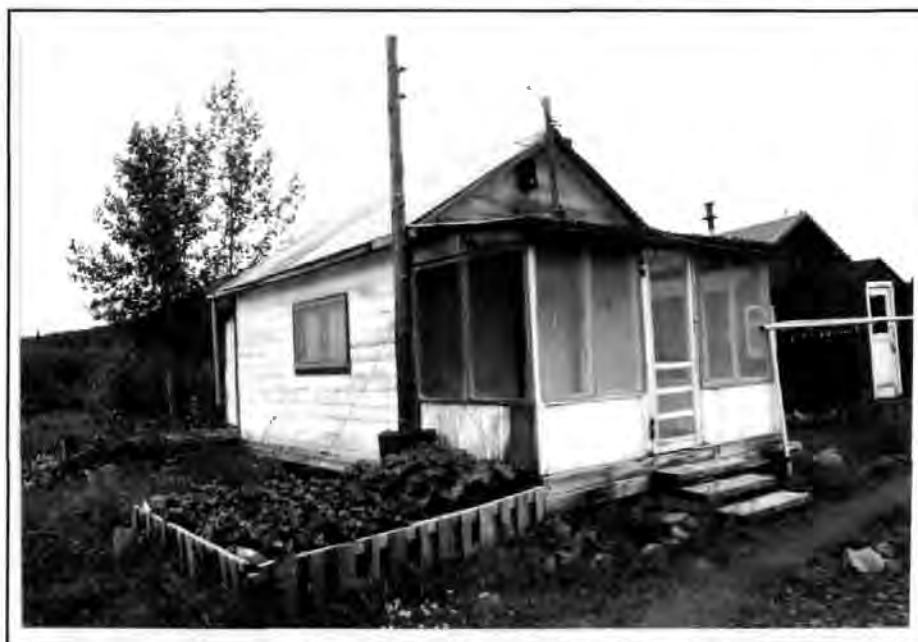
The **Pomgran/Aiken/Miscovich Guesthouse (IDT-203)** is a rectangular, one-story wood frame building (Figure 135). It measures 12'3"x18'4" and the foundation is wood blocks. The gable roof is covered with corrugated metal. The exterior is covered with shiplap and corner boards. The main entry is on the south elevation, which has a single-panel door with one light covered by a 6'x12'3" screen porch. The porch has a shed roof covered with corrugated metal. The east elevation has a one-light, fixed sash window. The west elevation has a 1/1 single-hung horizontal window. The north elevation has a five-panel door covered by an addition measuring 5'2"x10'5". The addition has a shed roof covered by roofing felt. The north elevation of the addition has two six-light, fixed sash windows. A boarded up doorway faces west.

**Figure 135. The Pomgran/Aiken/Miscovich Guesthouse, 1993. The view is looking northeast.**

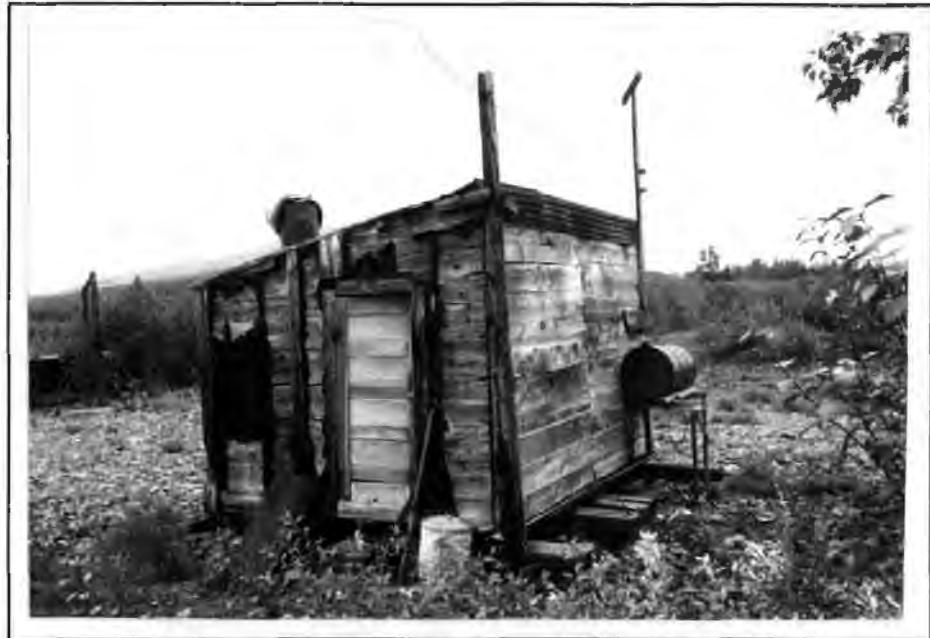
The **Generator Shed (IDT-204)** is a rectangular, one-story, wood frame building (Figure 136) located 25' northwest of the Pomgran/Aiken/Miscovich Guesthouse (IDT-203). The foundation is logs. The shed roof is covered with corrugated metal. The Generator Shed measures 10'10"x12'4". The exterior is covered with roofing felt over wood decking. A five-panel door is located on the south elevation. A six-light, fixed sash window is located on the north elevation. A window covered with corrugated metal is located on the west elevation. A cable attached to the foundation on the north side indicates that the shed is made to be towed. A generator is located inside the shed.

**Figure 136. The Generator Shed, 1993.**  
The view is looking northeast.

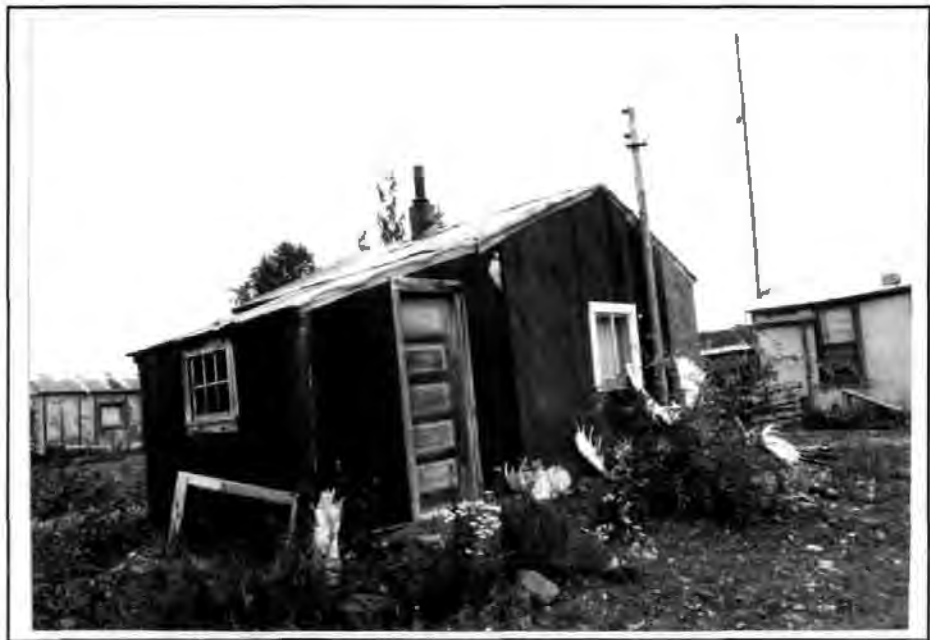
**Bunkhouse #1 (IDT-205)** is a square, one-story, wood frame building with an addition (Figure 137). The foundation is logs on grade. The gable roof consists of corrugated metal. The bunkhouse measures 15'2" on each side. The exterior is covered with roofing felt over horizontal wood siding. The main entry is on the west elevation, which has a two-light, fixed sash window. A shed roof addition measuring 7'7"x9'6" is located on the north elevation. The roof is covered with corrugated metal. The addition has a six-light, fixed sash window facing north and a five-panel door facing west. A six-light, fixed sash window is located on the south elevation of the bunkhouse. The interior walls are covered by wood siding. The ceiling is celotex and the flooring is tongue and groove.

**Figure 137. Bunkhouse #1, 1993.**  
The view is looking southeast.

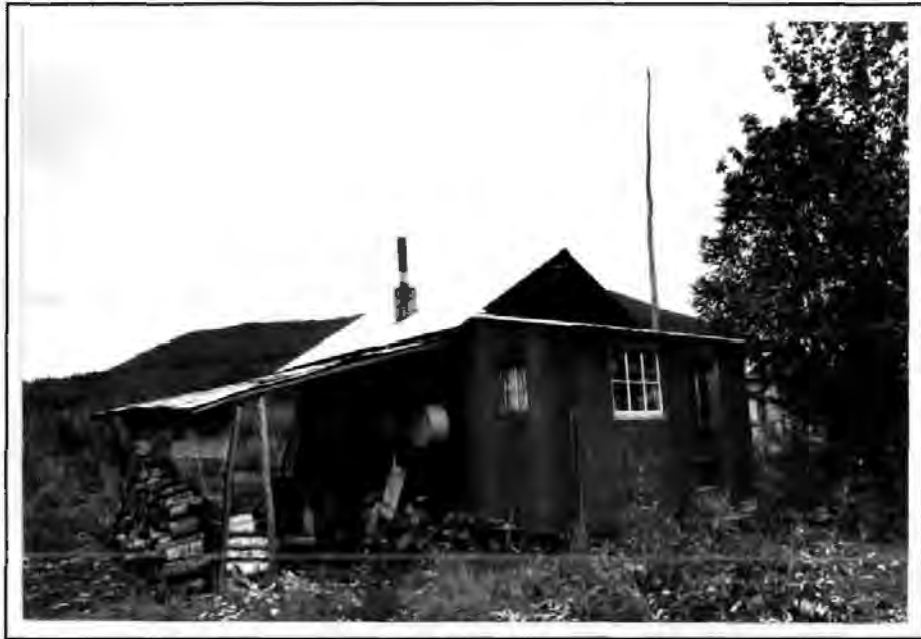
The **Bathhouse (IDT-206)** is a rectangular, one-story, wood frame building (Figure 138). The foundation is logs and beams on grade. The gable roof is covered with corrugated metal. The building measures 21'6"x23'2". The siding is roofing felt, except the west elevation which is covered with shiplap. The main entry is on the south elevation, which is covered by a shed roof addition measuring 5'6"x12'6". The roof of the addition is covered with corrugated metal. A two-panel door with six-lights and a six-light, fixed sash window face south. A four-light, fixed window faces west. The east elevation of the Bathhouse has a two-light, fixed sash window. An addition on the north side of the building has a shed roof covered with corrugated metal. The addition measures 10'2"x16'. The addition is open on the south side and has wood siding on the north and west sides.

**Figure 138. The Bathhouse, 1993.**  
The view is looking northeast.

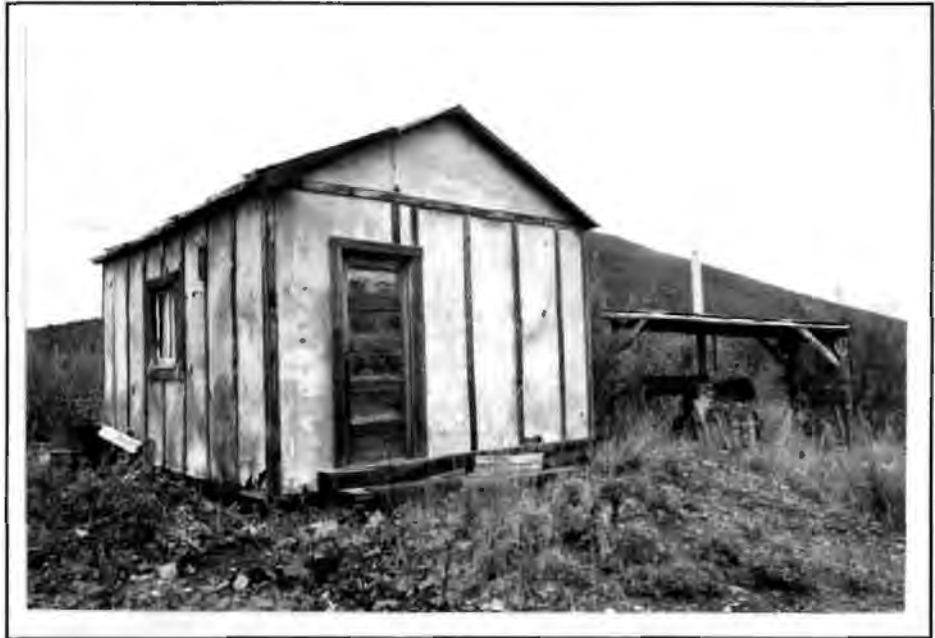
(IDT-207) is a rectangular, one-story, wood frame building (Figure 139) located 38' east of the Bathhouse (IDT-206). The foundation is beams and barrels on grade. The gable roof is made of corrugated metal. The Bunkhouse measures 12'2"x16'4". Celotex and batten boards cover the exterior walls. The main entry is on the south elevation, which contains a five-panel door. The north and west elevations have a two-light, fixed sash window. A three-panel door is located on the east elevation.

**Figure 139. Bunkhouse #2, 1993.**  
The view is looking northeast.

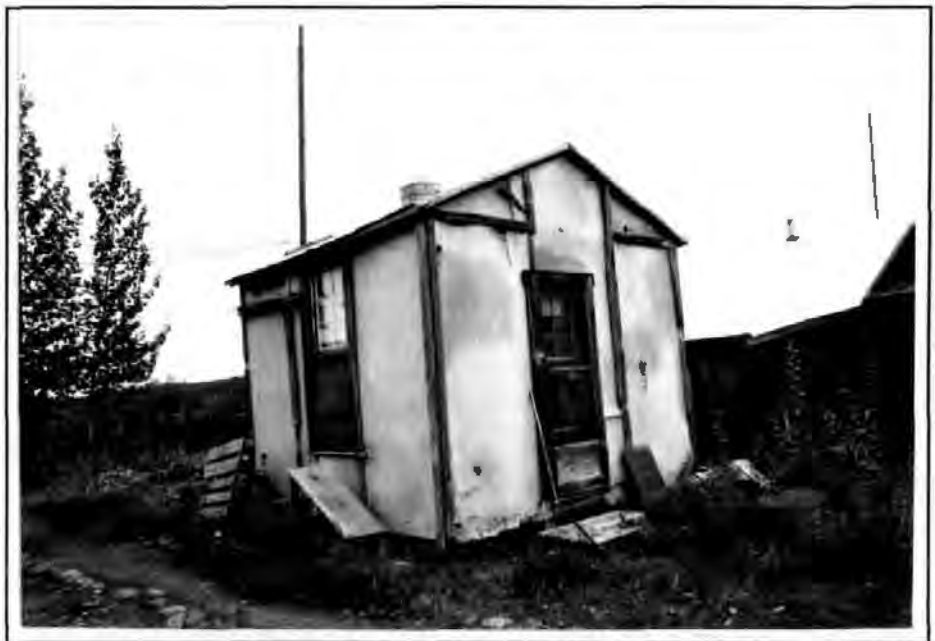
**Bunkhouse #3** (IDT-208) is a square, one-story, wood frame building (Figure 140) located 26'6" south of Bunkhouse #1. The foundation is logs on grade. The gable roof is made of corrugated metal. The building is 12' on each side. Celotex with batten boards covers the exterior walls. The main entry is on the west elevation, which contains a three-panel door with six lights. A six-light, fixed sash window is located on the north elevation.

**Figure 140. Bunkhouse #3, 1993.**  
The view is looking southeast.

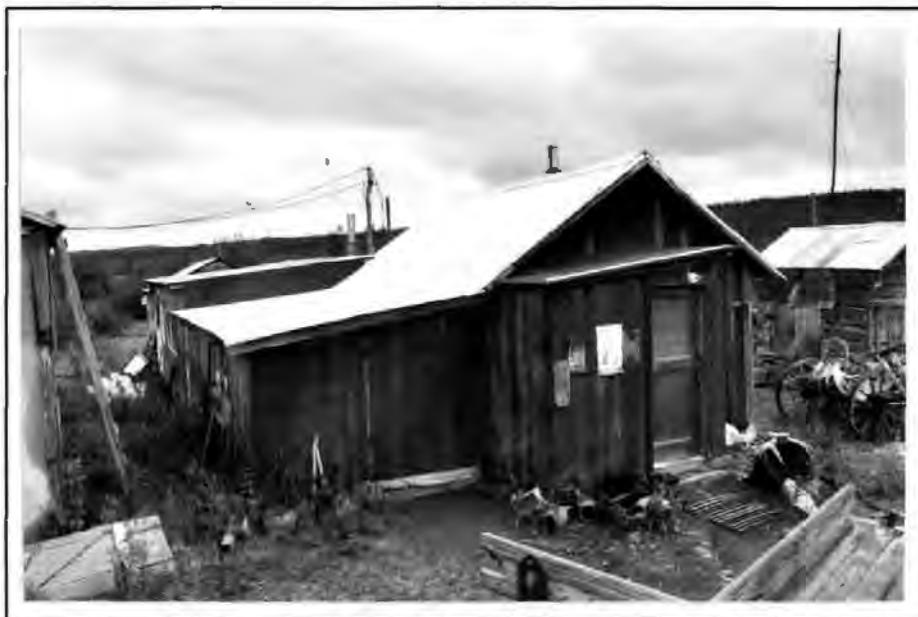
**The Office and Workshop** (IDT-209) is a rectangular, one-story, wood framed building with four additions (Figure 141). The office measures 14'x16'4". The foundation is logs and beams on grade. The gable roof is made of corrugated metal. The siding consists of roof-

ing felt and battens. The main entry is on the west elevation, which has a one-light, fixed sash window on the south end. The north end of the west elevation is covered by a shed roofed arctic entry measuring 4'x8'. The roof of the arctic entry is covered with roofing felt. A one-panel door with one-light faces west. The east elevation of the Office has a 2/2 horizontal double-hung window.

A rectangular, wood frame shed is located on the north side of the Office. The foundation is on beams and the shed roof is covered with corrugated metal. The addition measures 9'5"x16' and the exterior siding consists of roofing felt over horizontal wood siding. A plank door covered with roofing felt opens to the west. A pair of two-light, fixed sash windows are located on the north elevation.

**Figure 141. The Office and Workshop Building, 1993. The view is looking southeast.**

Another rectangular, wood frame shed addition is attached to the east side of this shed. The foundation consists of beams on grade and the shed roof is covered with corrugated metal. The addition measures 9'5"x22' and the exterior is covered with roofing felt over horizontal wood siding. The south elevation has two, two-light, fixed sash windows. The north elevation has a three-panel door with one-light, a six-light, fixed sash window, and a two-light, fixed sash window. This building is used as a laboratory.

A third rectangular, shed roof addition is connected to the west side of the second addition. The foundation is beams on grade. The gable roof is made of corrugated metal. The addition measures 9'5"x13'6" and the exterior is covered with plastic tarp over horizontal wood siding. A vertical plank door is located on the east elevation. A six-light, fixed sash window is located in the north elevation. This shed once housed a pump powered by a diesel engine.

A fourth addition is attached to the south side of the third addition. The foundation is not visible. The shed roof is covered with corrugated metal. The addition measures 17'2"x19'10" and the exterior is covered with plywood. The south elevation has a triple six-light window, a large plywood door, and a band of four single-light, fixed sash windows covered with plastic. The east elevation has a three-panel door with four lights and a triple two-light, fixed sash window. The west elevation has a three-panel door. This addition is a garage in the winter and is used to process concentrates in the summer.

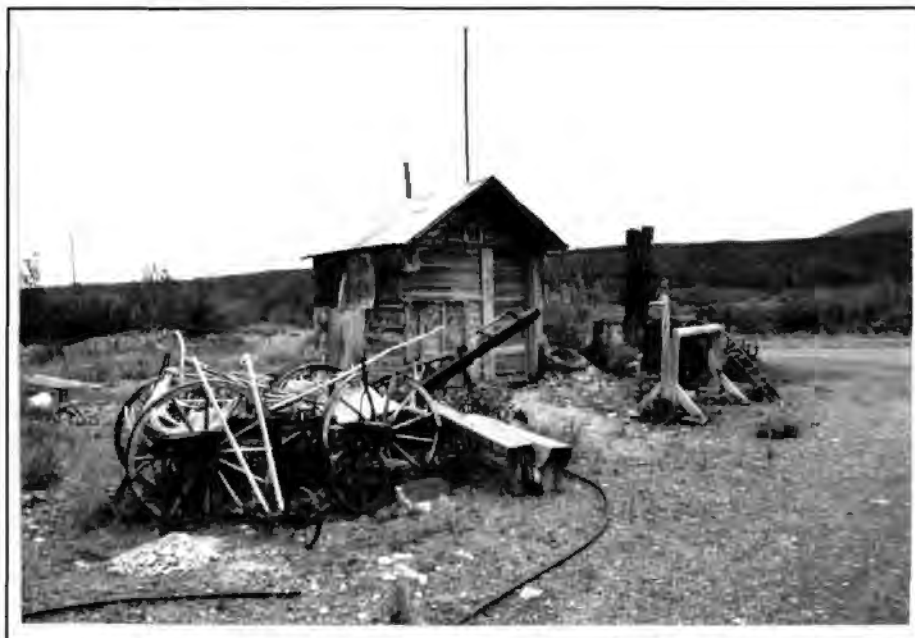
The **Well House (IDT-210)** is a square, one-story, wood frame building (Figure 142). The foundation is logs on grade. The gable roof is covered with corrugated metal. The building measures 8'x10'2". The exterior is covered with a combination of shiplap and horizontal wood siding. A five-panel door is located on the west elevation. The building is surrounded by old mining equipment that John Miscovich has collected, including pumps, wagons, coils of rubber hose, and stamps for crushing lode ore.

**Figure 142. The Well House, 1993.**  
The view is looking southeast.

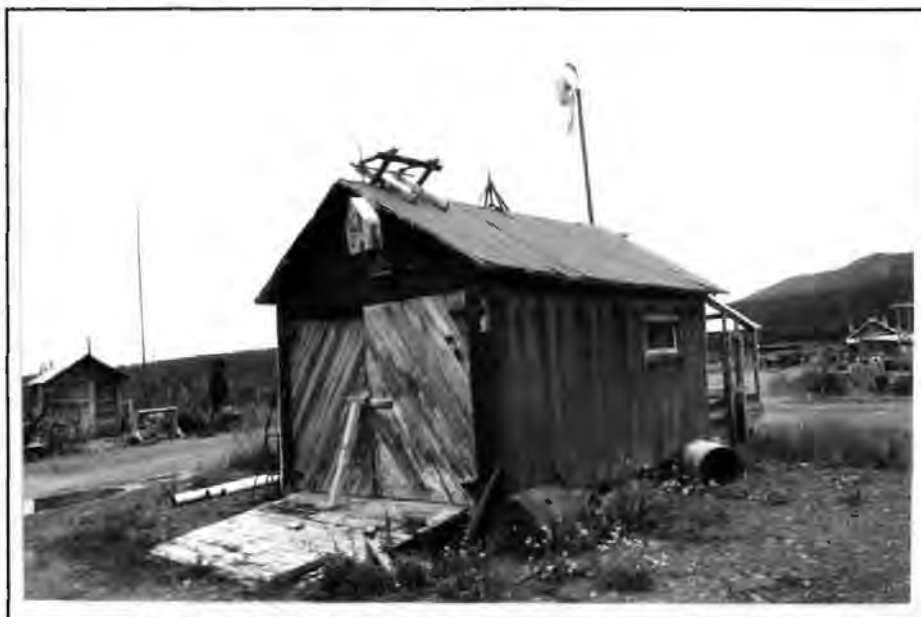
The **DeHouse Residence/Miscovich Garage (IDT-211)** is a rectangular, one-story, wood frame building (Figure 143). The foundation is wood blocks on grade. The gable roof is covered with corrugated metal. The garage measures 12'6"x24'6". Roofing felt over horizontal wood siding covers the exterior walls. The main entry is on the north elevation, which contains a pair of large diagonal plank doors. A ramp leads from the doors to the ground. The east elevation has a boarded up door. A single-light, fixed sash window is located in the west elevation. A shed roof greenhouse addition is centered on the south elevation. The roof of the addition is covered with fiberglass. The addition measures 8'4"x12'6".

**Figure 143. The DeHouse Residence/Miscovich Garage. 1993. The view is looking southeast.**

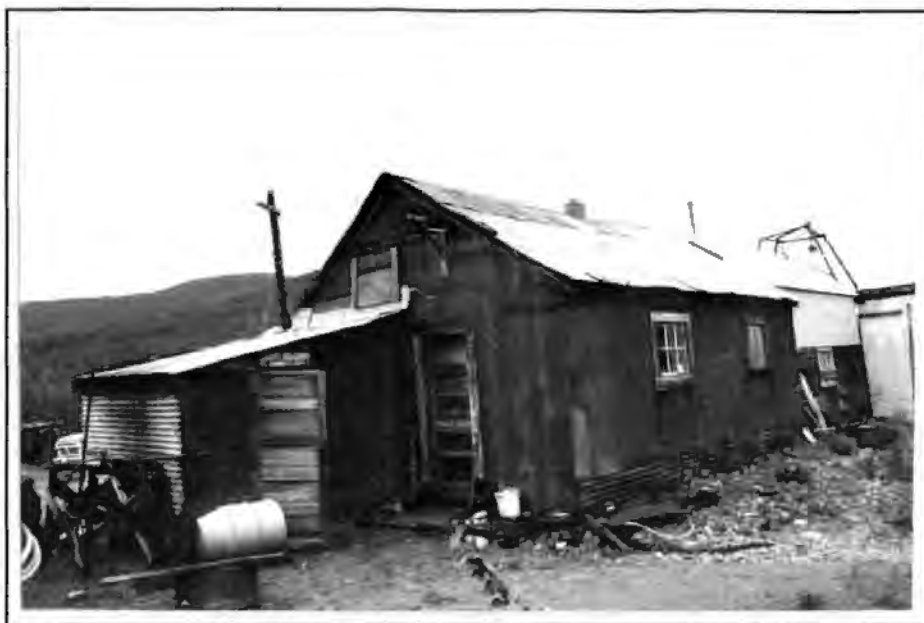
The Machine Shop (IDT-213) is a rectangular, 1.5 story, wood frame building with three additions (Figure 144). The foundation is horizontal timbers on grade. The gable roof is corrugated metal over shiplap. The shop measures 16'5"x23'11" and the exterior is covered with roofing felt over shiplap. The south elevation has two six-light, fixed sash windows and the north elevation has a two-light, fixed sash window. A small boarded up window is located under each gable. The west elevation has a five-panel door and a shed addition measuring 8'2"x10'. The addition, which houses a generator, has a shed roof covered with corrugated metal over wood decking. A five-panel door faces south.

A rectangular, one-story wood frame addition, which serves as a tractor garage, is attached to the east side of the Machine Shop. The foundation is vertical steel poles on grade. The gable roof is covered with aluminum. The addition measures 12'5"x19'6". The exterior is covered with a combination of shiplap and wood siding, except for the south elevation which is covered with aluminum. A pair of side-opening plywood doors is located on the east elevation. A five-panel door on the west elevation opens into the Machine Shop. The south elevation has a six-light, fixed sash window. A five-panel door on the south elevation opens into the north addition.

The rectangular, one-story, wood frame addition has a foundation of horizontal timbers on grade. The shed roof is covered with aluminum over wood decking. The addition measures 20'x30'4" and the exterior is covered with wood siding. A pair of single-light, fixed sash windows and a single-panel door with one-light are located on the east elevation. The north

elevation has a pair of single-light windows and a pair of fixed sash windows, one with six lights and the other with a single light. A pair of large side-opening doors and a six-light, fixed sash window are located on the west elevation. One of the swinging doors also has a six-light, fixed sash window.

**Figure 144. The Machine Shop (center) and additions, 1993. The view is looking northeast.**

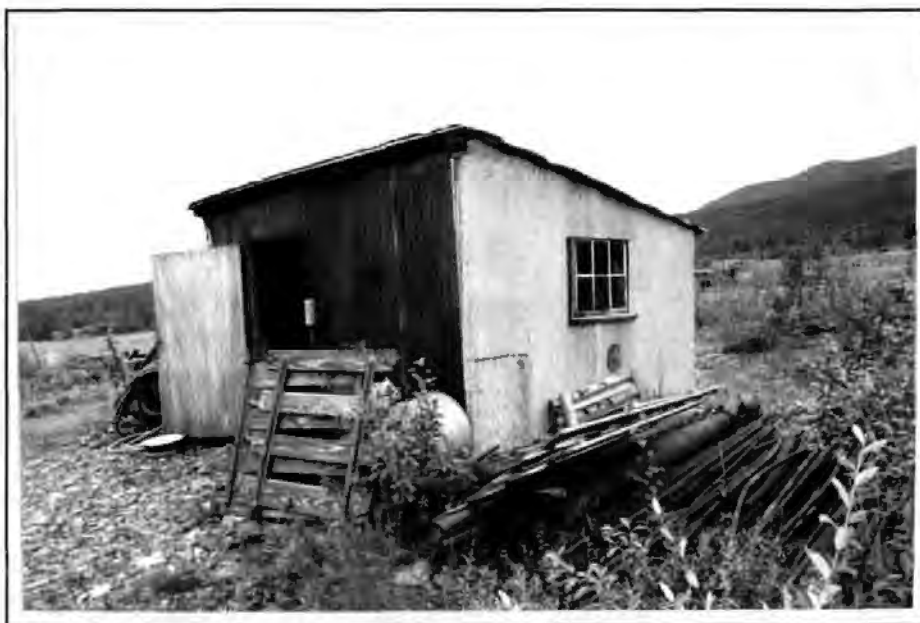
**The Fuel Storage Shed (IDT-214)** is a square, one-story, wood frame building (Figure 145) located 25' southwest of the Machine Shop. The foundation is on grade. The shed roof and exterior are covered with corrugated metal. The shed measures 11'2"x13'2". The main entry is on the north elevation, which has a plank door. A six-light, fixed sash window is located on the west elevation.

**Figure 145. The Fuel Storage Shed, 1993. The view is looking southeast.**

The date the Fuel Storage Shed was built is unknown. It belonged to Fred Patterson, who resided near the Discovery/Peter Miscovich Camp. Patterson moved his house to Flat and left the shed. John Miscovich moved the shed, which consisted of framing and a roof, to the Riley/Otter Creek Camp and put siding on it. He used the building as a generator shed before converting it to fuel storage (Miscovich 1995:VI-105).

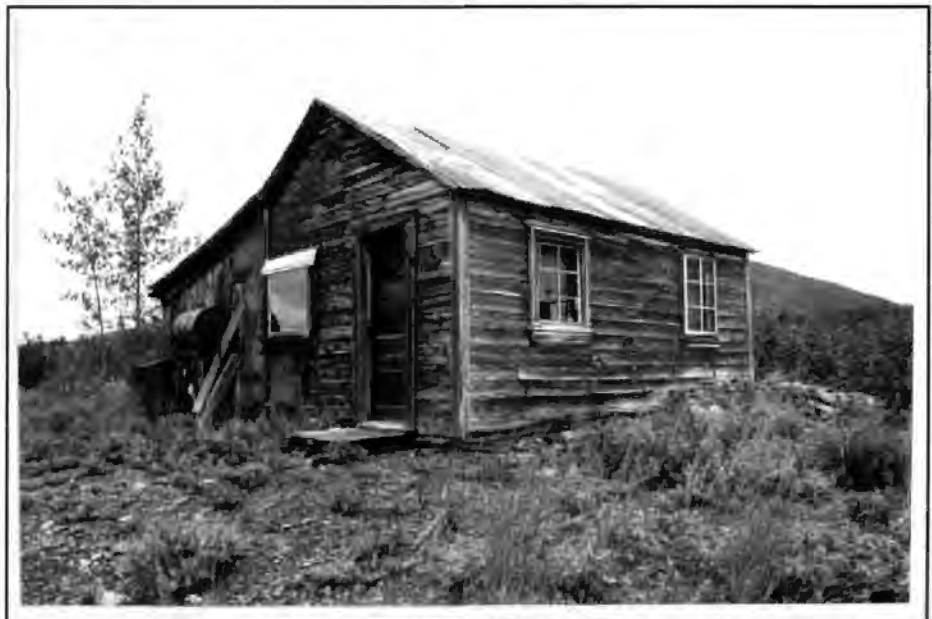
The **Riley Office/Kobler Cabin (IDT-215)** is a rectangular, one-story, wood frame building (Figure 146). The foundation is horizontal timbers. The gable roof is covered with corrugated metal over wood decking. The building measures 18'3"x24'9" and shiplap siding covers the exterior walls. The main entry is on the south elevation, which has a five-panel door and a single-light, fixed sash window. The east elevation has a six-light, fixed sash window and a single-light, fixed sash window covered by a six-light storm window. The north elevation has a two-light, fixed sash window and a six-light, fixed sash window. A rectangular, one-story addition on the west elevation has a shed roof covered with corrugated metal and measures 13'1"x14'4". The north and south walls are covered with shiplap and the west wall is covered with horizontal wood siding. A four-light, fixed sash window is located on the west side of the addition.

**Figure 146. The Riley Office/Kobler Cabin, 1993. The view is looking northwest.**

The Riley Office/Kobler Cabin is the oldest building in the Riley/Otter Creek Camp and one of the oldest in the Flat area. It was built about 1910 when J.E. Riley was mining in the area using a Bagley Scraper. After Riley started

dredging, the building became the J.E. Riley Investment Company office. Arnold Kobler lived in the building when he became part owner of the Otter Creek Dredging Company in the mid-1950s. John Miscovich moved the building, including the addition, to its present location in the 1960s. The shed addition is a storage room (Miscovich 1995:VI-101-102, 105, 107).

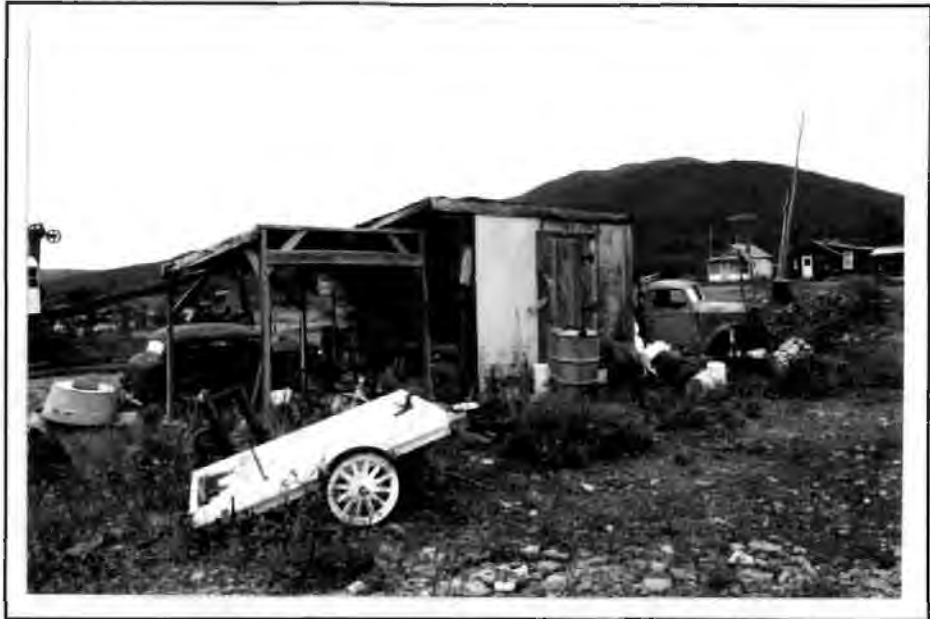
The Warehouse (IDT-216) is a rectangular, one-story, log framed building (Figure 147). The foundation consists of beams and logs on grade. The building measures 10'5"x11' and the shed roof is covered with corrugated metal. The exterior siding is celotex and batten boards. The main entry is on the east elevation, which has a plank door. A six-light, fixed sash window is located on the north elevation. A shed roof lean-to measuring 6'8"x10'1" is located on the south side of the shed. It is supported by corner posts and has no walls.

**Figure 147. The Warehouse, 1993.**  
The view is looking northwest.

The original location and the date the warehouse was built are unknown. Ernie Norman used it as a pig pen in the 1970s, when it was west of the present location of the Flat Post Office (IDT-124). John Miscovich moved the building to the Riley/Otter Creek Camp in about 1979 and has been using the building as a warehouse (Miscovich 1995:VI-106).

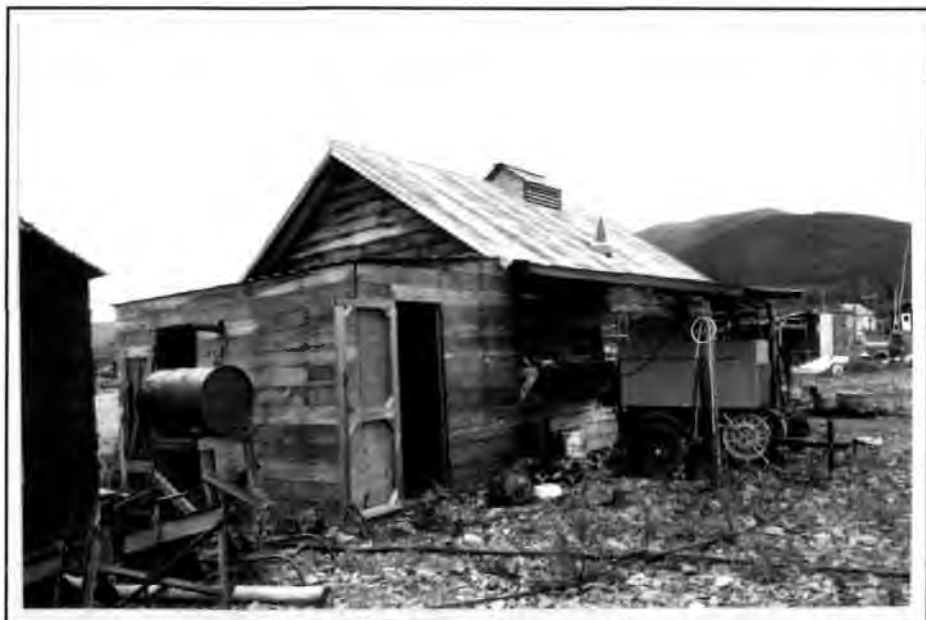
The Golden Horn Powerhouse (IDT-217) is a rectangular, one-story, wood frame building (Figure 148). The foundation consists of

**Figure 148. The Golden Horn Powerhouse, 1993.** The view is looking northwest.

wood blocks. The gable roof is made of corrugated metal and has a small cupola. The building measures 16'2"x22'2". Shiplap siding covers the exterior walls. The main entry is on the west elevation, which contains a pair of plywood doors and a plank door. The east elevation has a six-light, fixed sash window and a 7'x7'9" addition. The addition, which shelters a generator, has a shed roof covered with roofing felt. The south elevation of the Powerhouse has a plank door and a six-light, fixed sash window. The window is covered by an 8'4"x13'7" addition. The addition has a shed roof covered with corrugated metal. There is a plank door on the south and west sides of the addition and a screen door on the east side. The north elevation has a plank door and a six-light, fixed sash window.

A lean-to on the north elevation has a shed roof covered with corrugated metal. The lean-to measures 12'4"x19'8", has no walls, and shelters a Wilfley table. A welding shed measuring 6'2"x15'5" (Feature X, Figure 133) is located 7'9" east of the Powerhouse. The shed has a metal pole frame and no walls. The shed roof is covered with corrugated metal.
