BLM-Alaska Open File Report 64  
BLM/AK/ST-97/022+8111+040  
April 1997

## HISTORIC BUILDING SURVEY REPORT FLAT, ALASKA

by Rolfe G. Buzzell and Darrel L. Lewis

# **Historic Building Survey Report Flat, Alaska**

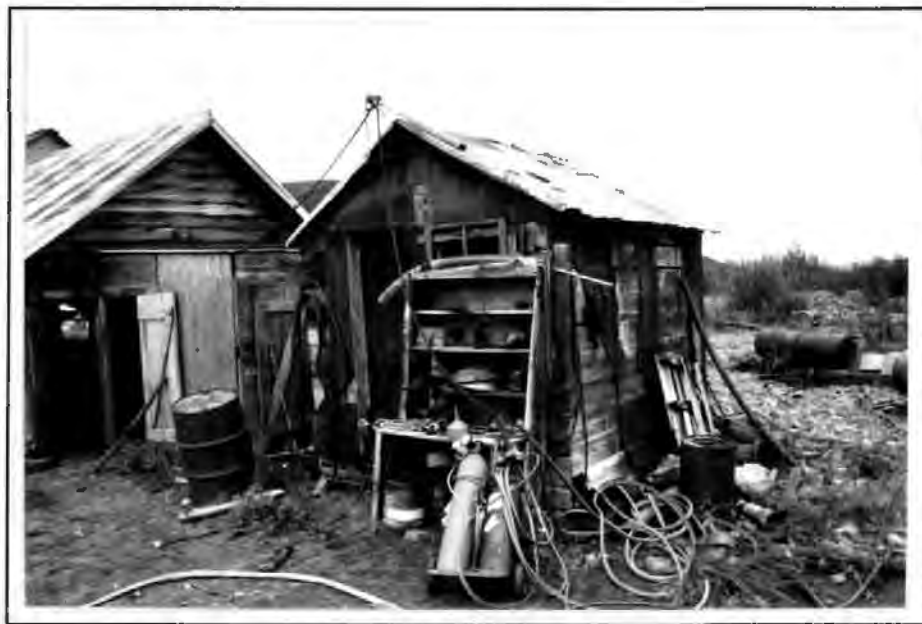
The **Drilling Shack on Skids** (IDT-218) is a rectangular, one-story, wood frame building (Figure 149) located about 8' south of the Golden Horn Powerhouse. The foundation is timber skids. The gable roof is covered with corrugated metal. The shack measures 8'2"x10'2". The exterior is covered with roofing felt over wood siding. The main entry is on the west elevation, which has a plank door and a single-light, fixed sash window.

**Figure 149. The Drill Shack on Skids, 1993. The view is looking northeast.**

When and where this shack was built are unknown. It was used as a drilling shack at the Discovery/Peter Miscovich Camp in the 1940s and 1950s before John Miscovich moved the building to the Riley/Otter Creek Camp in the 1960s (Miscovich 1995:VI-106).

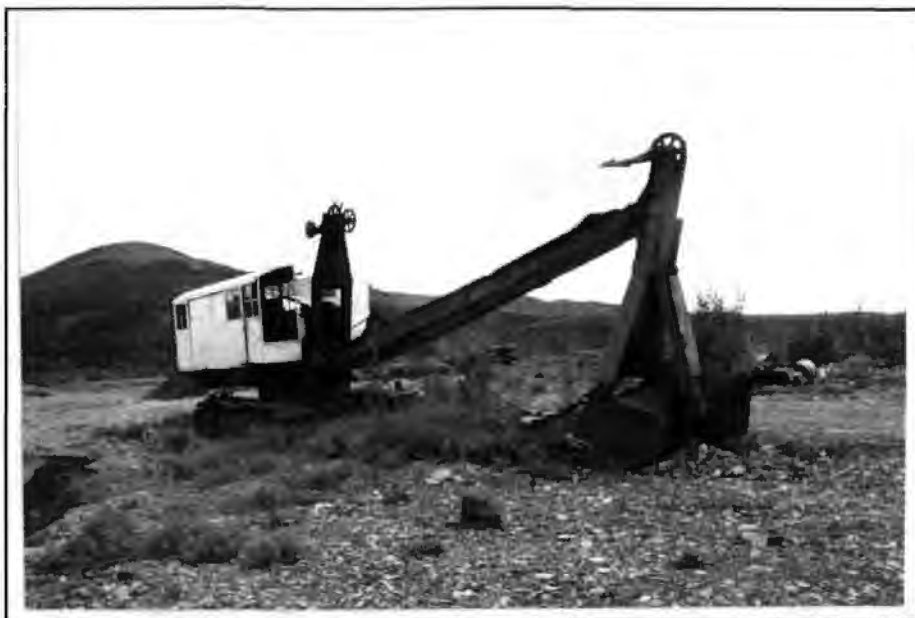
The **Miscovich Shovel (IDT-219)** is a 2.5 yard capacity shovel manufactured by the Pauling and Harnish Figure Corporation, of Milwaukee, Wisconsin. The shovel (Figure 150) is a diesel powered, track vehicle with an enclosed cab. It is mechanically operated and has no hydraulically operated controls. It weights about 65 tons. All of the mechanisms are in good working condition. The shovel originally had a 1.5 yard capacity bucket. John Miscovich enlarged the capacity by extending the sides of the bucket and putting larger shanks on the lip of the bucket.

**Figure 150. The Miscovich Shovel, 1993.**  
The view is looking southwest.

Peter Miscovich bought the shovel in 1935 and brought it up the Iditarod River by boat. John Miscovich assembled it and "walked" it overland to Flat. The Miscovich family used it for placer mining until World War II. After the war, they resumed using it on their Otter Creek claims. John Miscovich also used it in the early 1970s while mining on Flat Creek. He stopped using the shovel about 1974 or 1975 (Miscovich 1995:VI-106-107).

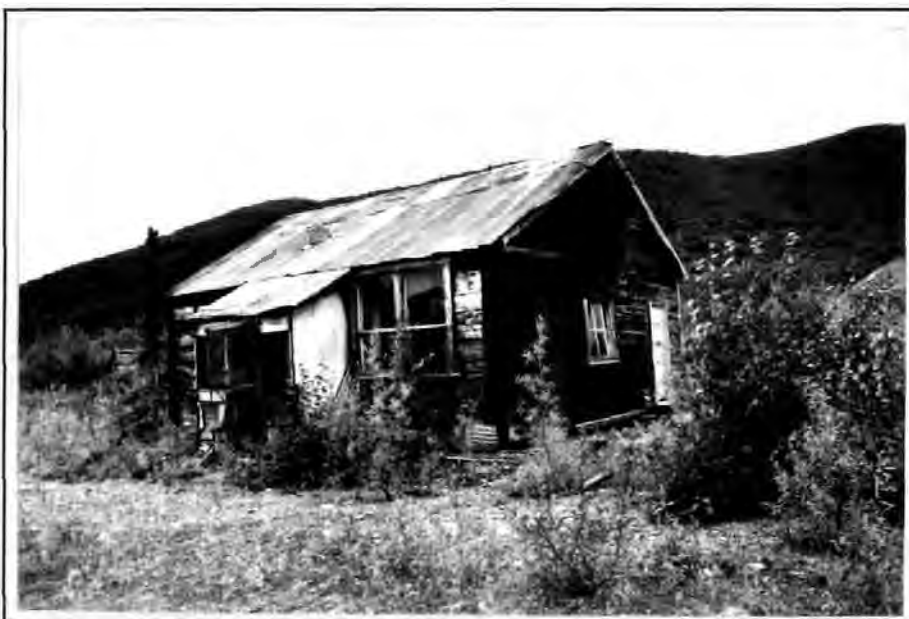
**The Bunkhouse (IDT-222)** is a rectangular, one-story wood frame building (Figure 153). The foundation consists of steel drums. The gable roof is covered with corrugated metal and the exterior is covered with roofing felt over horizontal rough cut siding. The main entry is on the south elevation, which has a pair of 2/2 single-hung windows and a four-light fixed sash window. An arctic entry with a shed roof is centered on this elevation. Corrugated metal covers the roof and the sides are covered with celotex. A screen door faces south. The east elevation has a six-light, fixed sash window and a five-panel door. The north elevation has a window covered with corrugated metal. The west elevation has a 1/1 single-hung window and a one-light, fixed sash window.

**Figure 153.** The Bunkhouse at the Discovery/Peter Miscovich Camp, 1993. The view is looking northwest.

Peter Miscovich built the bunkhouse in 1928 after the original log bunkhouse burned down. He used local rough cut lumber for the siding. The building was the mess hall and cook's quarters (Miscovich 1995:VI-99-100).

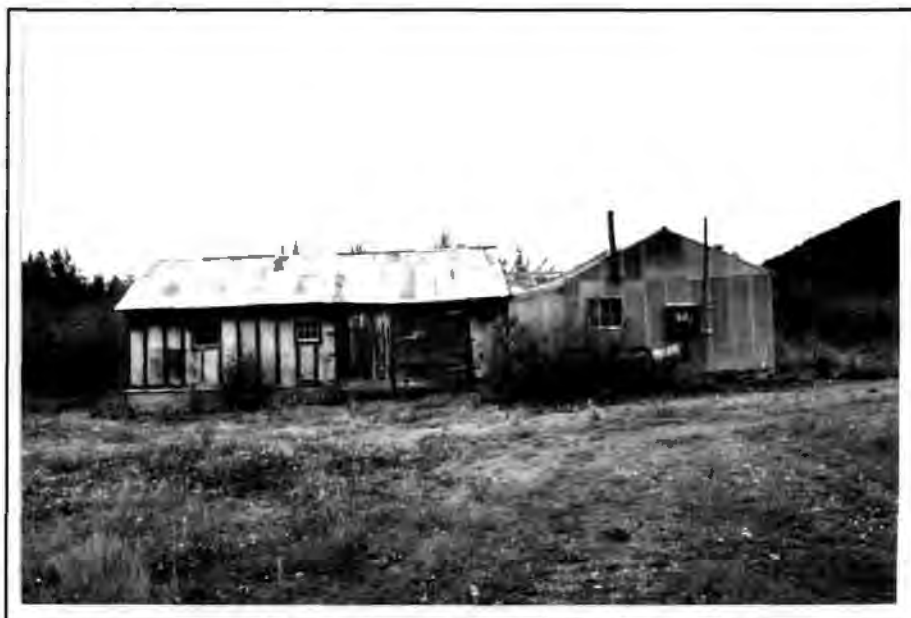
The **Workshop and Garage (IDT-223)** is an "L" shaped, one-story, wood frame building (Figure 154). The northern part of the building is rectangular in shape and has a gable roof oriented east-west. The roof and exterior walls are covered with corrugated metal. The east elevation has a six-light, fixed sash window. The north elevation has a six-light, fixed sash window and a large utility door with a six-light, fixed sash window. A short, gable roof addition connects the workshop and garage with a smaller addition on the south. This addition is rectangular with a gable roof oriented north-south. The roof is covered with corrugated metal and the exterior is covered with celotex and batten boards. The east elevation has a pair of large side opening doors and two six-light, fixed sash windows. The west elevation has a six-light, fixed sash window.

**Figure 154. The Workshop and Garage, 1993.**  
The view is looking west.

Peter Miscovich built the northern portion of the workshop and garage building in 1935. He used the building to store and maintain tractors. The southern portion of the building was the powerhouse at the Wireless Station in Flat (IDT-130). John Miscovich moved the powerhouse to the Discovery/Peter Miscovich Camp and attached it the garage (Miscovich 1995:IV-50; VI-100).

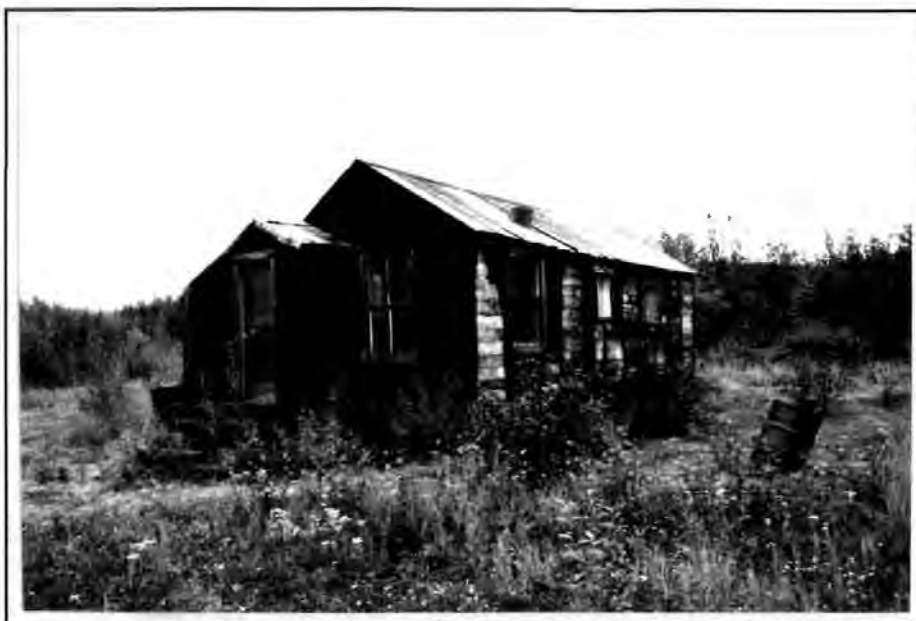
The **Peter Miscovich Office/Residence (IDT-224)** is a rectangular, one-story, wood frame building (Figure 155). The foundation is log piers. The gable roof is covered with corrugated metal. The exterior is covered with roofing felt over shiplap and wood siding. The main entry is on the north elevation, which contains a 2/2 single-hung window. An arctic entry with a gable roof covered with corrugated metal is located on the east side of the north elevation. The exterior of the arctic entry is covered with roofing felt over shiplap. A one-panel door with one light faces north. The east elevation of the Office/Residence has a two-light, fixed sash window. The west elevation has a 1/1 single-hung window, a two-light, fixed sash window, and a window opening with no glass. The south elevation has a one-panel door with one light.

**Figure 155. The Peter Miscovich Office/Residence, 1993. The view is looking southeast.**

This building was constructed in the 1920s about 300 yards from its present location. Peter Miscovich bought this building in 1948 from Martin Roslin and moved it to the Discovery/Peter Miscovich Camp after his original office/residence building was destroyed by a fire in 1947. Miscovich added the arctic entry on the north side after the building was moved (Miscovich 1995:VI-100).

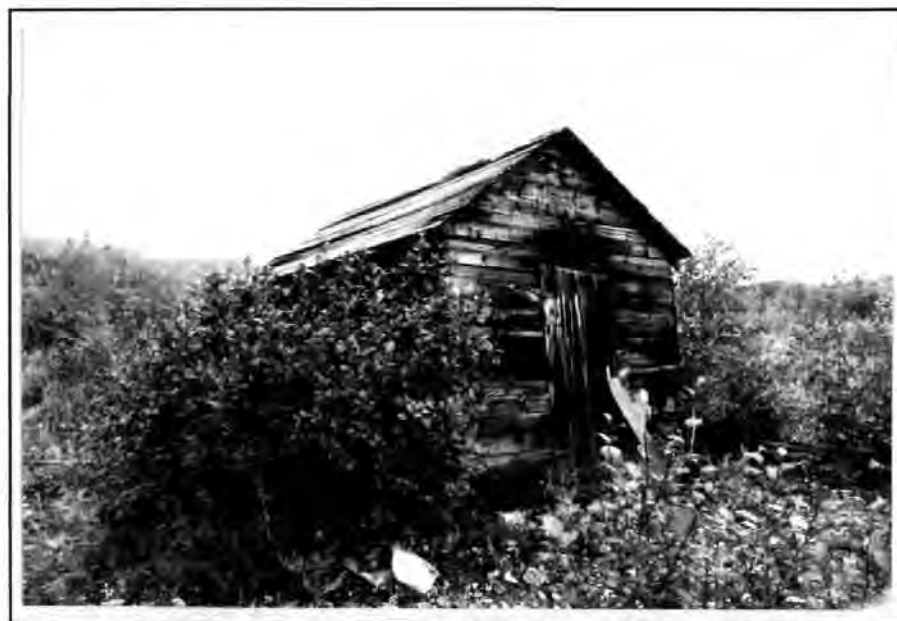
The Parts Shed (IDT-226) is a rectangular, one-story, wood frame building (Figure 156). The foundation is horizontal timbers on grade. The gable roof and exterior walls are covered with wood decking. The main entry is on the south elevation, which contains a plank door. The building has no other doors or windows.

**Figure 156. The Parts Shed, 1993. The view is looking northeast.**

The date the Parts Shed was built and whether it has been moved are unknown. Peter Miscovich used the building to store equipment parts (Miscovich 1995:VI-100).

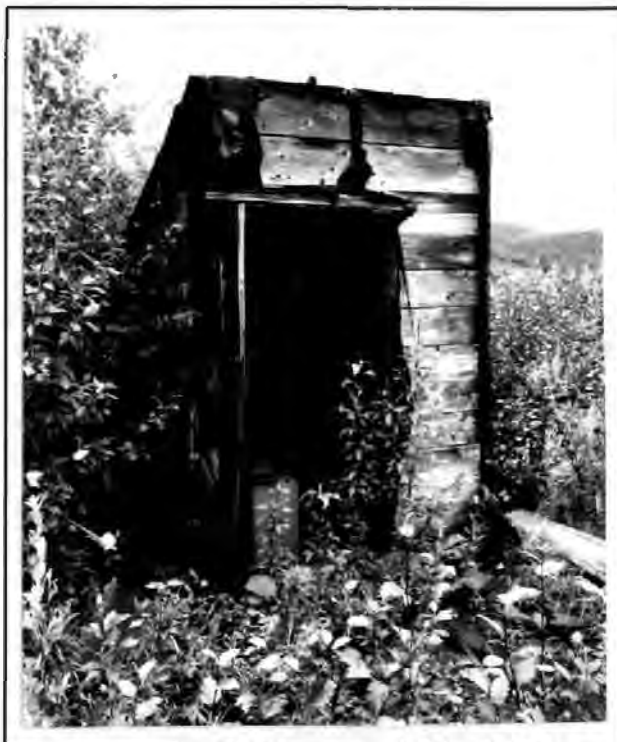
The **Generator Shed (IDT-225)** is a rectangular, one-story, wood frame building (Figure 157). The foundation is on grade. The shed roof and exterior walls are covered with roofing felt over wood decking. The main entry is on the south elevation, which contains a door opening but no door. The building sheltered a generator.

**Figure 157. The Generator Shed, 1993.**  
The view is looking north.

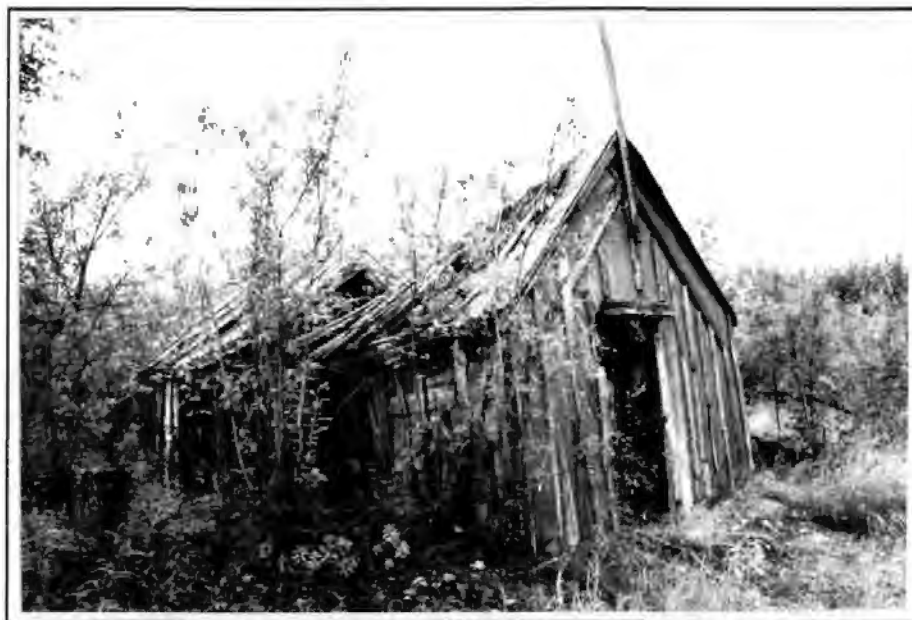
The **Miscovich Blacksmith Shop (IDT-227)** is a rectangular, one-story, wood frame building (Figure 158). The foundation is on grade. The partially collapsed gable roof is covered with roofing felt over wood decking. The exterior is covered with roofing felt over horizontal wood siding. The main entry is on the north elevation and contains a door opening but the door is missing. The building is in poor condition.

**Figure 158. The Miscovich Blacksmith Shop, 1993.**  
The view is looking southwest.

Peter Miscovich built the blacksmith shop in the 1920s in Flat. It was located near the site where Alex Matheson later built his home (IDT-102). The building served as his blacksmith shop when he was leasing the Guggenheim mining claims in the early 1920s. Peter Miscovich moved the building in 1924 when he started building the Discovery Camp. In recent decades, the Miscovich family has used the building for storage (Miscovich 1995:VI-100-101; Barnett 1995:162).

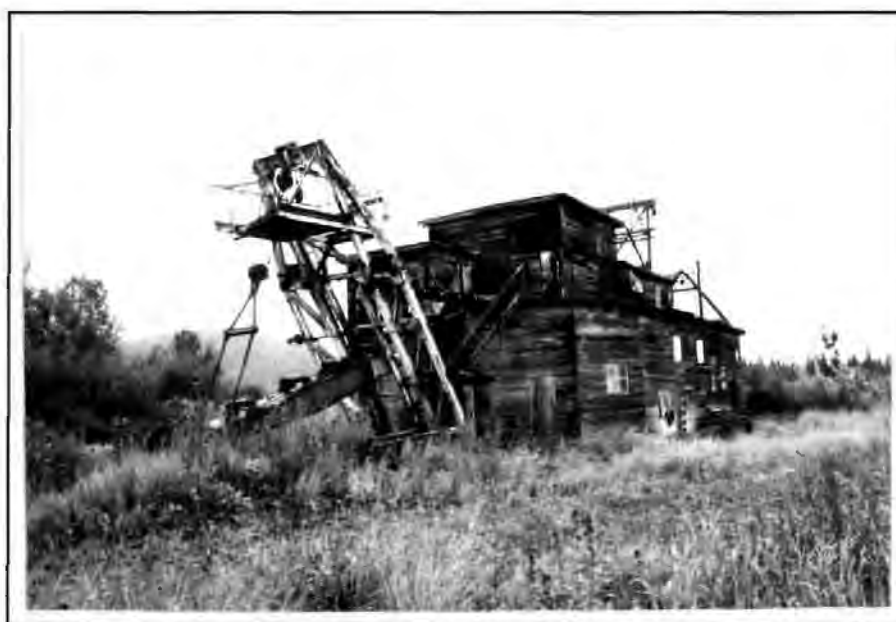
The Riley/Miscovich Dredge (IDT-220) is a three-story, steel frame structure (Figure 159) located three-quarters of a mile east of the Discovery/Peter Miscovich Camp. The hull is made of steel pontoons and rests on a shelf in a dredge pond. The flat roof is covered with roofing felt. The dredge measures 40'x220' and the exterior is covered with horizontal wood siding. Harry Donnelley converted the dredge from a wooden hull to a steel hull in 1938. The gasoline engine was also converted to a three-cylinder, 125 horsepower Enterprise marine diesel engine. John Miscovich replaced the wood-burning boiler, which was used to keep water used in the dredge from freezing in the spring and winter, with an oil-burning boiler in 1959. The dredge had 56-3.5 cubic foot buckets. The bucket line is about 40' south of the dredge.

**Figure 159. The Riley/Miscovich Dredge, 1993. The view is looking northeast.**

The Union Iron Works of San Francisco built the Riley Dredge. The dredge was shipped to Nome, but not used there. In 1914, the Riley and Marston Mining Company installed the dredge on the right limit of the Discovery Claim on Otter Creek, two miles east of Flat (Brooks 1914:56). The Riley Investment Company acquired ownership of the dredge and it mined near the confluence of Black and Otter Creeks from 1914 to 1920. It moved upstream toward Granite Creek, mining claims

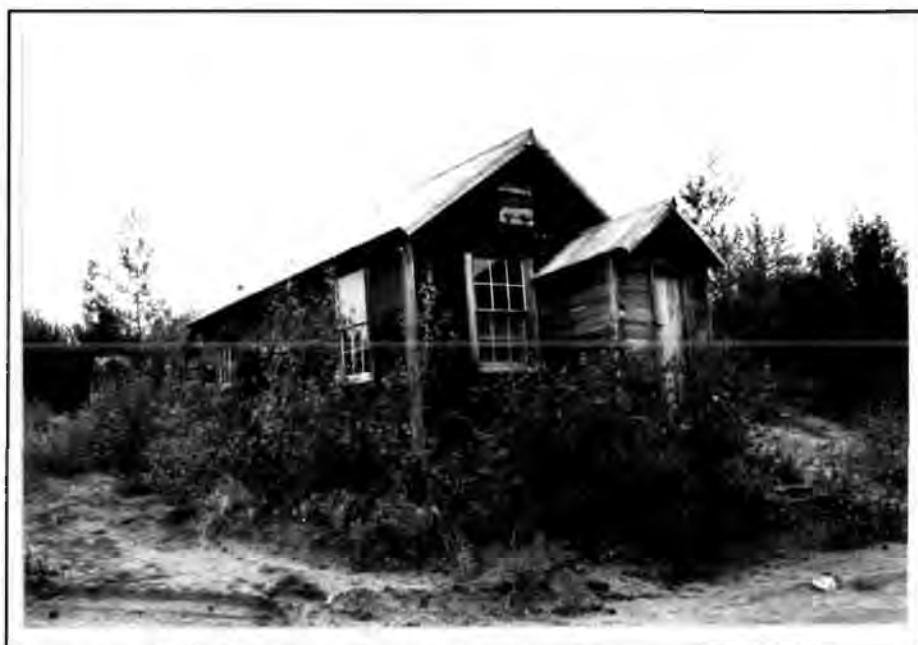
The **Golden Horn Assay Office (IDT-233)** is a rectangular, one-story, wood frame building (Figure 161). The foundation is timbers on grade. The gable roof is covered with corrugated metal. Shiplap siding covered by roofing felt covers the exterior walls of the building. An arctic entry with shiplap siding and a plank door is on the eastern half of the north elevation. Corrugated metal covers the gable roof. A 6/6 double-hung window is located west of the arctic entry. A 6/6 double-hung window and a six-light, fixed sash window are located on the east elevation of the building. A six-light, fixed sash window, a 6/6 double-hung window, and a five-panel door are on the west elevation. A shed roof addition on the south elevation has shiplap siding. The roof is covered with corrugated metal. A single-light, fixed sash window faces south.

Figure 161. The Golden Horn Assay Office, 1993. The view is looking southwest.

The assay office was built in the 1930s. Bert Needing, the mine manager, lived in the building during the 1930s. Living quarters were located in the front (north end) of the building. Assay activities were conducted in the back of the building (Miscovich 1995:VI-98-99).

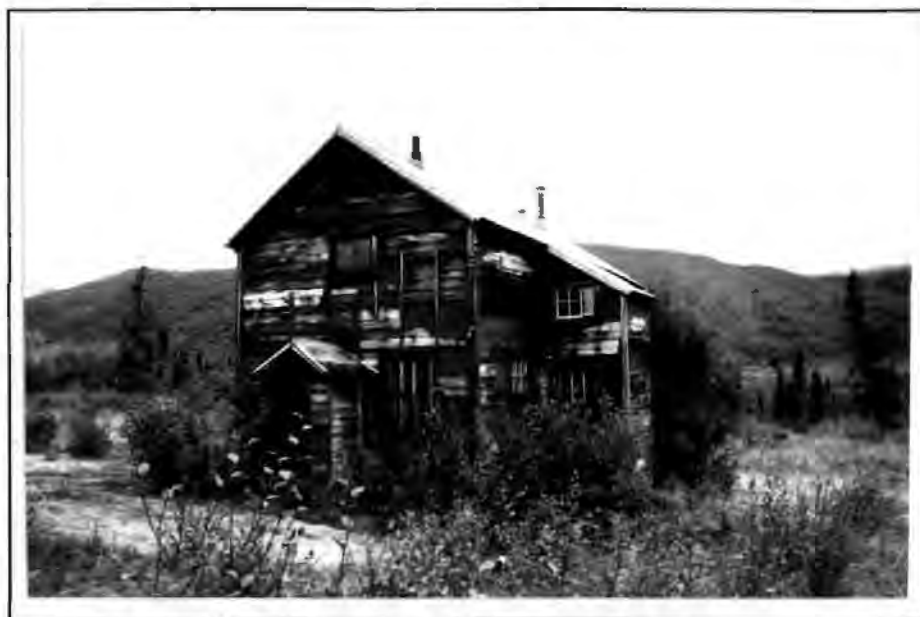
The **Golden Horn Bunkhouse (IDT-232)** is a rectangular, two-story, wood frame building (Figure 162). The foundation is timbers on grade. Corrugated metal covers the gable roof. The siding is shiplap covered by roofing felt. The main entry is on the south elevation. A gable roof arctic entry is centered on the ground floor. It is flanked by two 6/6 double-hung windows. A six-light, fixed sash window is located above the arctic entry on the second floor. Three 6/6 double-hung windows are located on the ground floor of the west elevation. The

**Figure 162. The Golden Horn Bunkhouse, 1993. The view is looking northwest.**

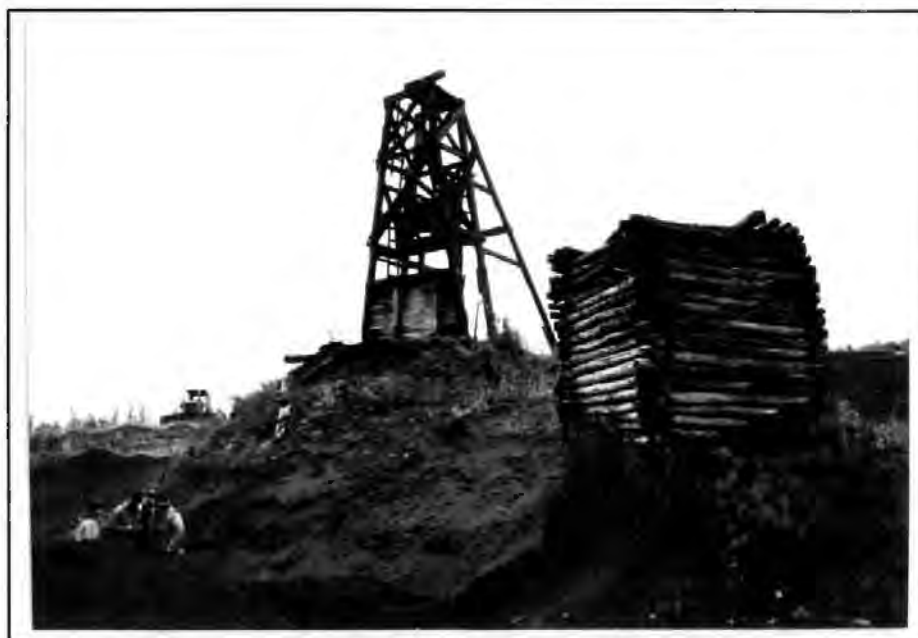
The **Golden Horn Log Cribbed Vertical Shaft (IDT-229)** of the Golden Horn Mine Complex is a log structure made with double-notched logs (Figure 163, right foreground). The depth of the shaft is unknown.

The **Golden Horn Wood Framed Vertical Shaft (IDT-230)** is a wood frame structure constructed with planks and timbers (Figure 163, center). The shaft is framed with vertical timbers and the interior is sided with horizontal wood planking. The vertical shaft extends down through four levels. The depth of the shaft is unknown (Bundtzen *et al.* 1992:22).

**Figure 163. The Golden Horn Wood Framed Shaft (center) and Log Cribbed Shaft (right), 1993. The view is east.**

Mining engineer Wesley E. Dunkle constructed the vertical shaft in the mid-1930s.

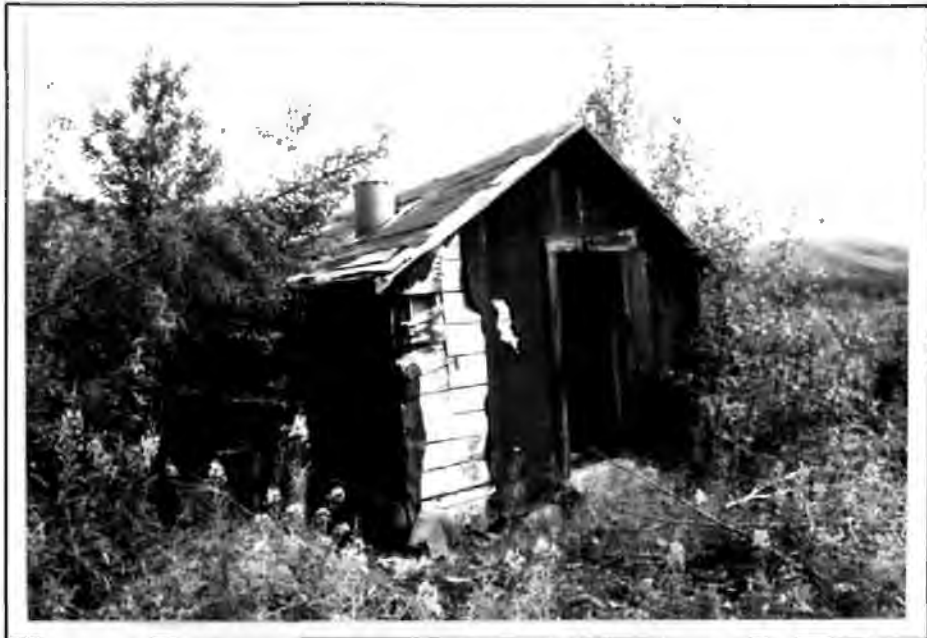
The **Small Bunkhouse (IDT-237)** is a rectangular, one-story, wood frame building (Figure 165). The gable roof and exterior are covered with roofing felt over horizontal siding. The building measures 17'9"x20'4" and the roof line is oriented east-west. The main entry is on the east elevation but has no door. A window opening is located on the north and west elevation. The cabin is in poor condition.

**Figure 165. Small Bunkhouse, 1993.**  
The view is looking southeast.

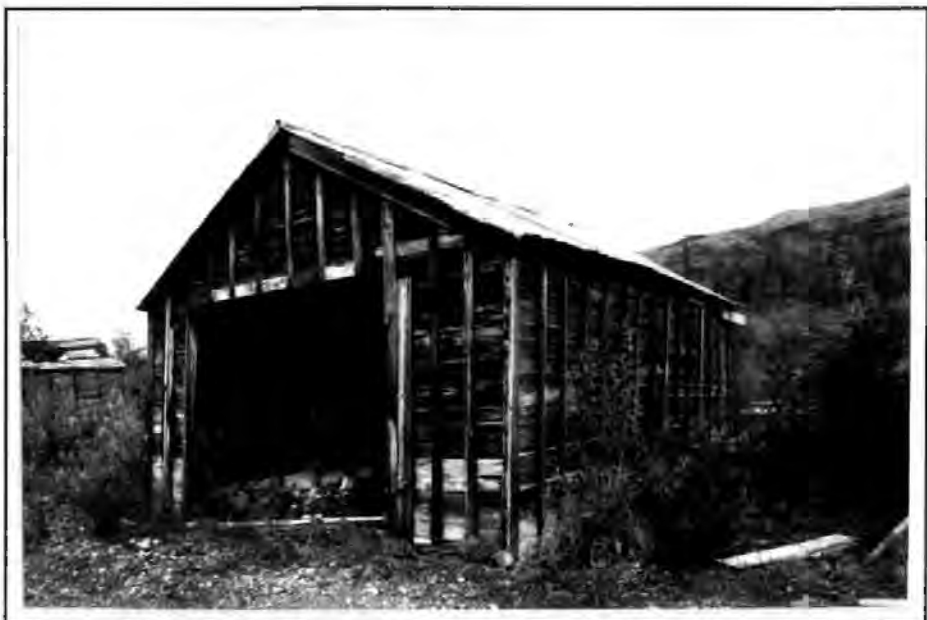
The **Garage (IDT-238)** is a rectangular, one-story, wood frame building (Figure 166). The foundation is on grade. The gable roof is covered with corrugated metal. The exterior is covered with roofing felt and battens over shiplap. Most of the roofing felt is missing from the walls. The building measures 17'4"x20'7" and the gable roof is oriented east-west. The garage has large door openings on the east and west elevations, but the double

**Figure 166. The Garage at the Fullerton Camp, 1993.** The view is looking northeast.

doors are missing. Most of the interior of the garage is flooded by water from a beaver pond located immediately to the east.

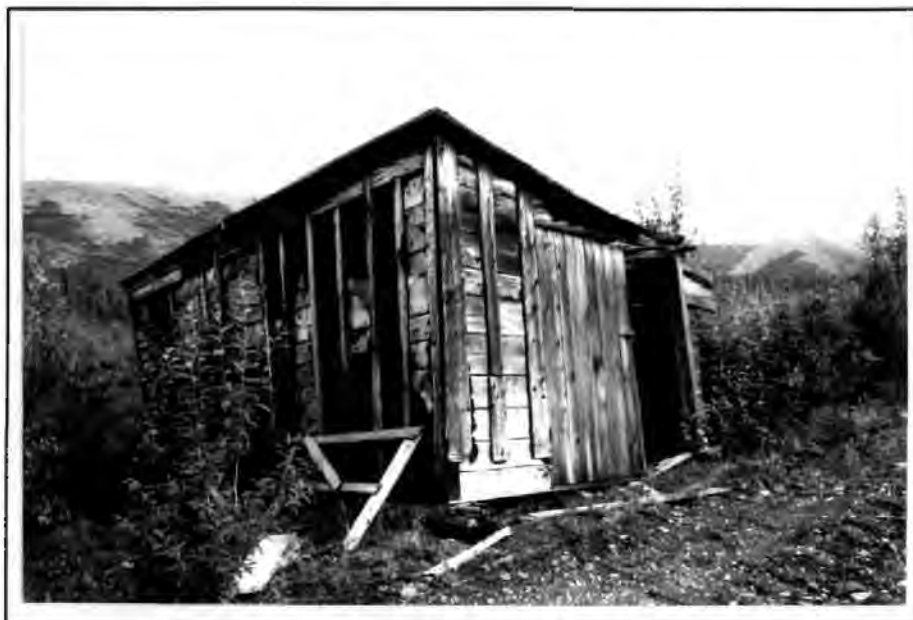
The **Storage Shed (IDT-239)** is a rectangular, one-story, wood frame building (Figure 167). The foundation is logs on grade. The partially collapsed shed roof is covered with roofing felt over wood decking. The exterior walls are covered with roofing felt and batten boards over horizontal siding. Most of the roofing felt is missing. The building measures 11'6"x 20'7". The main entry is on the west elevation, which has a large plank door and a smaller door opening.

The door to the latter is missing. The building is in poor condition and is partially flooded by a beaver pond immediately to the east.

**Figure 167. The Fullerton Storage Shed, 1993. The view is looking southeast.**

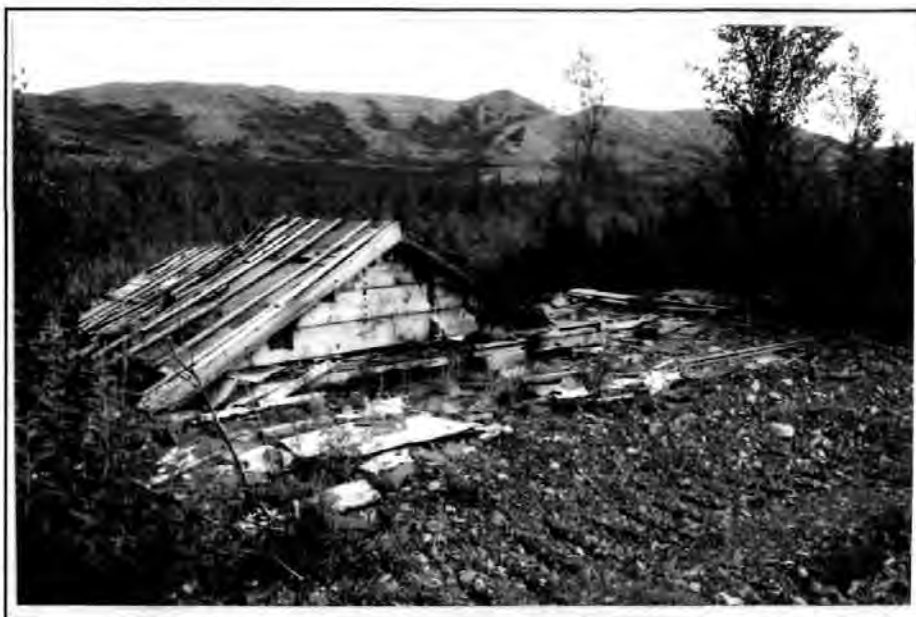
**Figure 168. The ruins of the Fullerton Work Shop, 1993. The view is looking southeast.**

The **Work Shop Ruins (IDT-241)** consists of the remains of a rectangular, one-story, wood frame building (Figure 168). The foundation is wooden blocks. The floor is made of decking and is intact. The rest of the building has collapsed. Roofing felt and batten boards cover the gable roof, which is intact. The building measures 17'2"x18'4". The exterior was

covered with roofing felt over wood siding. The north wall is partially intact, but is laying north of the building foundation. Sections of the other walls and artifacts, such as rusted tools and five 50 gallon barrels, are scattered around the ruins.
