# Full Stream Ahead

May/June 2007

### Oregon's John Day River Proper Functioning Condition Assessment on a Large River

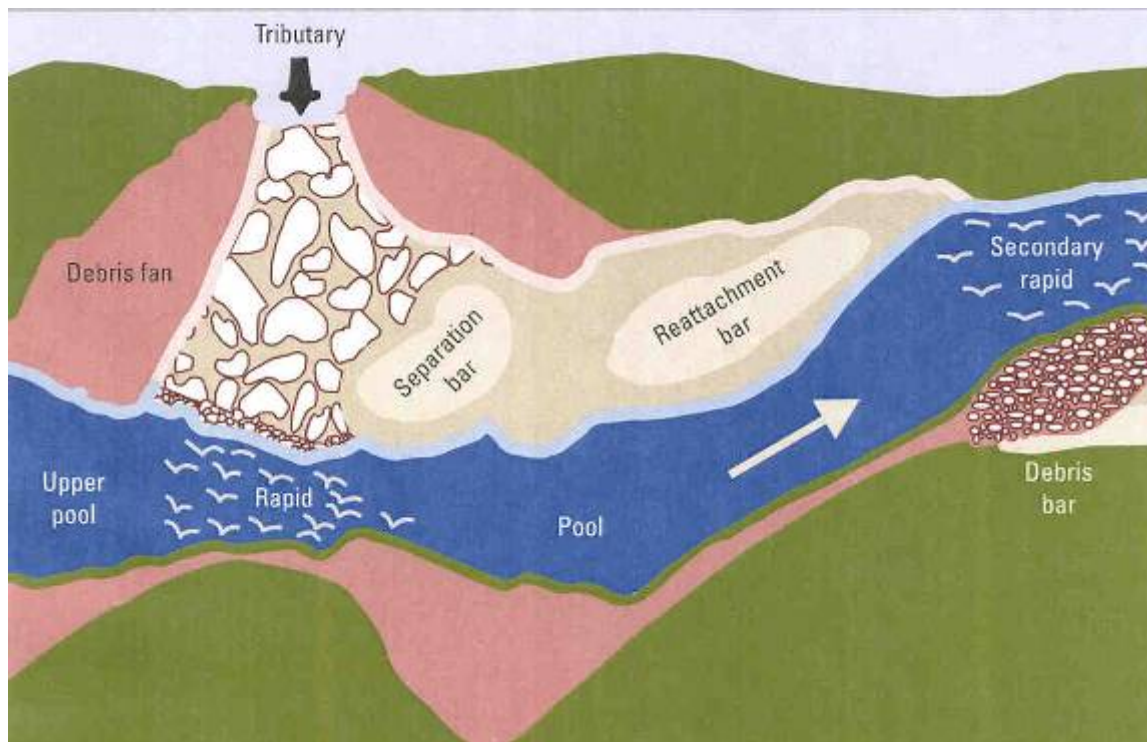
**Figure 1.** Diagram showing a fan-eddy complex in Grand Canyon on the Colorado River. The same process is occurring in the John Day River system. Debris flows from tributary canyons carry coarse sediment that is deposited at the juncture with the river, forming deposits called debris fans. Debris fans constrict the river and raise its bed elevation, creating rapids. Especially during floods, the river entrains the sediment on the debris fan and transports it downstream through the pool, where the larger particles become lodged on debris bars that form secondary rapids. Between the constrictions of the primary and secondary rapids, pools and eddies form, creating a depositional setting (adapted from Gloss, S.P., Lovich, J.E., and Melis, T.S., eds. 2005. The state of the Colorado River ecosystem in Grand Canyon: U.S. Geological Survey Circular 1282, 220 p.).

The lower John Day River flows through repeating areas of narrow and wide valley bottoms. There is the real possibility that a large canyon river's dimension, pattern, and profile are controlled by the landform through which it flows. When we looked at the lower John Day River, even through canyon reaches, we found that while the landform does play a role, so does riparian vegetation. Large wood undoubtedly played an important role prior to exploration and development. In the narrowest canyon reaches, tributary confluences are "hot spots" for riparian areas. If a tributary delta or canyon-wall rock fall is large enough (i.e., both in terms of quantity and size of particles delivered to the John Day River), the deposit will produce a constriction of the main-stem channel at high flows, creating backwater conditions of greater depth and slower velocities, inducing deposition of finer sediments upstream from the constriction. As high flows work down through the constriction, finer particles in the tributary sediment deposit may be transported downstream, producing a slender point bar on the side of the initial tributary input (see Figure 1). In the wider valley bottom reaches, riparian vegetation and large woody material is necessary for energy dissipation, point bar and floodplain development, etc.

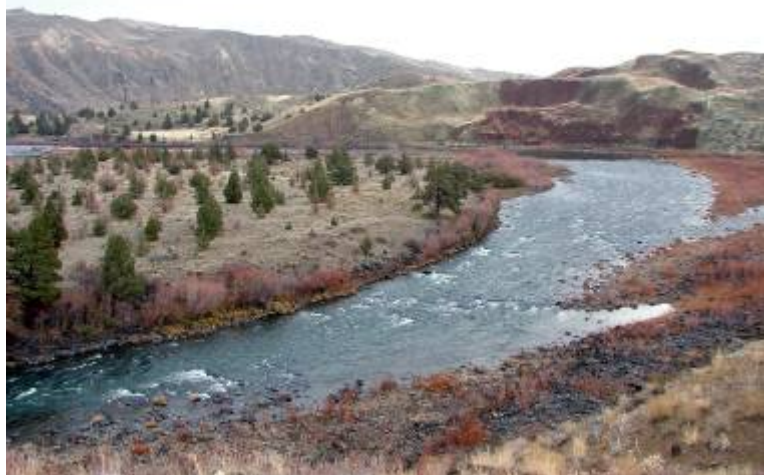
**Figure 2.** The red stems of coyote willow clearly show the extent of colonization of rocky banks below Clarno Rapids. This photo was taken in early December 2006, with river flows about 400 cubic feet per second. A few days later, nearly all the willows were inundated and remained so until June 2007.

The brunt of the recovery is being carried by these few species with other willows, sedges, rushes, and bulrush filling in where smaller sites can accommodate them. The current flow conditions and substrate variety requires this flexibility in species composition. In this recovery, plants are needed that can stay totally submerged for up to 6-8 months like torrent sedge and threesquare bulrush, to plants that can be wet and then dry for several months but still have root masses that can withstand high flows such as coyote willow (see figure 2). The John Day River is dictating the conditions needed to recover and the group of plants that meet those requirements are the ones present today, facilitating the evolution from its current state and moving it toward the higher identified potential. Some of these species are ones we don't particularly relish like reed canarygrass, but at this point in recovery it is doing the job and we feel that through succession it may have a reduced extent (see figure 3).

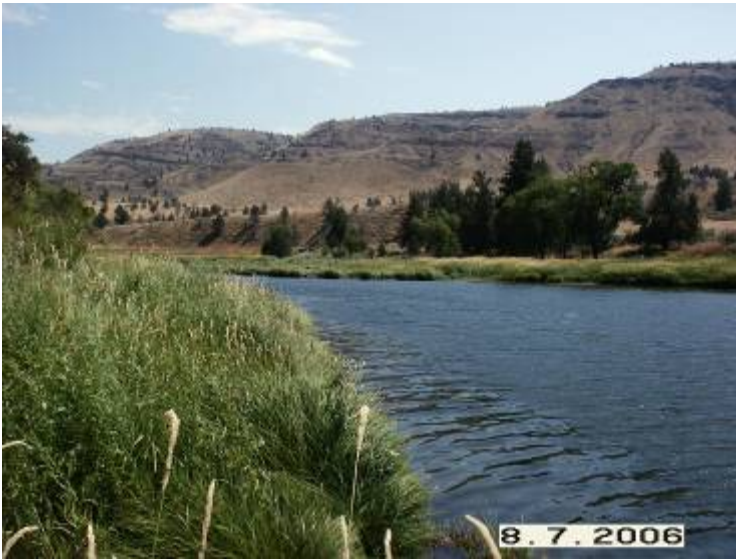
**Figure 3.** Wide, slow-flowing section of the upper river where both banks are completely covered by a combination of torrent sedge at the lowest level and reed canarygrass higher on the banks. This is a repeating pattern in this type environment throughout the river.

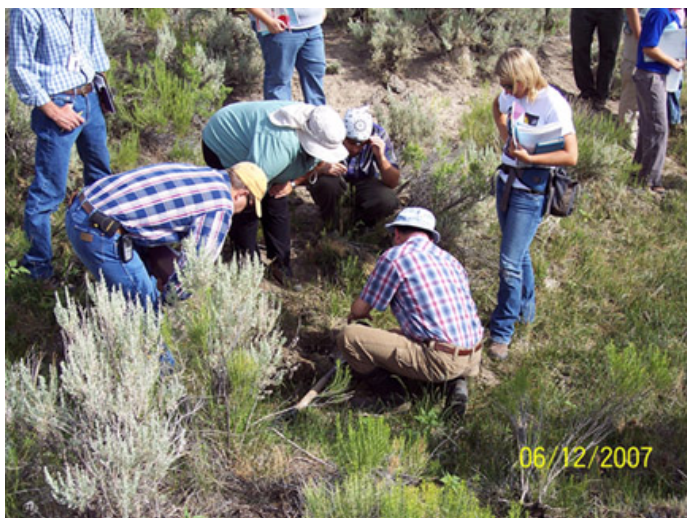
Desi Zamudio showing group hydric soil features on a lentic site.

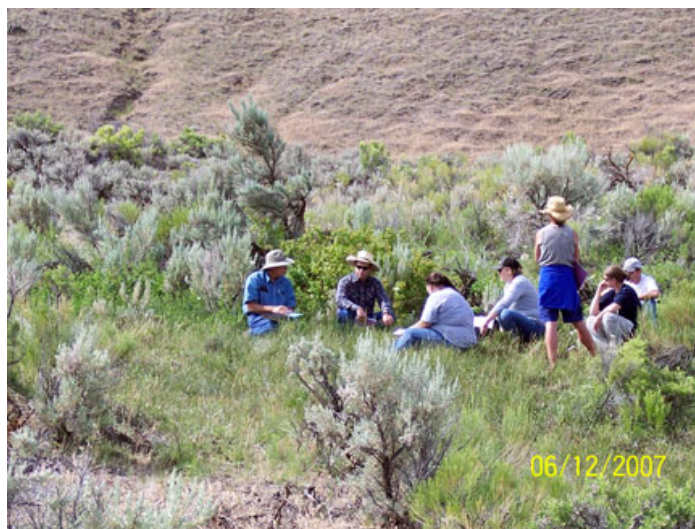
ID Team discusses the lentic PFC assessment on a spring fed wetland.
